Ground-Penetrating Radar  
Report# 20808  
City of Fort Saskatchewan – Harbour Pool

1 March 2017

Re: **Ground-penetrating Radar Digital Report #20808**

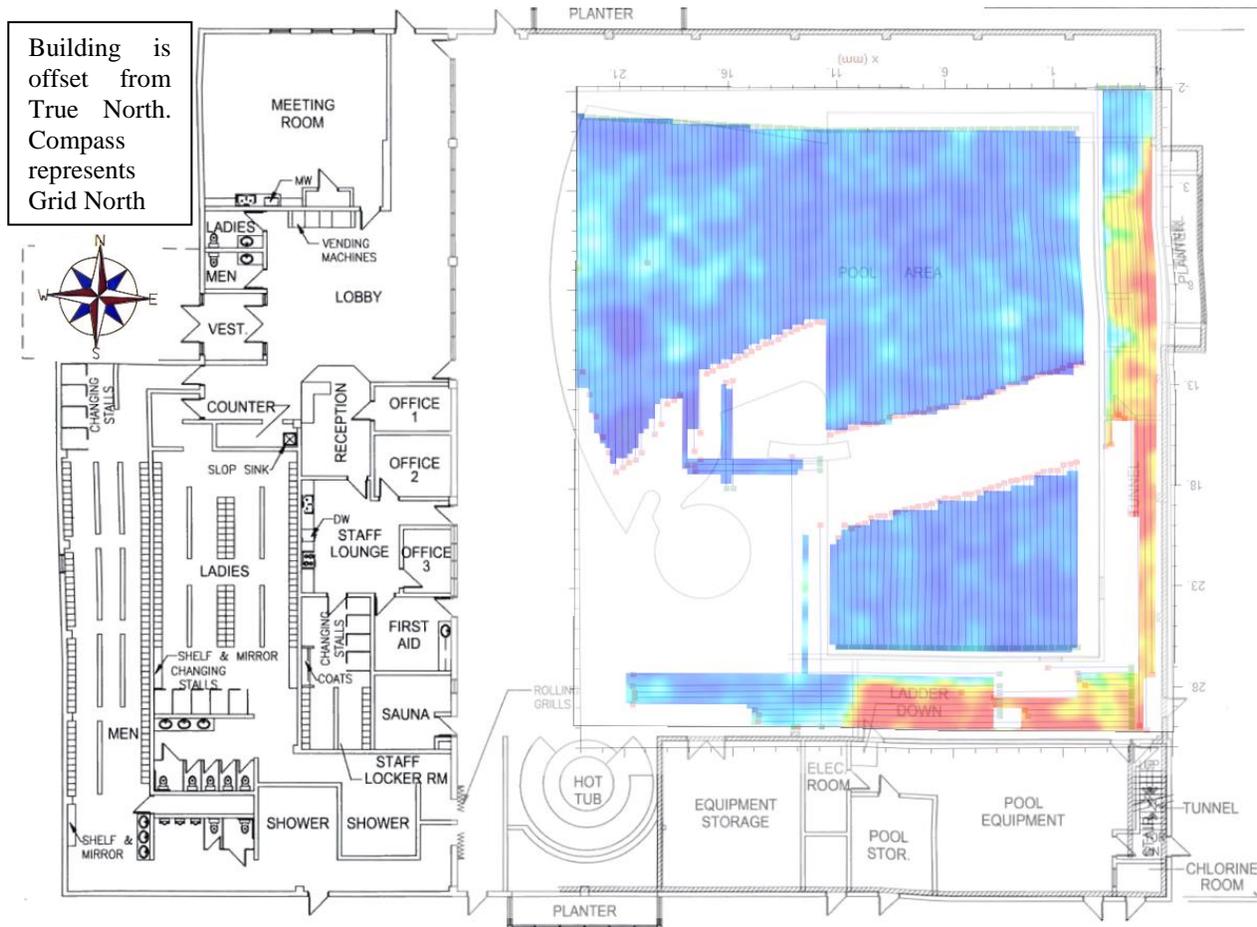
**Figure 01:** Overlay of pool area drawing, pool basement drawing, GPR data coverage and reflectivity map from the bottom of the concrete slab.

The data in the image above shows a large number of highly reflective areas. Typically, such strong reflectivity near the bottom of a concrete slab would coincide with suspected voids. The data lines up consistently with tunnels, rooms and other known voids, shown in the basement map. The areas surrounding tunnels all appear as relatively low reflectivity within a narrow and consistent range. The data which is shown in various shades of blue in the included imagery is considered low probability of voids. The areas within the tunnels and basement rooms all appear red, indicating a high probability of containing voids, which is exactly as expected.

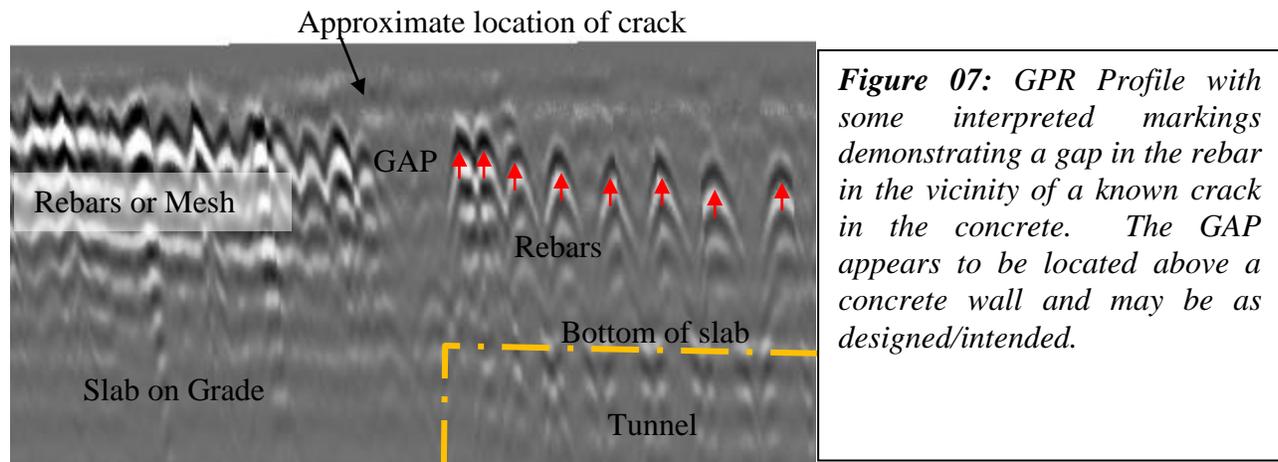
At the northeast corner of the pool basin a crack has formed running roughly east/west, but curving towards the northeast. This crack appears to be located near the northern end of the tunnel system. The concern was described to Maverick as being that a potential void beyond the tunnel, and large amounts of shifting in this case, could allow water intrusion into the tunnel system.

The examination of the GPR data within this area yields little or no evidence of voiding beneath the pool deck slab.

There does appear to be a wider spacing of the steel reinforcement bars in this precise area. In the GPR data, which runs north to south, and displays the east/west rebar, there is a single space between two adjacent rebars which is approximately double the spaces between any of the other rebars. The location of this additional gap appears to coincide with the wall denoting the north end of the tunnel below. This may be as designed/intended.

**Figure 07:** GPR Profile with some interpreted markings demonstrating a gap in the rebar in the vicinity of a known crack in the concrete. The GAP appears to be located above a concrete wall and may be as designed/intended.

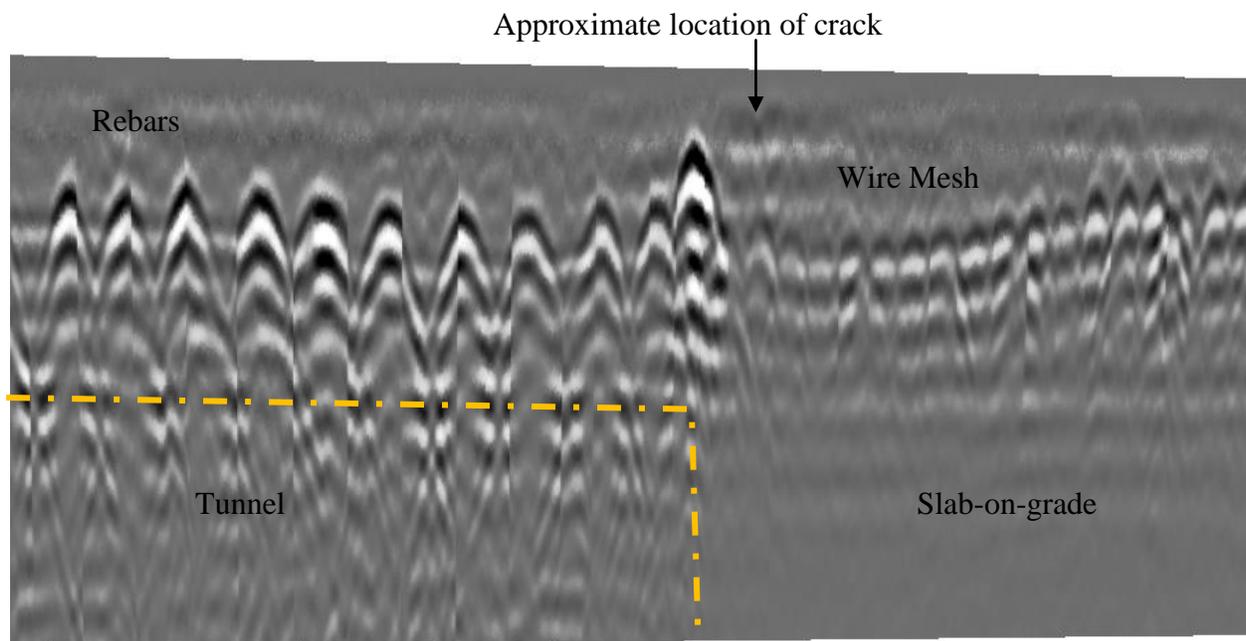
At the southwest corner of the pool another crack was noted, running approximately north/south from the edge of the pool. This location also lines up with end of a tunnel in the basement area.

The GPR data from this area indicates a transition from a structural slab containing multiple patterns of steel bar reinforcement to a slab-on-grade containing what appears to be wire-mesh. The crack which formed appears to be in the immediate vicinity of the slab change.

**Figure 02:** GPR profile showing the transition from structural slab to wire-mesh slab-on-grade.

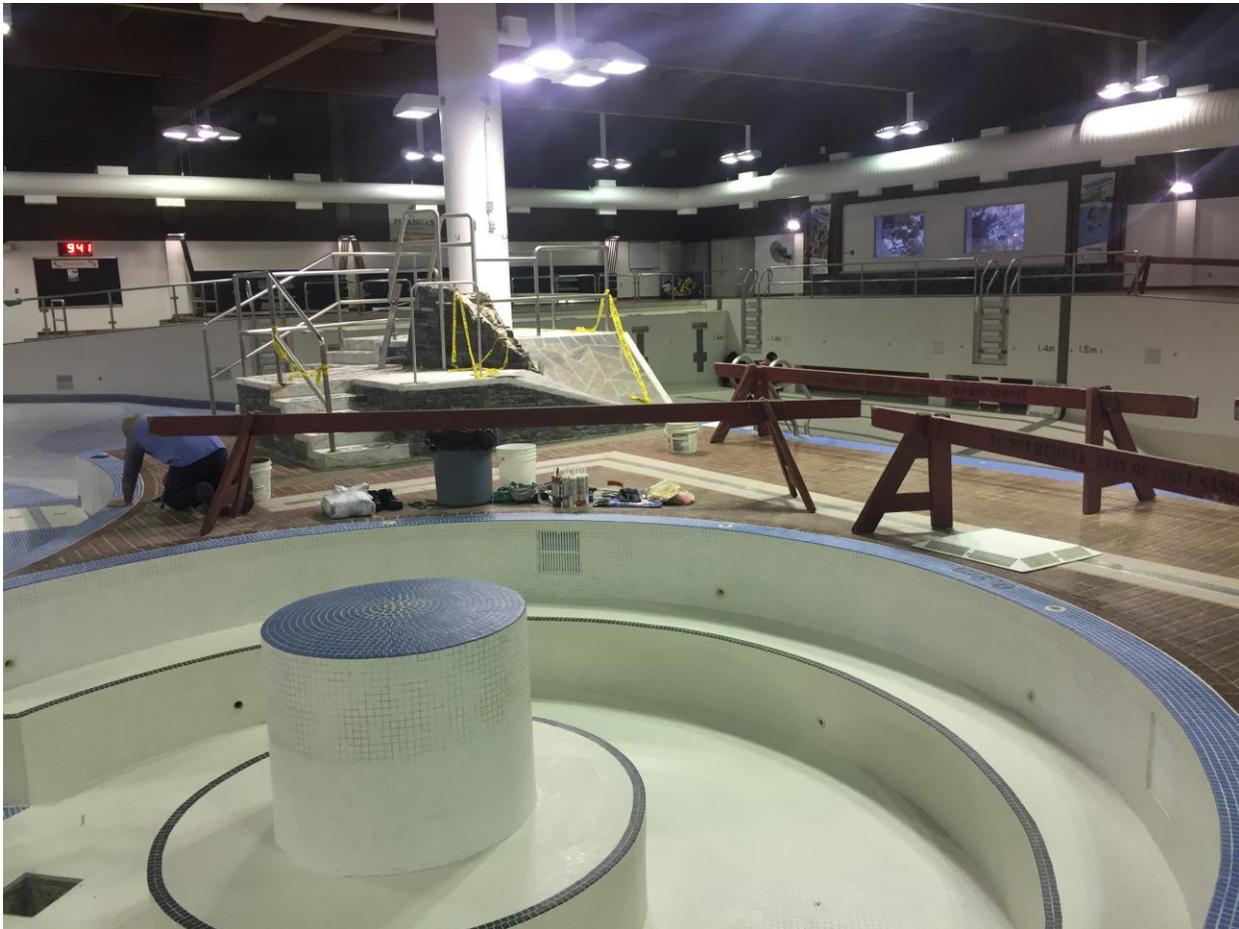
**Figure 03:** A photograph of the “island” structure which includes an unexpected crack in the concrete parallel to its south face.

The island area was examined using GPR. The lines of data immediately adjacent to the island show a complete lack of top-surface rebar. It may be that the rebar was cut and removed when the island was installed, or it may be that the area was designed to allow for relative movement between the main column and the rest of the pool deck.

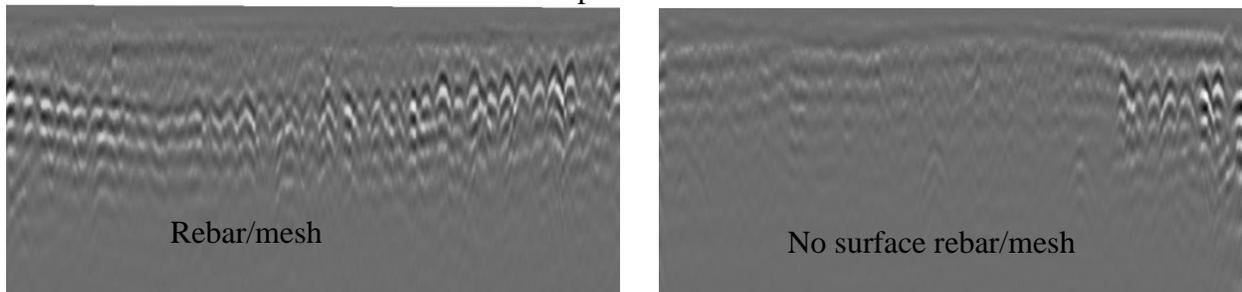
**Figure 04:** Two adjacent GPR profiles. The left image was gathered approximately 0.4m from the island, the right image was gathered 0.1m from the island.
