February 04, 2019

**RE: Harbour Pool – City of Fort Saskatchewan
Main Pool, Warm Pool, and Whirlpool Additional Testing**

RJC No. EDM.118534.0003

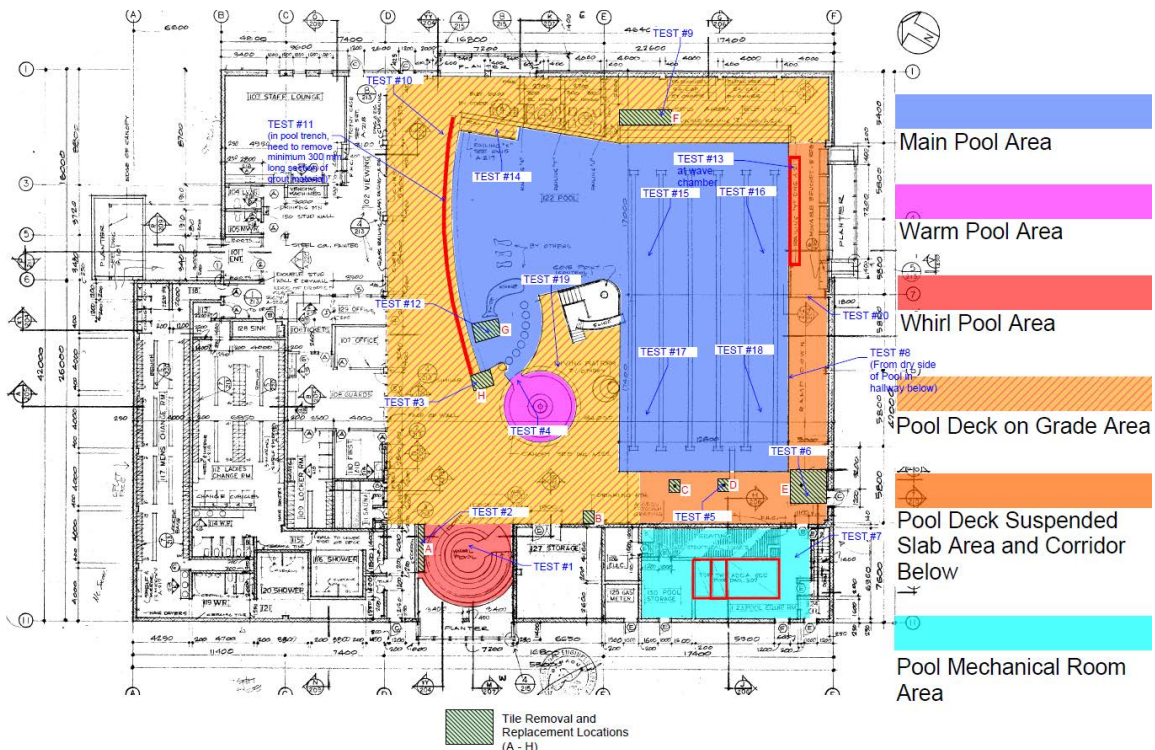
Figure 1: Pool Deck Area – Chloride Test Locations (1-20) and Tile Removal Areas (A-H)

The chloride testing performed indicates that this threshold limit has been exceeded at four test locations (Nos. 10, 11, 13, and 20). Concentrations are approaching the threshold at eight locations (Nos. 7, 8, 9, 12, 14, 15, 18, and 19). Very low concentrations were recorded at the Whirl Pool, adjacent deck, and at select locations in the Main Pool and surrounding deck (Nos. 1 to 6, 16, and 17). We also noted that the testing did not identify high chloride contamination at debonded tile locations.

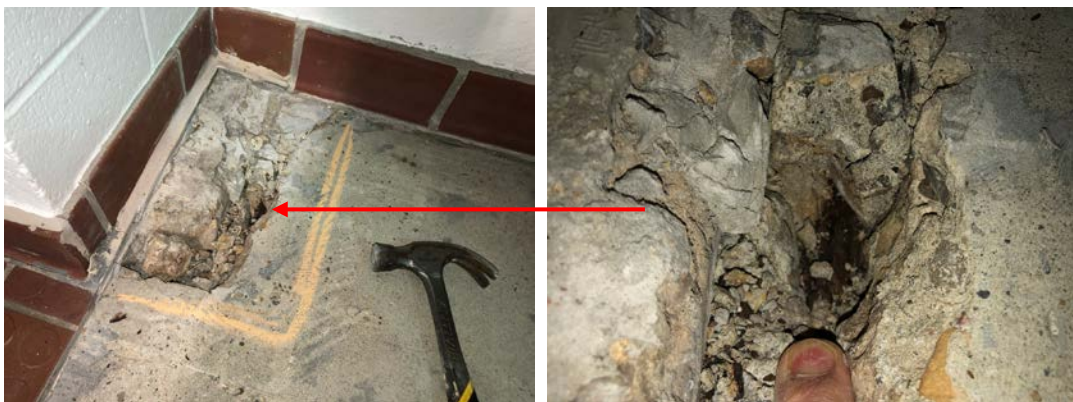
- It is our understanding that repairs and waterproofing are being completed by the Owner's Contractor as per recommendations within our March 2018 Structural Assessment report. RJC was not involved with the repair program.
- The concrete slab-on-grade surfaces at Tile Removal Area A, adjacent to the Whirl Pool, appear to be in good condition. No issues were identified.
- Concrete delamination due to corrosion of steel reinforcement and concrete spalling was identified at Area B (Photo 1). Concrete spalling appears to be the result of differential movement at an existing expansion joint in the slab-on-grade structure. The existing reinforcement exposed at the concrete spall is experiencing significant signs of corrosion.

Photo 1: Delamination at expansion joint below Tile Removal Area B

Chain drag testing and hammer sounding of the suspended and slab-on-grade surfaces identified very little deterioration, except at existing drains and mechanical penetrations, which were considered to be in poor condition. Spalled and unbonded grout material were identified at other locations of tile removal. Concrete repair, waterproofing, and detailing at these locations are recommended.

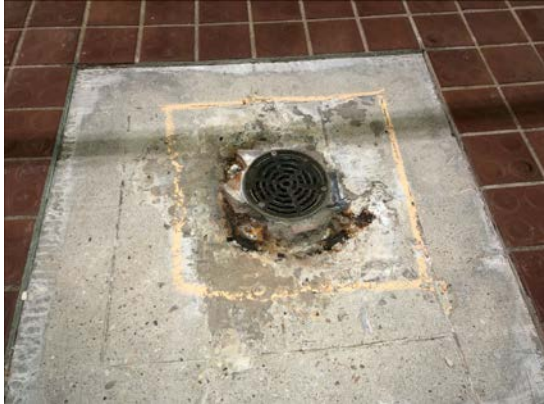
- Concrete delamination due to corrosion of the embedded steel reinforcement, in the suspended structural slab, was identified at Areas C and D, adjacent to existing floor drain locations (Photos 2 and 3).

Photo 2: Delamination at Tile Removal Area C

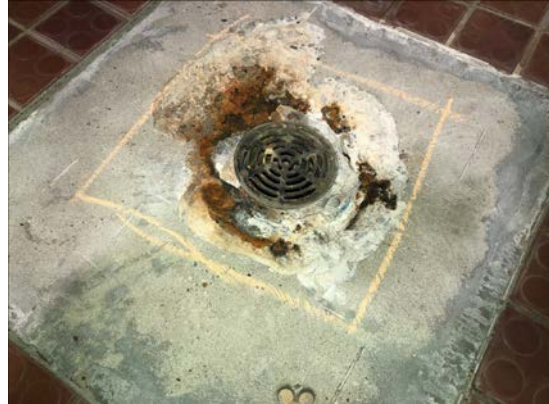
Photo 3: Delamination at Tile Removal Area D

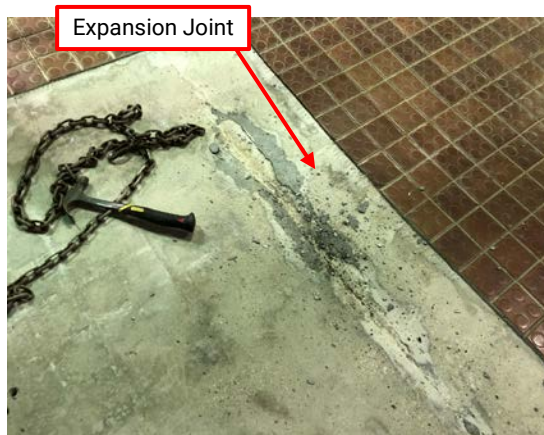
- Unbonded grout at the expansion joint in Area E was noted at the southwest end of the pool deck, adjacent to the emergency exit doors (Photo 4).

Photo 4: Unbonded grout at expansion joint

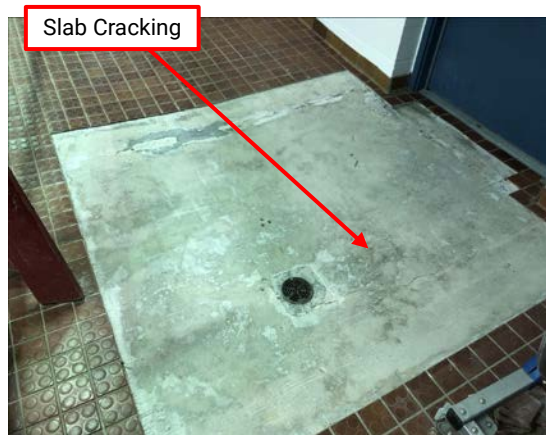
Cracking in the suspended slab was also observed running in line with the floor drain in this area (Photo 5). Visual review of the slab soffit identified efflorescence staining directly below the surface crack, indicating moisture penetration through the tile and grout finishes, and through the structure at this location.

Photo 5: Slab cracking at Tile Removal Area E

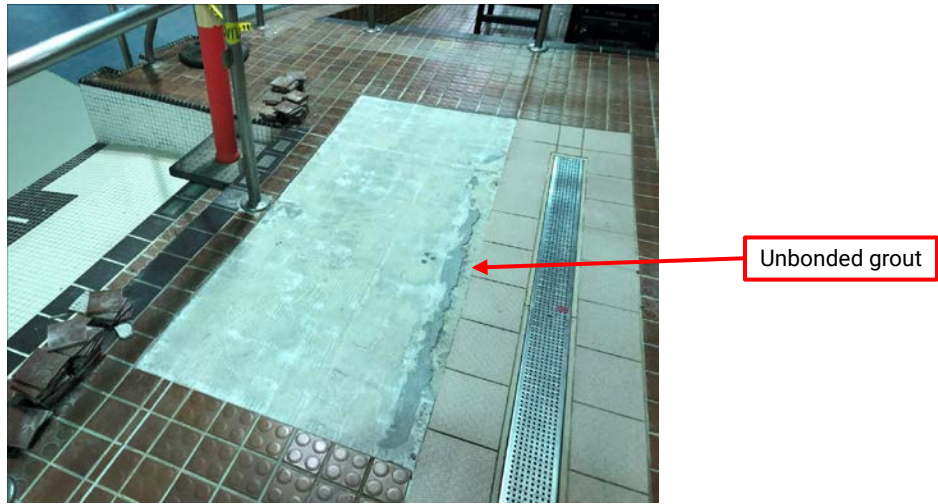
- Unbonded grout adjacent to the floor drain trench was identified at Area F (Photo 6). The grout in this area appears to have been installed to allow for sloping towards the trench.

Photo 6: Spalled grout sloping material at Tile Removal Area F

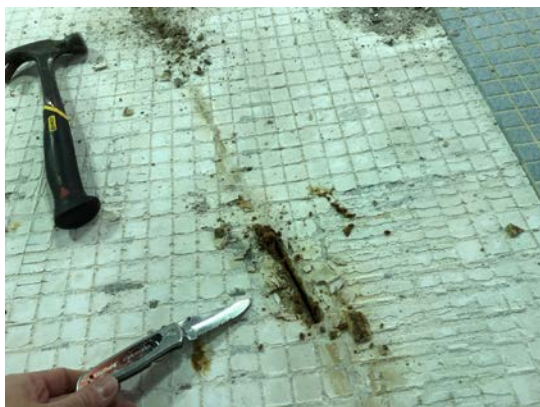
- Significant debonded tile was observed at the west end of the Main Pool area, adjacent to the Warm Pool, Area G. Review of the structural drawings indicated a control joint located in the area of removal. The joint is approximately 2" deep and a moist sand/clay material was identified in the joint (Photo 7). Moisture appears to be migrating below the tiles in this area along the joint.

Photo 7: Control joint at Tile Removal Area G Photo 8: Unbonded grout at Tile Removal Area G

In general, the concrete structure appears to be performing well at this time. Removal of tiles at locations previously identified as debonded appears to be primarily at locations of existing expansion or control joints in the structure and around drain and penetration locations. It appears that movement at joint locations is occurring, resulting in failure of the tiles above, and allowing moisture penetration to occur below. Waterproofing and detailing joint locations to allow for movement would be required to minimize moisture penetration and future deterioration of the tile finishes.

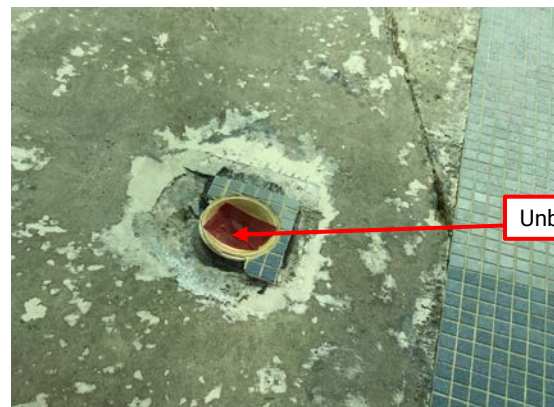
The concrete structure generally appears to be in good condition; however, unbonded grout was identified at the mechanical penetration (Photo 8) during hammer sounding.

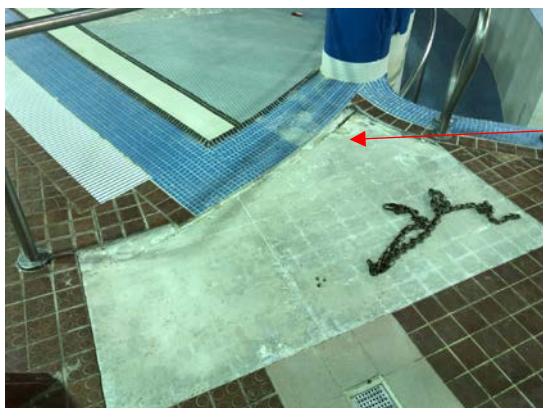
- Concrete delamination and spalling were identified at Area H, at the existing expansion joint intersection (Photo 9 and 10). Concrete spalling appears to be the result of differential movement at an existing expansion joint in the slab-on-grade structure.

Photo 9: Tile Removal Area H

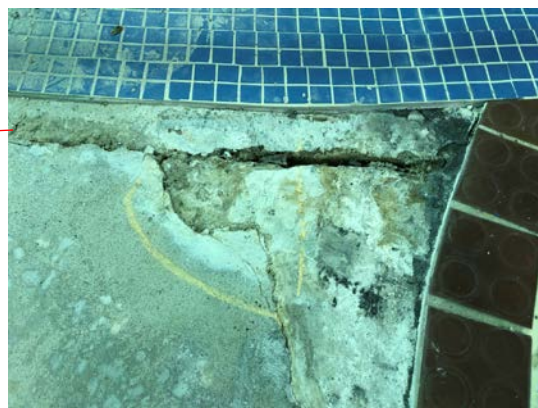
Photo 10: Concrete delamination at expansion joint
