September 4, 2014  
Project No. 214320  
**FINAL**

**CITY OF FORT  
SASKATCHEWAN**

## **HARBOUR POOL FACILITY EVALUATION, FORT SASKATCHEWAN, ALBERTA**

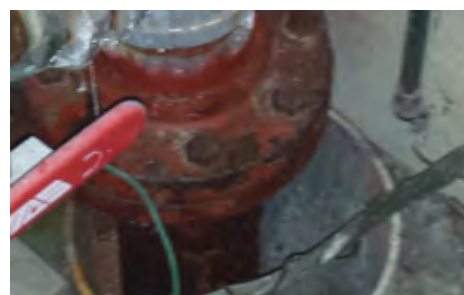
**Figure 1: Corrosion Pitting on DCW**

The Aquatic Centre has its own dedicated 100mm diameter water service. The water service enters into the pool mechanical room where it is reduced in size to 50mm before passing through a water meter then servicing the facility. Deepening Surface corrosion in apparent on the domestic water service flange connection. This is caused by condensation from moisture produced at the adjacent element pool filtration system on the surface. We recommend refurbishing the surface to remove rust and re-application of rust inhibitor paint.

*Opinion of Probable Cost = < \$500*

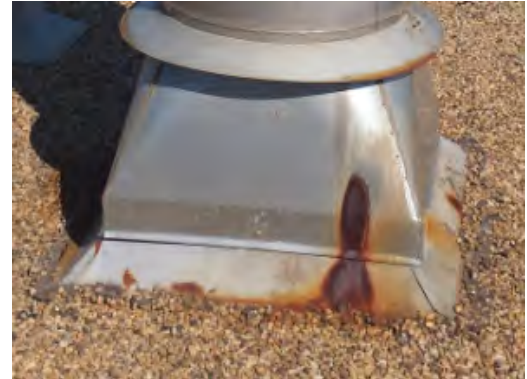
**Figure 2: Surface Corrosion at B Vent Base Flange**

AS-1 is located in the mechanical penthouse and operates in conjunction with a dedicated return air/relief air fan. The combined system is a recirculation system that provides a ventilation rate of (nominally) 30,000 cfm. This equates to approximately 6 Air changes per hour and satisfies the ASHRAE recommended range of 6-8 Air changes per hour for Pools with Spectator areas. The Air system is equipped with a category 1 heating furnace section that is vented with B vent up through the roof. AS-1 can provide tempered air as required for the facility during the heating season. AS-1 was noted to be in very good condition. Figure 2 indicates surface corrosion at the base of the flue. This is caused by the condensation of acidic flue gases falling on metal surface. This is also noted at the base of the Stainless Steel boiler vents as shown on Figure 3.

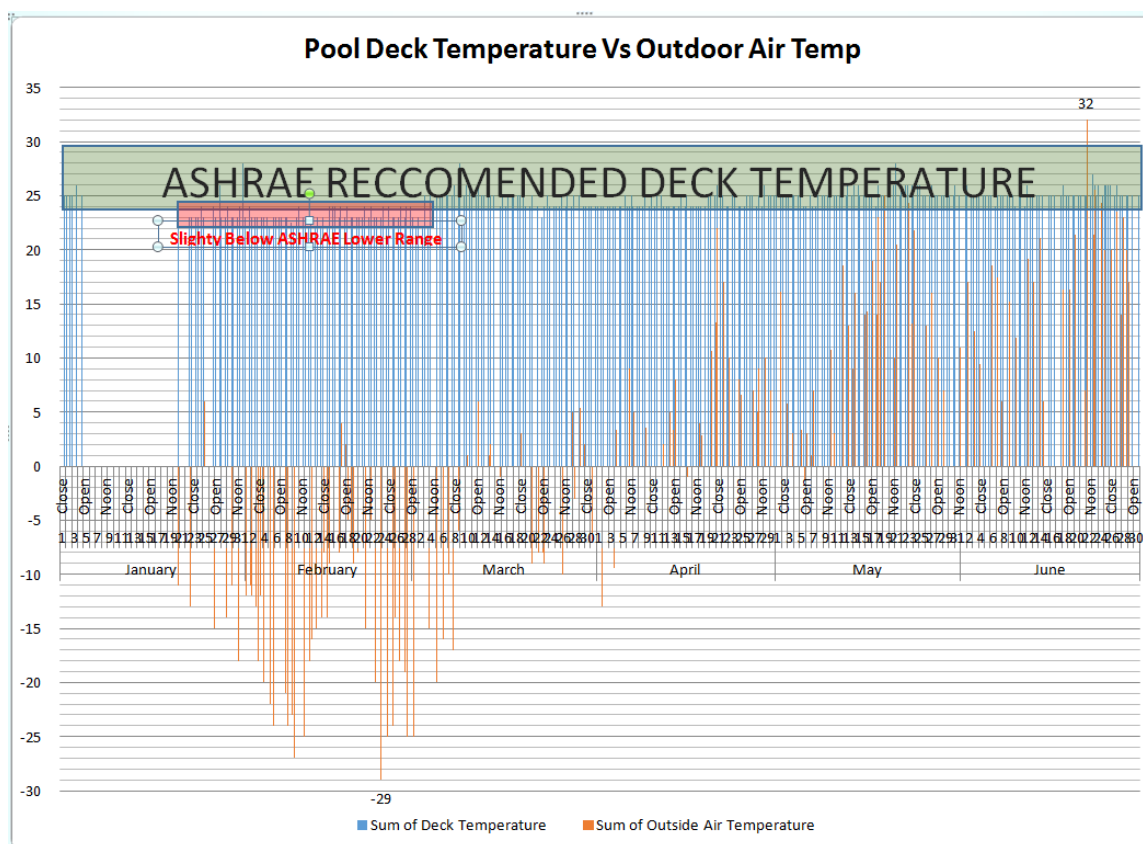
**Figure 4: Pool Deck Temp vs Outdoor Temp (January to June)**

The existing system was unable to maintain the environmental conditions on this humid day within the ASHRAE recommended limits due to the lack of active cooling/dehumidification in the system.

Figure 4 Summarizes received log information of pool deck temperature versus outdoor air temperature. The facilities group tracks temperatures during the open/noon/closing hours of the pool. It can be seen that for representative "Coldest days" The HVAC SYSTEM is capable of maintaining indoor deck temperatures. It is evident through that logged information for in February indicates that the deck temperature is slightly outside the recommended range. A Simple cause of this can be the deviation of calibration between the HVAC control duct temperature sensor and the manual deck thermometer used in the log. This can be addressed by resetting the user set point for the heating season. Further trending of data can help identify a growing hysteresis between the two temperature measuring devices and allow facility staff to maintain temperature sensing equipment as necessary. Figure 5 summarizes the received log information of pool deck humidity versus outdoor air temperature. It can be seen that for the representative data controlling the humidity inside of the ASHRAE recommended limits occur, however not very often.

If the city of Fort Saskatchewan desires their pool air system to be capable of maintaining environmental conditions during the 1% of the typical meteorological year, some cooling/dehumidification can be introduced to the unit by coupling a parallel closed loop fluid cooler to the recovery coil located in the unit. The amount of cooling ability will be limited to the existing coil performance characteristics. Alternately a separate cooling/dehumidification system can be considered for installation. This approach is generally cost prohibitive without any available (existing infrastructure), only to benefit less than 1% in the year and is not recommended.

*Opinion of Probable Cost = \$50,000 - \$90,000*

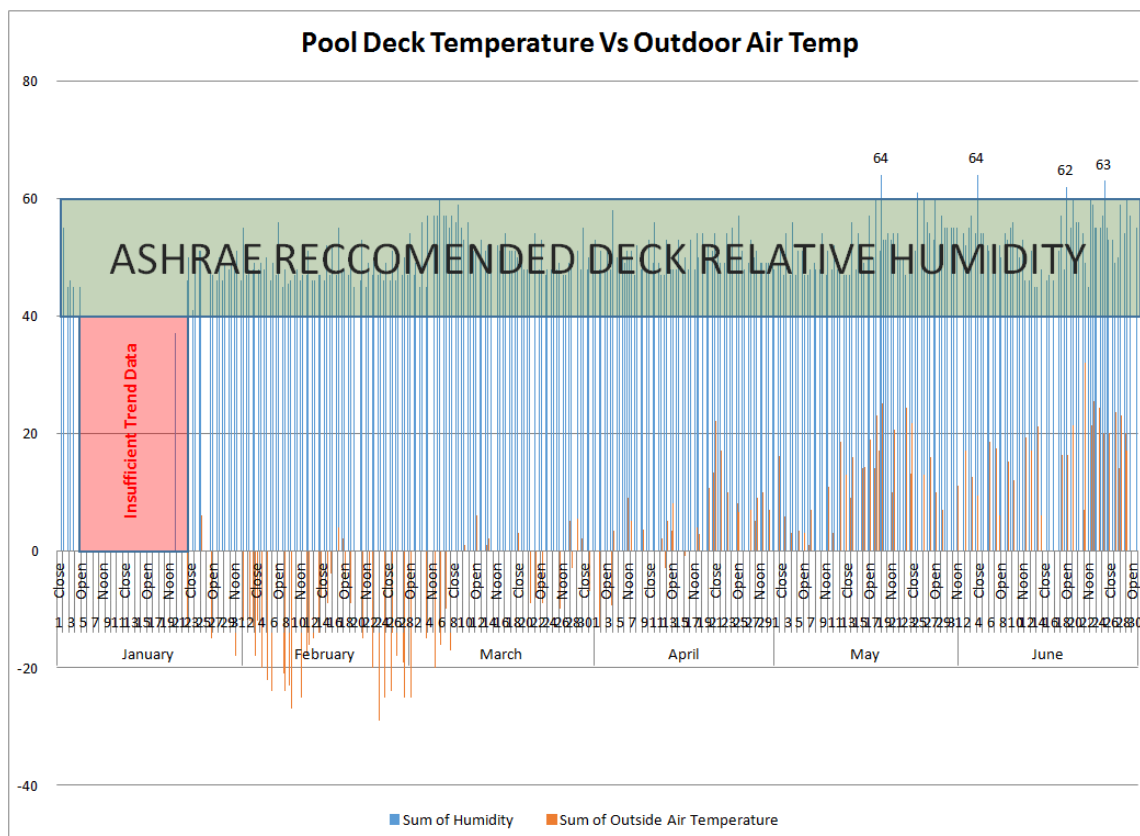
**Figure 5: Pool Deck Humidity vs Outdoor Temp (January to June)**

Pool humidity is maintained by modulating the outside air damper setting in the air system. This approach is generally acceptable in Alberta due to the relatively dry air environment throughout a typical year; as there is less than 1% of time where the outdoor air conditions makes it more challenging to stay within the recommended environmental limits.

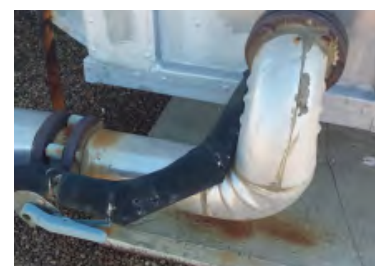
**Figure 7: Alum. Jacket Deterioration**

Evidence of previous leaks can be identified on the heat recovery piping. Glycol piping above the roof is complete with aluminum jacketing. Evidence of deterioration can be found near the exhaust recovery coil above the roof. A local exhaust above the whirlpool is also untitled to evacuate increase chloramines generation above the whirl pool. At the time of the review, the system was not operating.  
*Opinion of Probable Cost = < \$1,500*

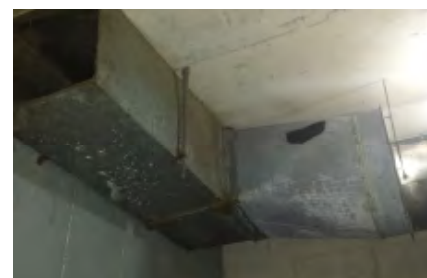
**Figure 7: Exhaust Fan Hole @ Duct**

The Trench Drain is passively ventilated via a duct mounted exhaust fan. The fan appeared to be in Fair to good Condition. It was noted that duct damage is evident at the connection ductwork. The hole can be repaired and refurbished.

*Opinion of Probable Cost = < \$100*
