**STRUCTURAL ASSESSMENT REPORT**

**FORT SASKATCHEWAN UTILITY SERVICES  
WATER TOWER STRUCTURAL CONDITION  
ASSESSMENT**

FOR: THE CITY OF FORT SASKATCHEWAN | DATE: NOVEMBER 28, 2016

C016.1488

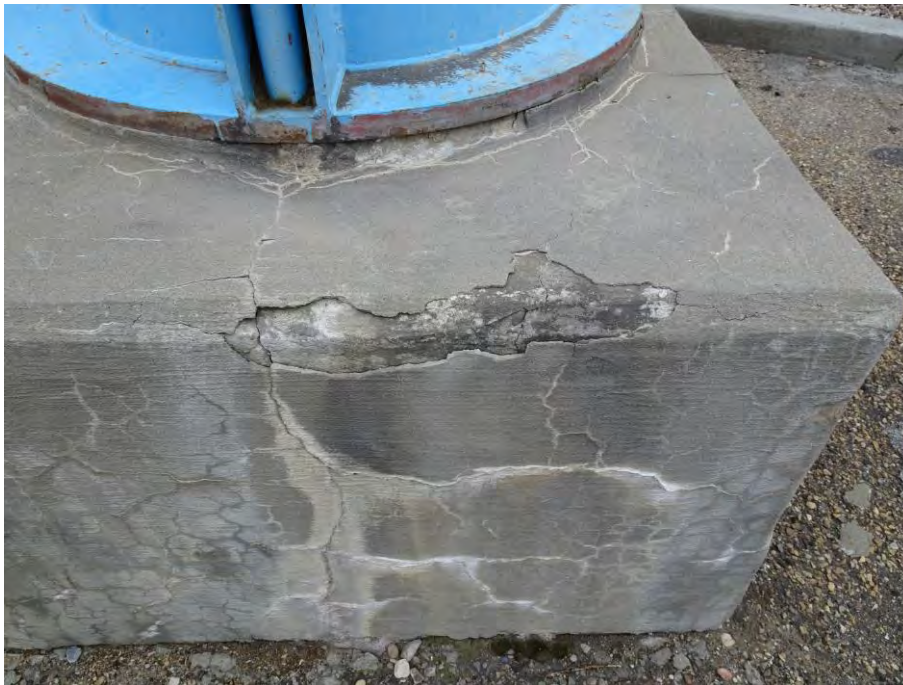
- Piers are generally in good condition; cracking was observed on piers #4, #5 and #6. Refer to photo S-1.
- Plaster around all six of the exposed column piers appeared to have cracking and delamination; generally all in poor condition. Refer to photo S-2.
- Signs of partial deteriorated grout underneath the base plate of column #4 were evident. Refer to photo S-3. Grout among the remainder of base plates appear to be in good condition.

Photo S-1: Cracking evident at column pier #1

- Cracking in the piers will only worsen overtime as water is able to penetrate the concrete. The plaster coating of the piers is already showing signs of delamination and therefore we recommend removal of all the plasters. This will expose any additional cracking on the piers which shall be remediated. Depends of the extent of the cracks an epoxy injection can be utilized for the repairing of the piers. Piers shall be protected by reinstating the plaster or applying a waterproof coating.

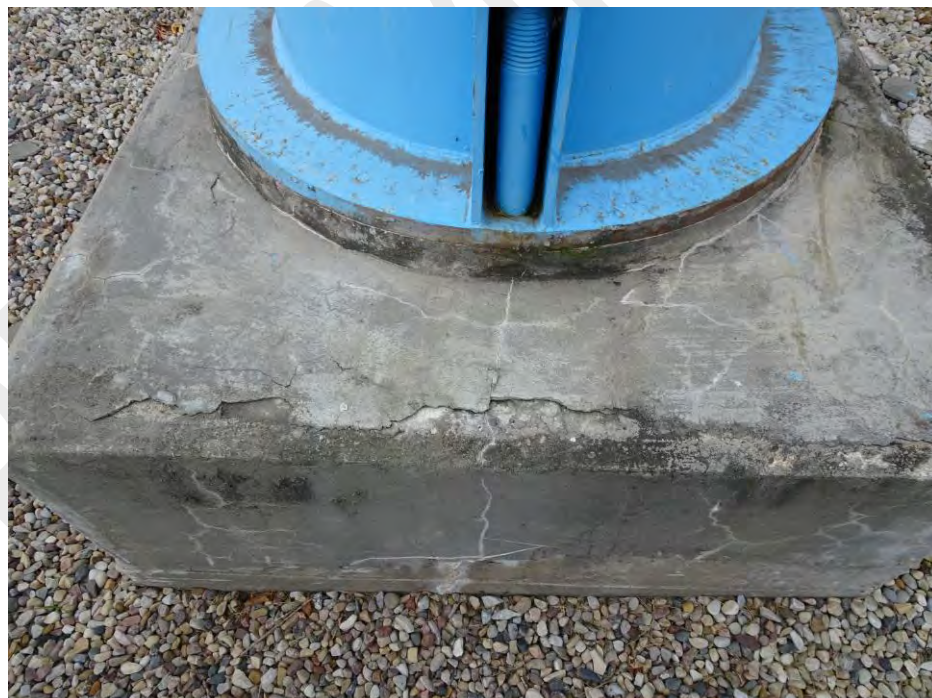
Photo S-2: Plaster has thin cracking throughout and delamination is evident (Pier #3)

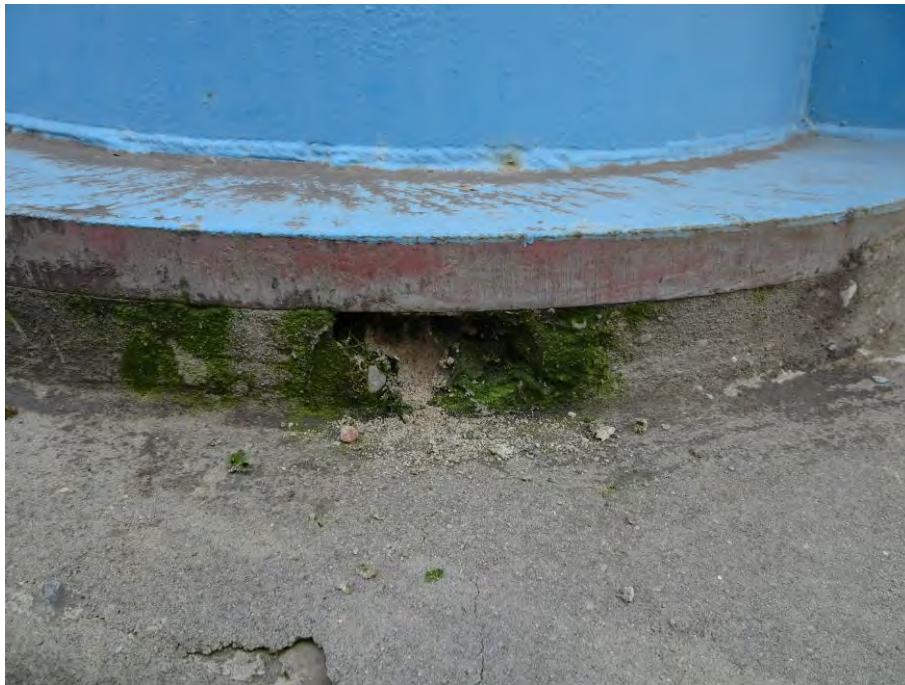
Photo S-3: Deteriorated grout at the underside of the column baseplate (Pier #4)

- Grout deterioration at column 4 should be repaired.
- After cleaning the rusted anchor bolts at the gap between anchor bolt and base plate holes, the gap shall be filled with elastomeric sealant to prevent water penetration.

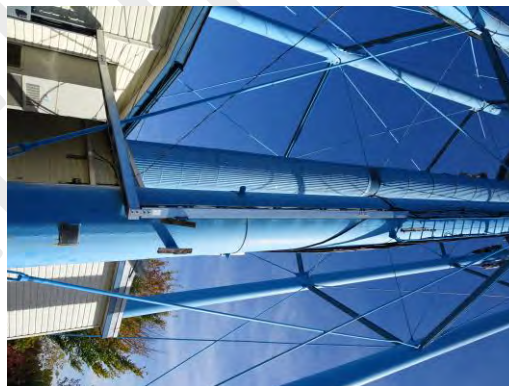
- The access ladder attached to Water Tower column #1 was observed that the lower portion had been removed at some point. The distance from grade up to the first rung was measured at approximately 23ft. Refer to photo S-4.
- A vertical lifeline is provided for the fall protection system. The cable and connectors were visually inspected and appeared to be in good condition.
- Based on our visual observations, the ladders structural integrity was in good condition.

According to Alberta Occupational Health and Safety Code (OHS 2009), a fixed ladder equipped with an integral fall protection system that meets the requirements of CSA 2259.2.1 shall be used for climbing the Water Tower. As noted previously in this document, the lower portion of the existing

fixed ladder had been removed. It is our opinion that the current arrangement does not conform to the OHS 2009 requirements. Therefore the following recommendations are provided:

Photo S-4: Access ladder's lower portion has been removed (Column #1)

- The lower portion of the fixed ladder shall be designed, installed and tested in accordance with OHS 2009 and PIP Standard STF05501. The bottom of the ladder shall not be higher than 150mm above the concrete foundation.
- The existing vertical lifeline shall be extended to the bottom of the fixed ladder. The vertical lifeline shall be designed, installed and tested in accordance with CSA 2259.2.1.
- To prevent unauthorized personnel climbing the ladder, a ladder guard as shown in Figure A-1 is recommended.
- A lifeline system shall be installed on the access ladder to top of the water tank.
- The record drawings of the fixed ladder and fall protection system shall be certified by a professional engineer registered in the province of Alberta.

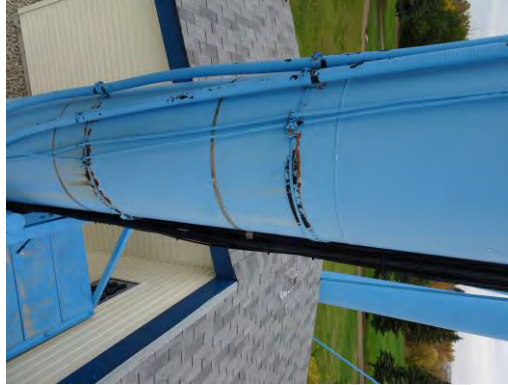
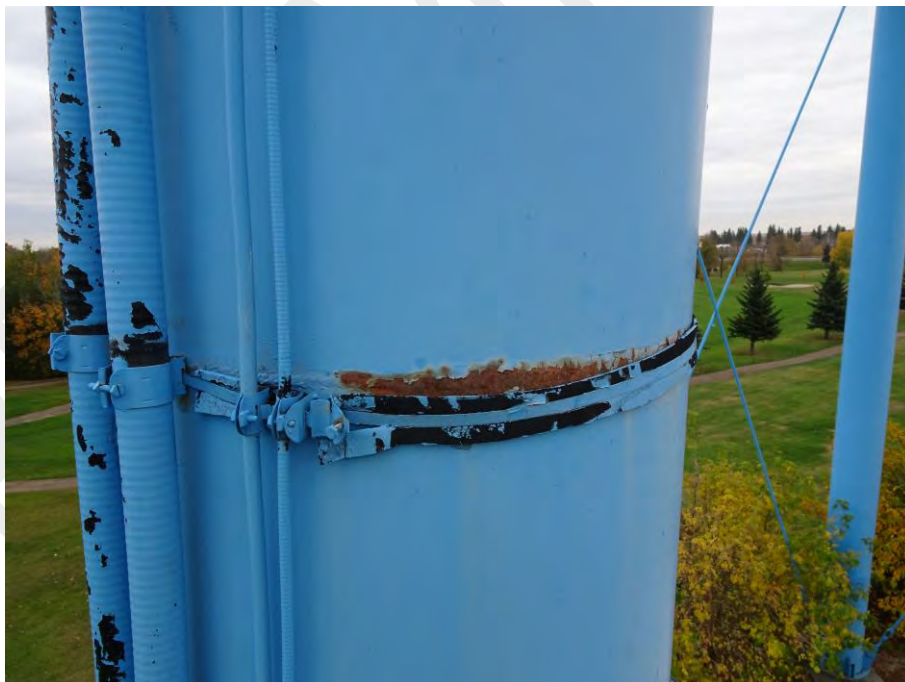
- Each of the six columns has experienced wear from the cable strapping which has resulted in spot rusting and stripping of the paint. Refer to photos S-5 and S-6.
- Column welds appeared to be intact with a few rust spots in areas where paint as flaked off leaving the unprotected steel exposed to the elements.
- No major concerns were observed at gusset plate connections for the bracing welded to the columns.
- Anchor bolts at the base plate showed signs of general corrosion around base plate hole. Through visual inspection no cracks were observed. Refer to photo S-7.
- The columns were deemed in good condition.
- Column paint appeared to be in acceptable condition, except as listed above.

Photo S-5: Rusting and paint wear (Column #2)

Photo S-6: Rusting and paint wear (Column #2)

- To control the rusting on the columns and bracing, it is recommended to patch/repaint the columns.
- Disconnected cladding around the riser pipe should be repaired and properly sealed to remediate the water and potential animal penetrations.

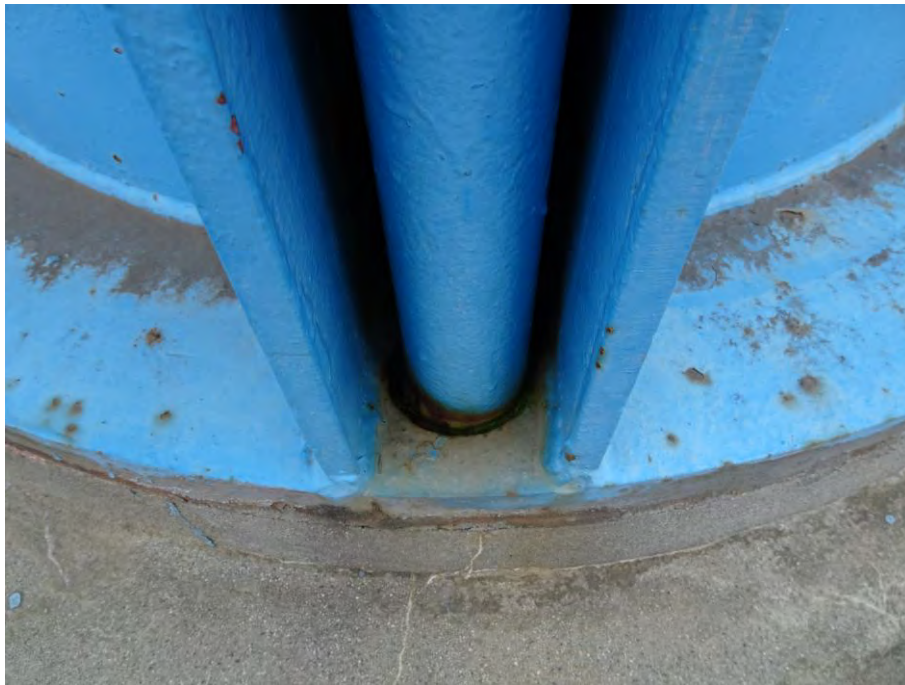
Photo S-7: Anchor bolts at column baseplate (Pier #5)

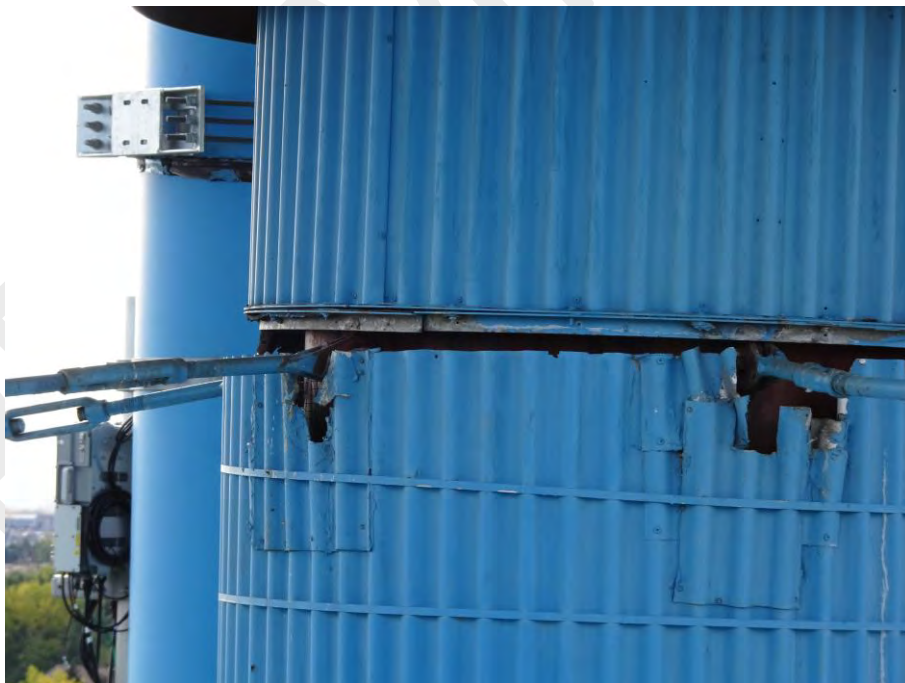
- Cladding around the riser showed signs of paint deterioration and rusting.
- At multiple elevations the cladding was observed to be disconnected to the structure, which creates access points for not only the elements but animals to penetrate easily. Refer to photo S-8.

Photo S-8: Openings in the riser cladding

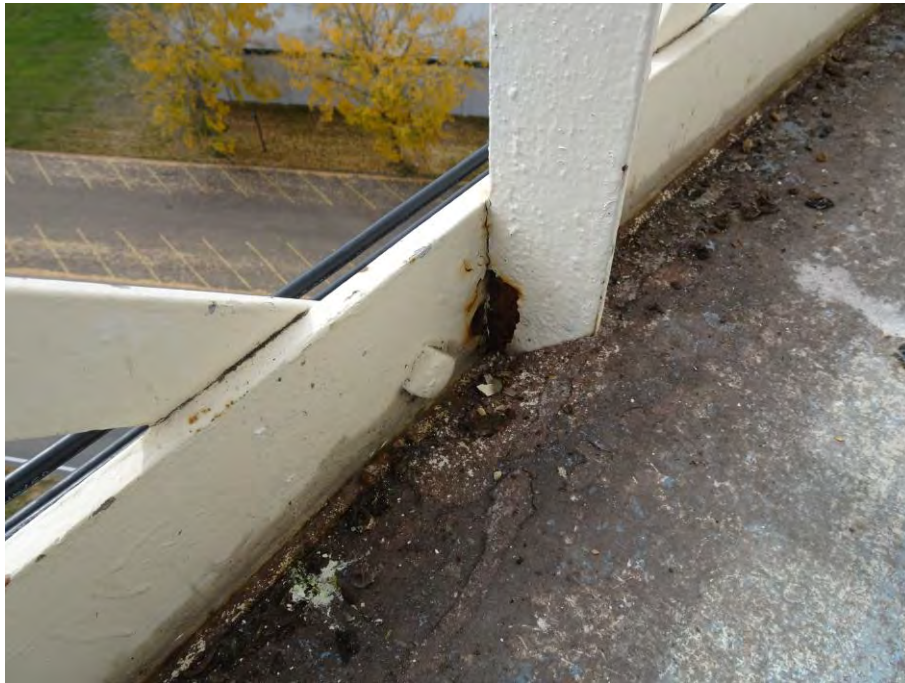
- Catwalk (balcony) and its handrail appeared to be in good condition.
- Sporadic signs of rusting were found both on the catwalk floor as well as the handrails. Refer to photo S-9.
- Antennas were observed to be attached to the catwalk handrail at various locations. Refer to Antenna observations.
- The top of the tank is accessible from the catwalk level via a fixed ladder which is welded to the tank shell. However no fall protection system is in place on the ladder making it unsafe to climb. Refer to photo S-10.

Photo S-9: Spot rusting on handrail and catwalk floor

- To control the sporadic rusting on the catwalk handrails, it is recommended to patch/repaint the handrails.
- To create a safer floor on the catwalk it is recommended to apply a slip resistant coating.

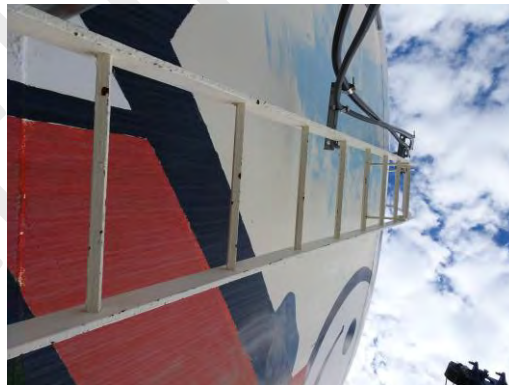
Photo S-10: Access ladder to top of tank does not have a vertical lifeline

- A fall protection system is recommended to be installed for the access ladder on the catwalk to tank hatch.

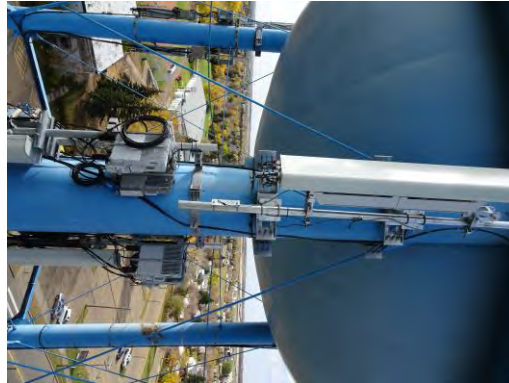
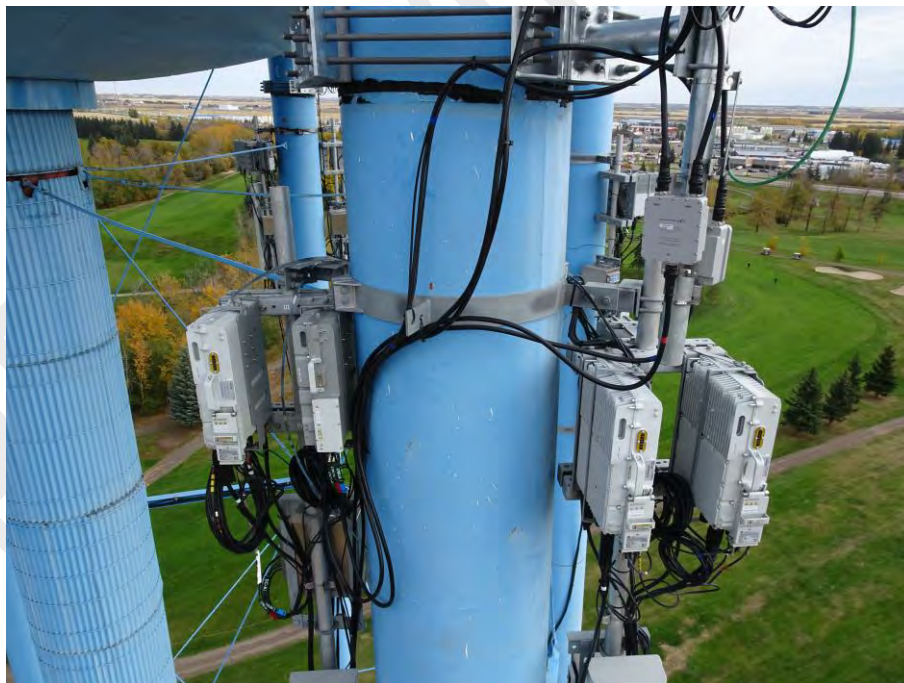
- Antennas, cables and the hardware associated were present on all of the six columns except for column number 1. Refer to photo S-11 and S-12.
- Besides the columns, the catwalk handrail also acted as a host to multiple antennas. There were a few locations in which the connections were loose. Refer to photo S-13.

Photo S-11: Antennas and hardware connected to column #4

Photo S-12: Antenna hardware connected to column #6

- The number of antennas shall be limited to 4 per column. These antennas shall be oriented in different angles to reduce the additional wind projected area.
- The dimensions of future antennas shall be less than the existing. The largest existing antenna assumed in this evaluation is 6'-6" Long x 1'-2" Wide x 12" Deep.
- No antenna shall be fastened into the catwalk handrail.

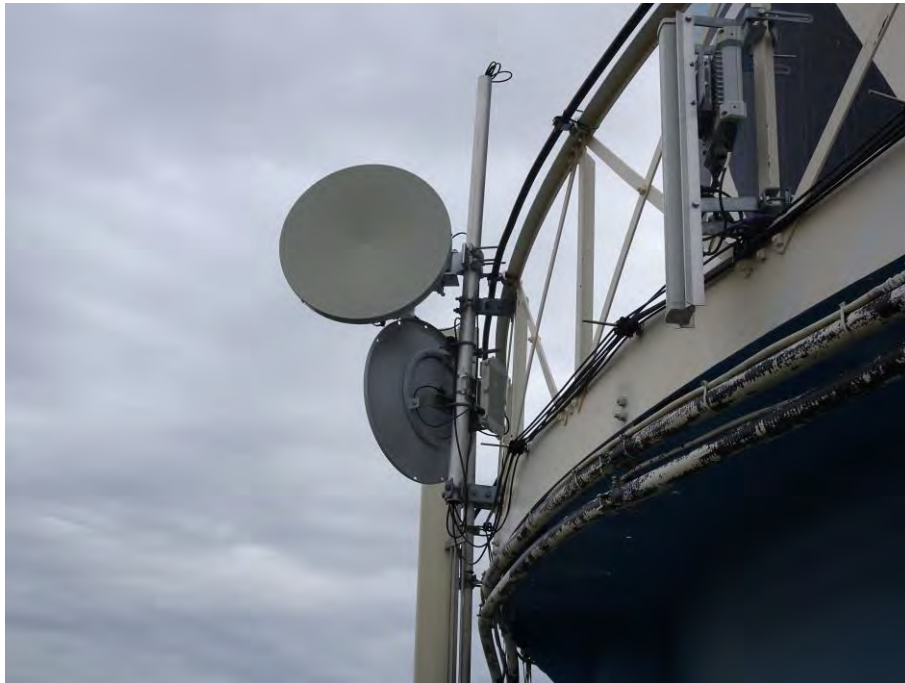
Photo S-13: Antenna hardware connected to catwalk handrail

- Existing antennas attached to catwalk handrail to be relocated. Connection to catwalk girder plate with additional new post is acceptable.
- Future antennas can be installed as per evaluation summary provided in Section 4.
