## Harbour Pool

### 2018 Main Pool, Warm Pool and Whirl Pool Structural Assessment

10001 - 94 Avenue  
Fort Saskatchewan, Alberta

March 2018

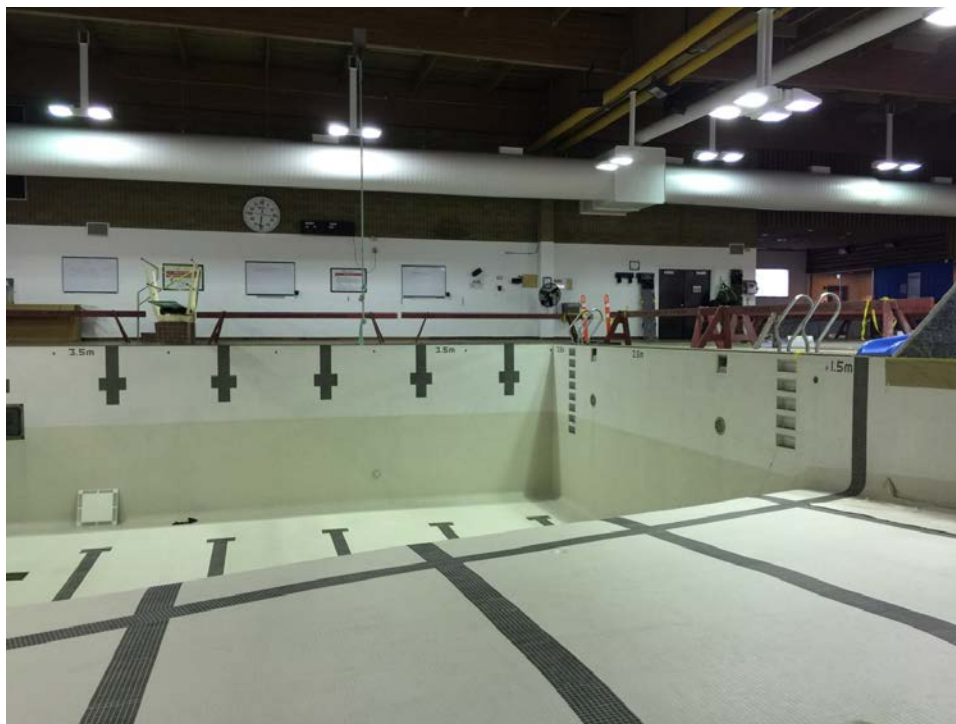
The main pool (Appendix B, Photo 1) generally appears to be in good condition except for the following:

Photo 1: Main pool

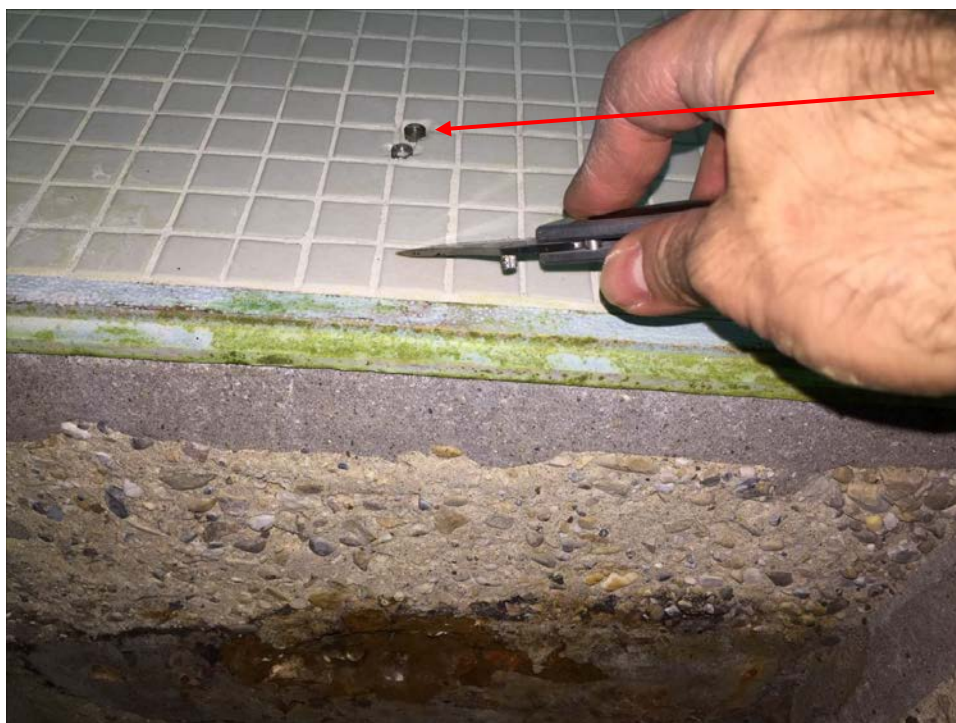
- Generally the mosaic tiles and grout appear to be in good condition, however damage to the tile and grout finishes at anchor penetrations for drain covers was noted at multiple locations (Photo 2) and debonded tile locations were identified during chain drag and hammer sounding testing as described in Section 5.0 below. Debonded tiles were not visibly deteriorated or lifted. Near-term repairs are not considered a requirement, however, for budgeting purposes probable costs for removal of the existing main pool tile and grout assembly, allowance for concrete repairs, and application of a new waterproof finish designed to protect the structure beneath have been provided below for long-term durability of the pool structure.

Photo 2: Anchor penetrations through mosaic tiles

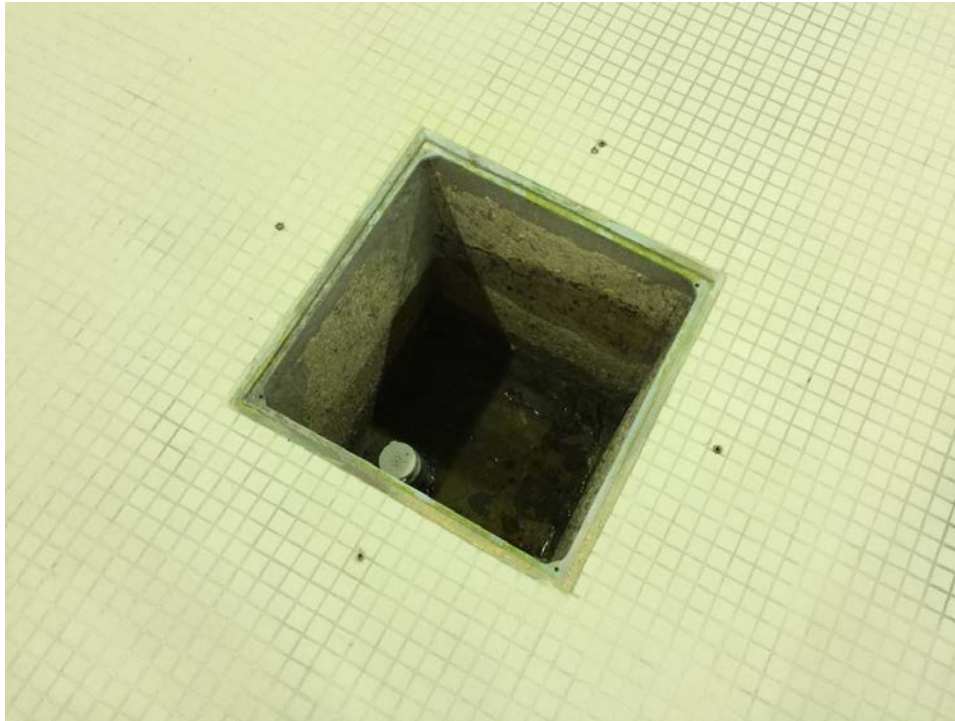
**Photo 3: Drain outlet**

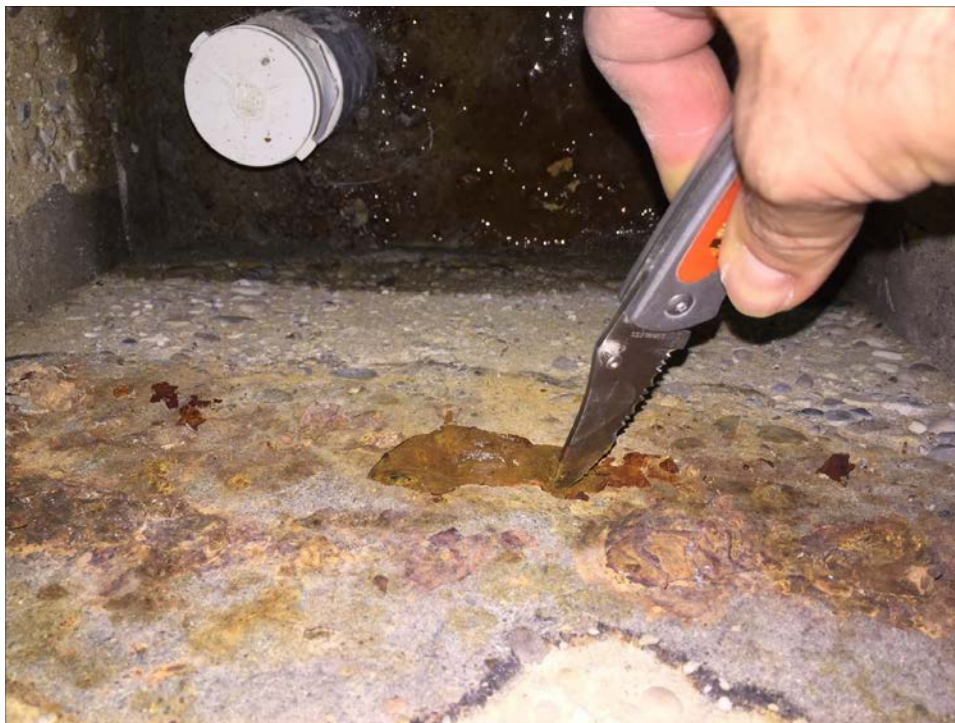
- Covers on the recesses for the drain outlets located in the main pool area were removed while onsite (Photo 3). Concrete deterioration was observed inside the outlets (Photo 4) and the tiles along the perimeter of the drain were debonded. Repair is recommended and would include removal of unsound concrete material, concrete repair, application of a coating, and sealing of perimeter joints and anchor penetrations.

**Photo 4: Deteriorated concrete at drain outlet**

- Concrete repair in pool drain outlets and re-application of tile and grout (6 locations)
- Removal of the concrete topping in within the wave chamber, repair the delamination present, and apply a waterproof membrane (3 chambers).

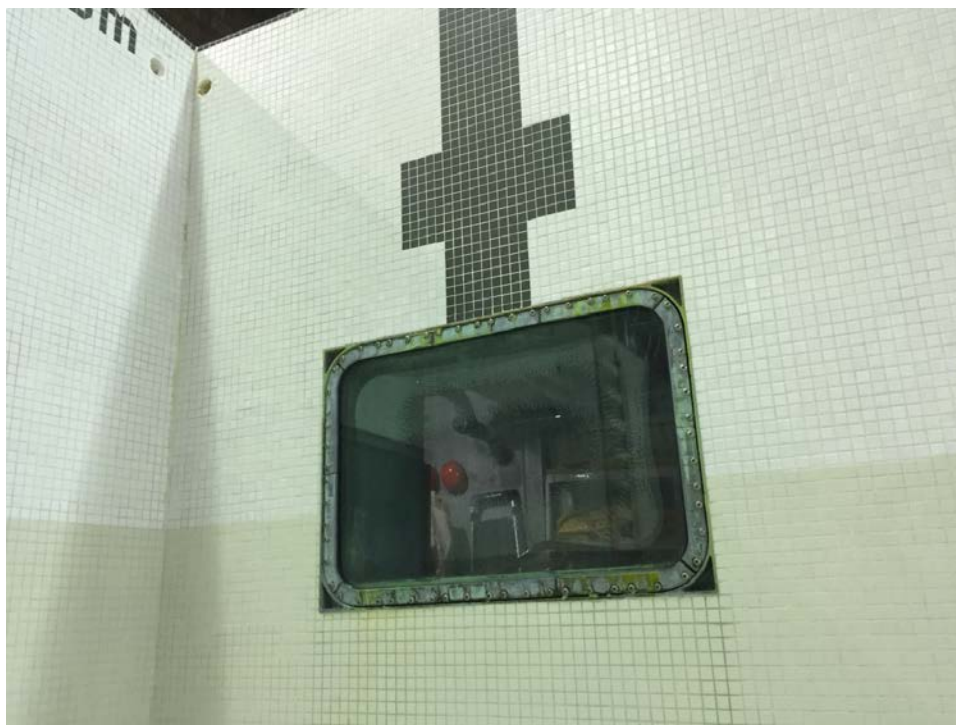
Photo 5: Underwater viewing window – within pool

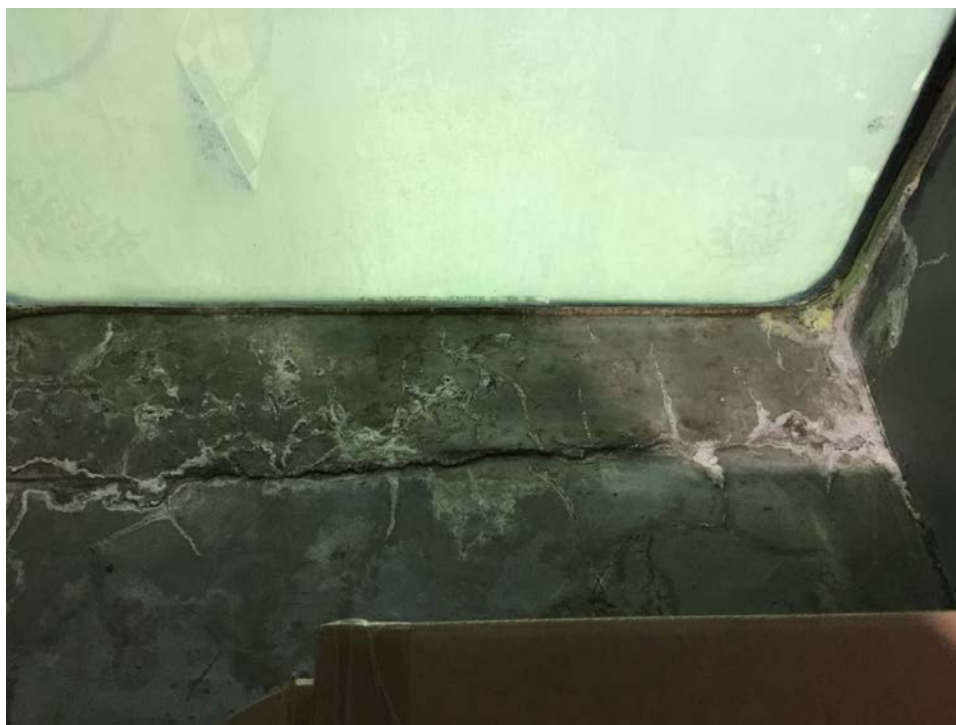
- Underwater viewing windows are located in the deep end of the main pool area (Figure 2). Viewing windows generally appear to be in fair condition (Photo 5). Efflorescent staining was observed around the viewing window (Photo 6). A cementitious parging material has been installed around the window block out. The parging material was loose during review; however, the underlying concrete appeared sound. We were informed that during filling operation of the pool, leakage at the windows occurs until sufficient pressure is obtained to seal the windows but that leakage does not occur once the pool is full. Immediate repairs are not required, however, probable costs for replacement have been provided in our recommendations.

Photo 6: Staining and efflorescence at interior of underwater window – dry side of pool

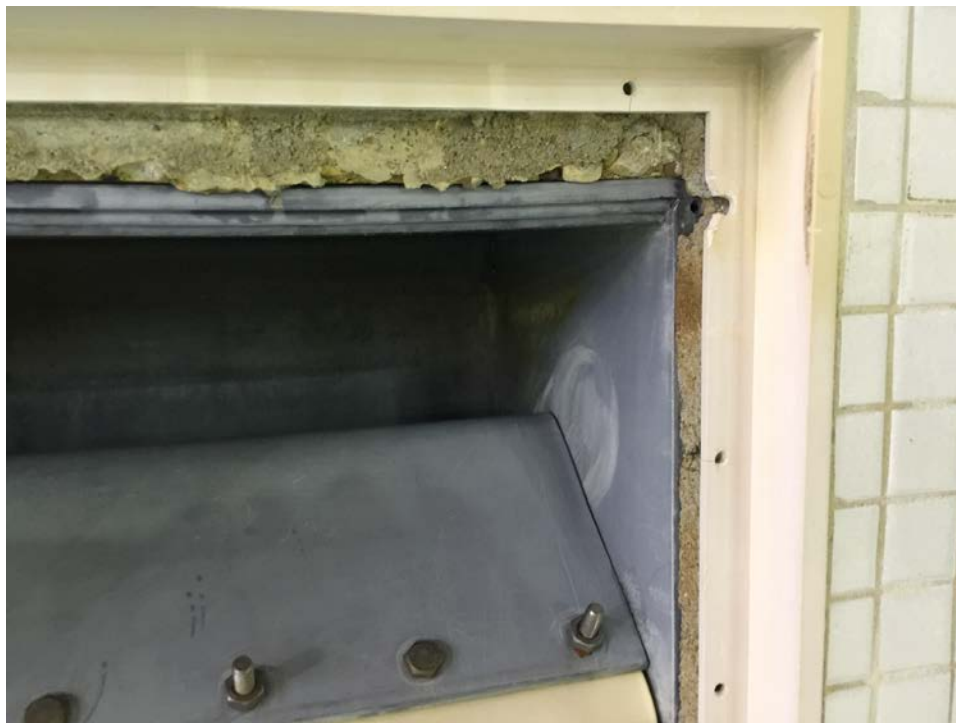
- A scupper cover was removed by the pool staff while we were onsite (Photo 7). Cementitious grout was observed around the perimeter of the scupper, which may allow water infiltration into the structure at these locations. No present deterioration was identified during our review.

**Photo 7: Pool scupper**

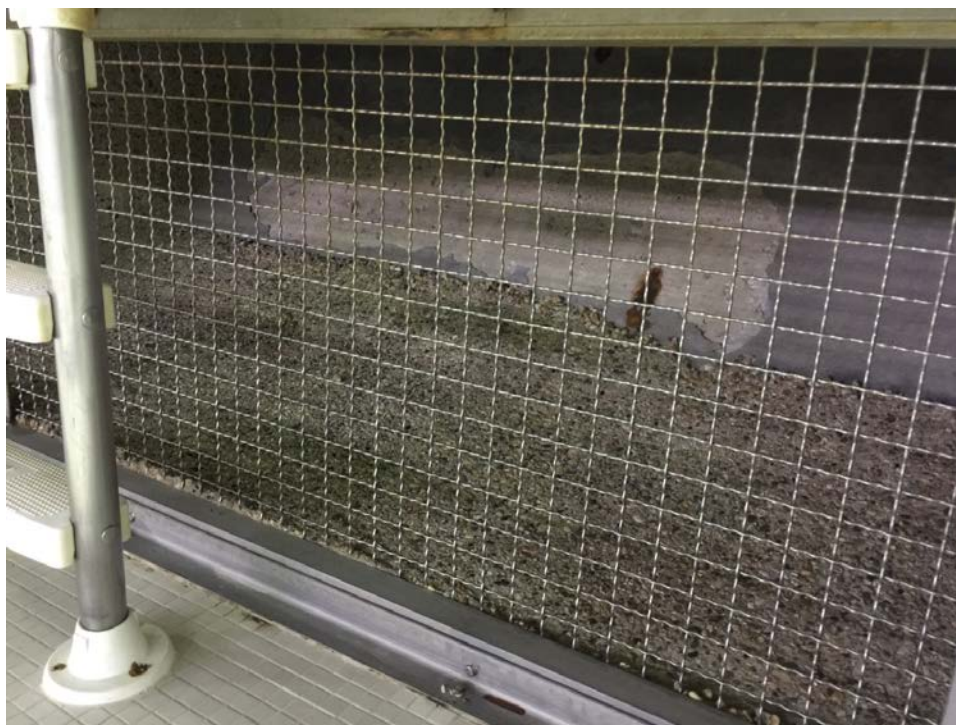
- Wave pool chambers are located at the northeast end of the deep end (Figure 2). A bonded thin concrete topping appears to have been applied onto the concrete structure (Photo 8). Debonding and failure of the thin concrete topping was observed at multiple locations in the wave pool chambers. Water staining and efflorescence at crack locations was observed on the hallway opposite the wave pool chamber (Photo 9). Hammer sounding of the underlying structural concrete structure was not possible during review, however, corrosion was observed at one small location. We note that the wave pool chambers are exposed to wetting and drying conditions and exposed to higher mechanical forces due to movement of water in these chambers, resulting in more severe exposure conditions than adjacent areas. Removal of the loose material, concrete repairs, application of a waterproofing membrane system on the exposed concrete structure, and sealing the wave pool chamber openings is recommended.

**Photo 8: Wave pool chamber – staining and loose concrete**

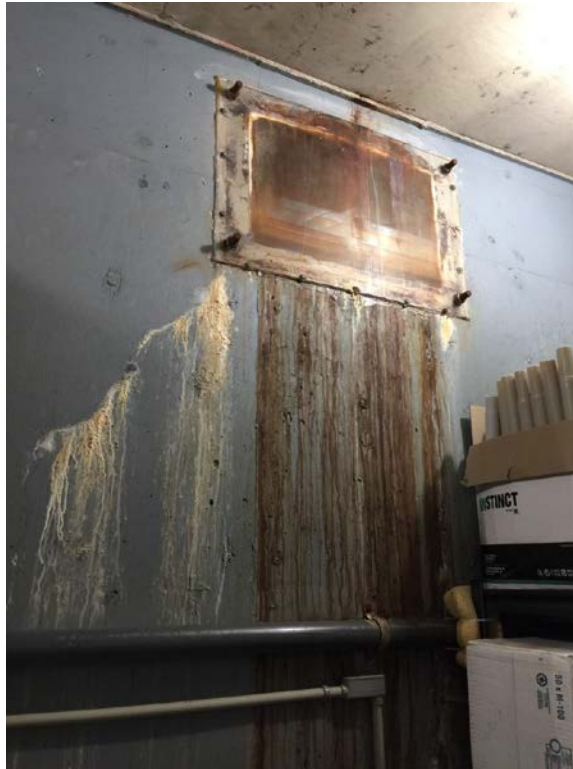
**Photo 9: Opposite wall of wave pool chamber – staining and efflorescence at cracks**

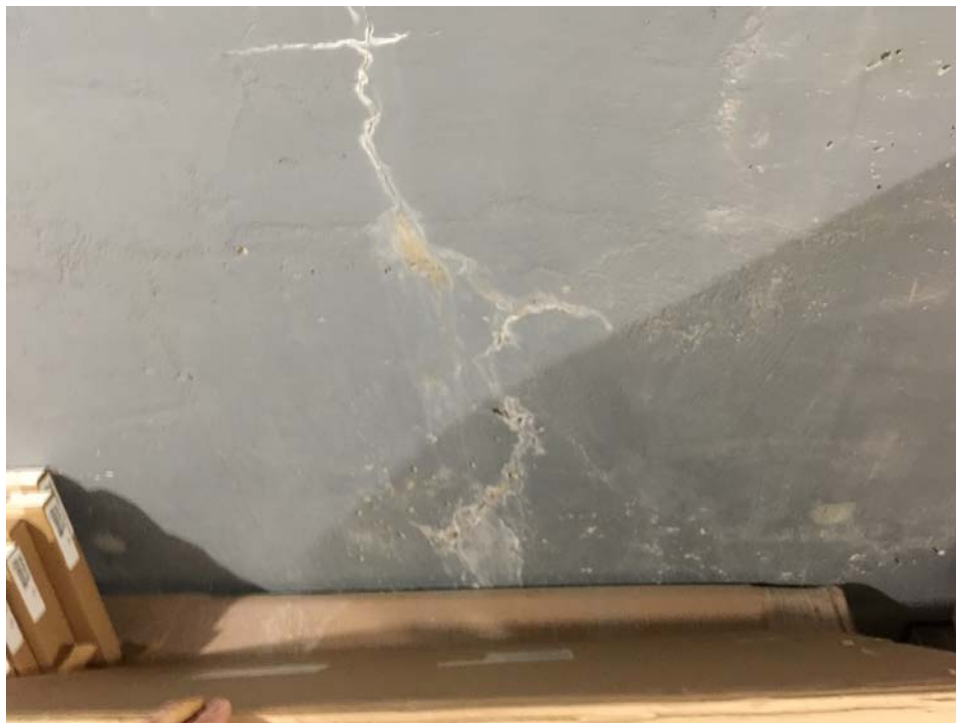
- Water staining and efflorescence at crack locations in the pool wall was observed at a couple locations in the corridor adjacent the main pool deep end (Photo 10). Application of a cementitious material was observed on the corridor wall, which prevented visual assessment of the underlying concrete. Hammer sounding identified minor locations of unsound cementitious material (Photo 11). The staining on the concrete surface appears to indicate that water penetration is occurring at crack locations in the pool wall or at mechanical openings. Removal of the cementitious material would be required to determine extent of unsound concrete if any and / or presence of moisture between the concrete and cementitious material. Probable costs for removal of the cementitious material at locations of water staining are included in our recommendations.

**Photo 10: Main pool deep end wall as viewed from below  
grade corridor – staining and efflorescence at cracks**

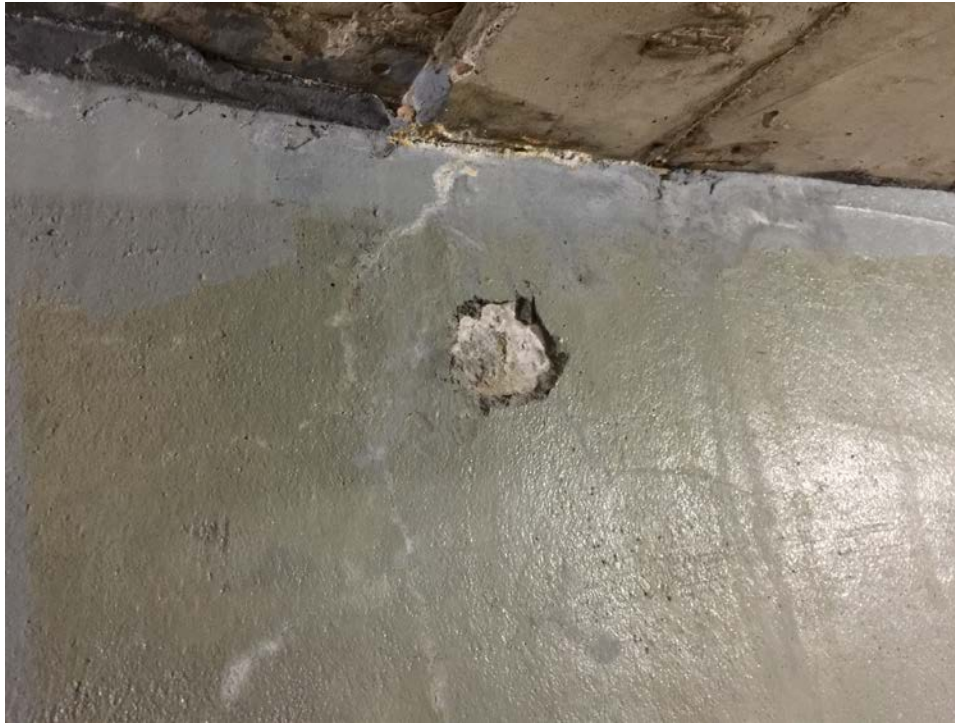
**Photo 11: Main pool deep end wall from below grade corridor – cementitious material applied onto wall**

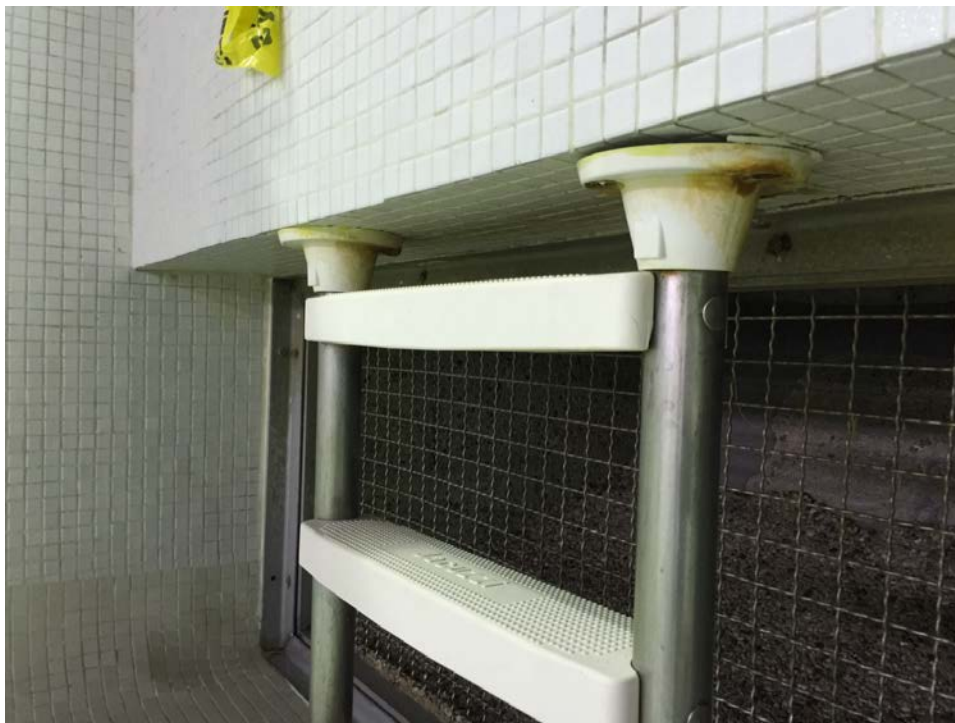
- Surface corrosion staining was observed at a couple of the pool ladder anchor locations (Photo 12). Ladder connections were loose at a couple locations. Tightening loose anchors and installation of new sealant is recommended as part of general maintenance, and are not included in the costs presented below.

**Photo 12: Pool ladder connection – rust staining**

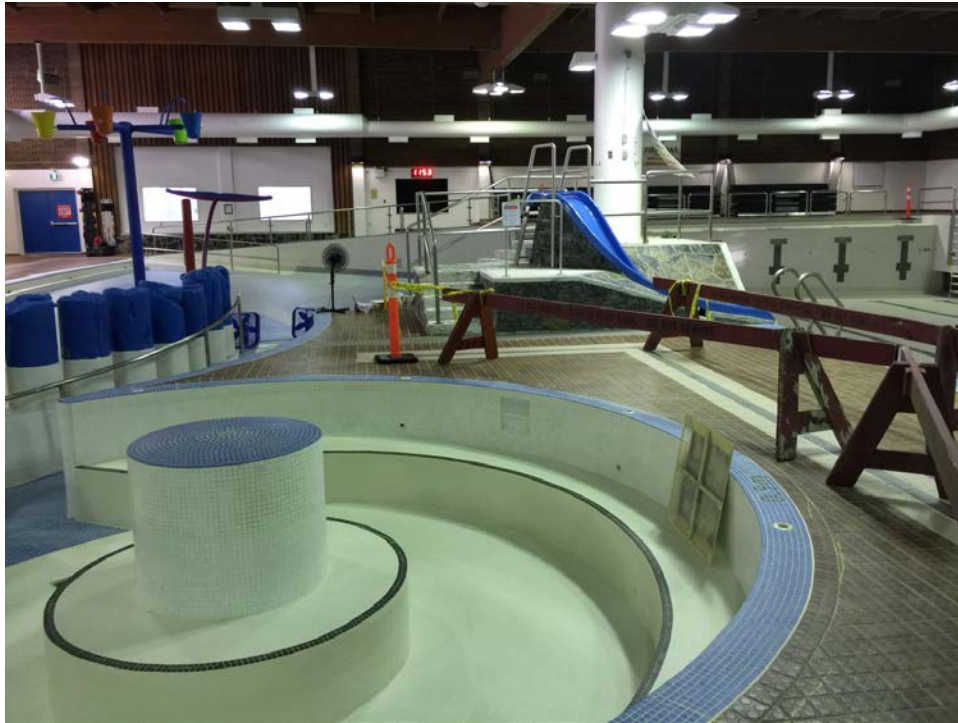
**Photo 13: Warm pool**

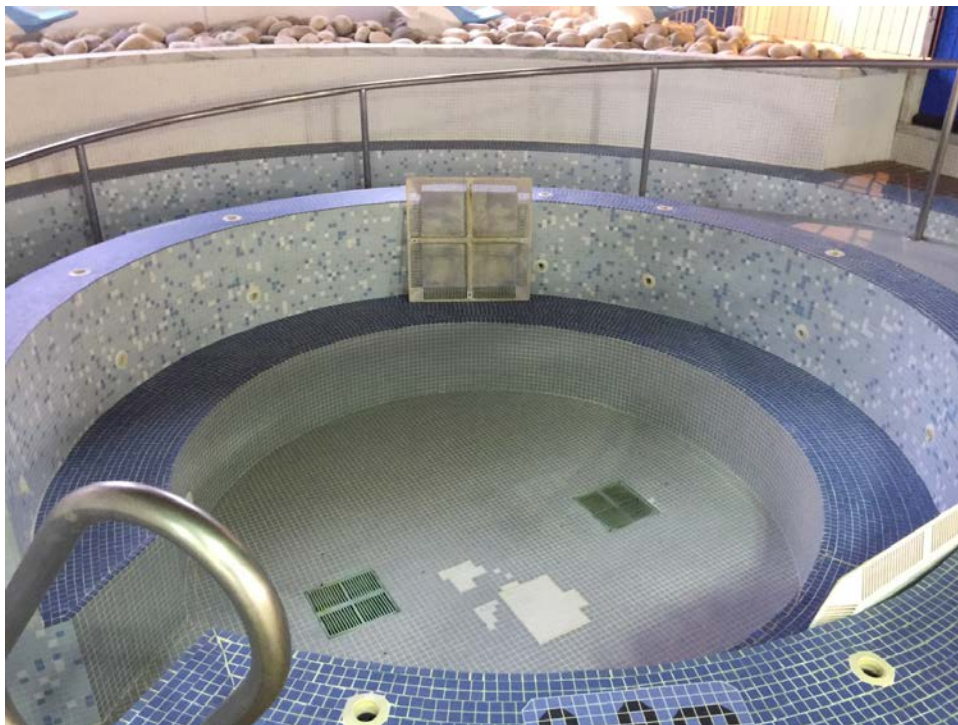
- Warm pool and whirl pool generally appear to remain in good condition (Photos 13 and 14). Selective replacement of the mosaic tile was observed in the whirl pool floor area. Debonded tile locations were identified during chain drag and hammer sounding testing as described below. Debonded tiles were not visibly deteriorated or lifted. Near term repairs are not considered a requirement, however, for budgeting purposes probable costs for removal of the existing warm pool and whirl pool tile and grout assembly, allowance for concrete repairs, and application of a new waterproof finish designed to protect the structure beneath have been provided below for long term durability of the pool structure.

**Photo 14: Whirl pool**

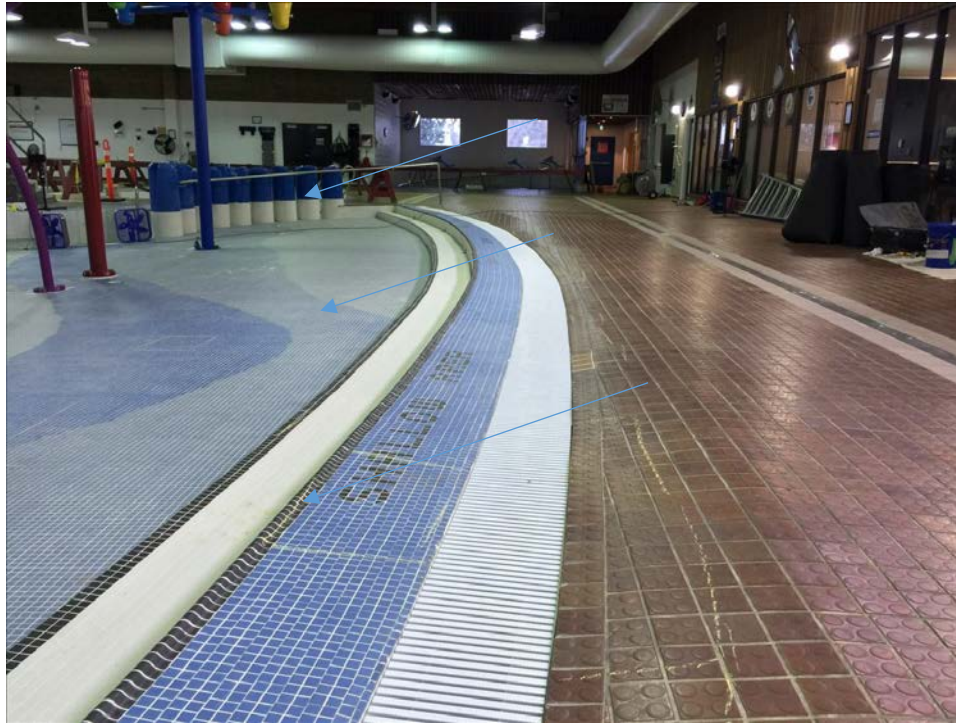
- A pool drainage trench is located at the entrance to the main pool area (Photo 15). We observed a cementitious parging material within the bottom of the trench at select locations where the plastic trench grating was removed. The parging material has debonded and become loose at multiple locations (Photo 16). Removal of the existing grout material and installation of a new sloping material and waterproofing membrane is recommended.

Photo 15: Pool deck and trench drain

- Removal of grout in the bottom of the main pool trench and application of new sloping material and waterproof membrane ( $\pm$  21 lin. m).
- Removal and replacement of one floor drain in the mechanical room.

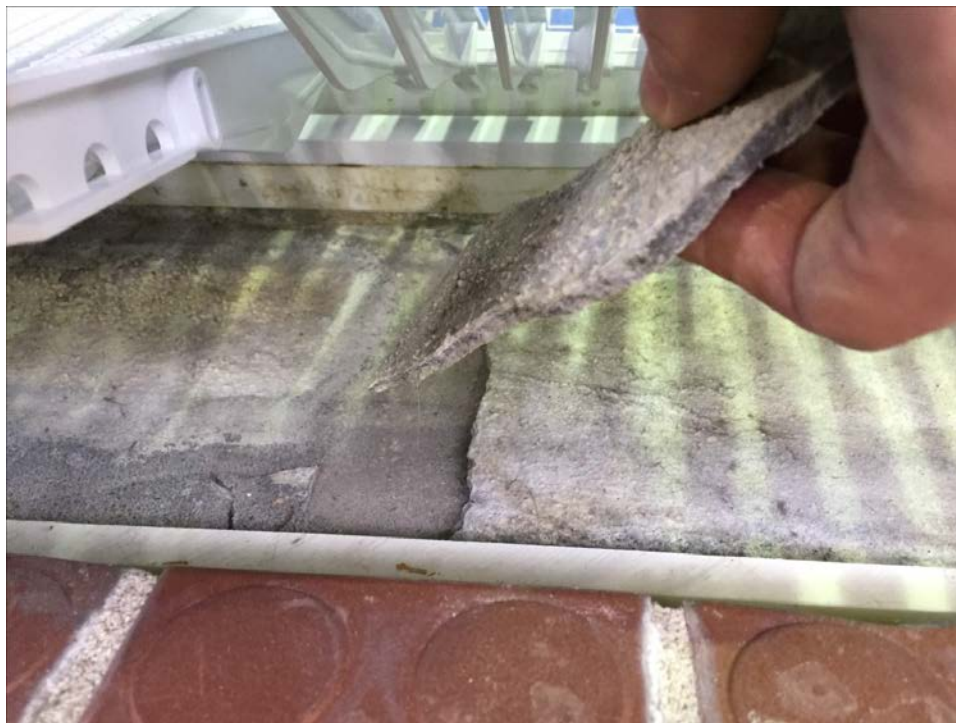
Photo 16: Debonded grout in pool deck trench drain

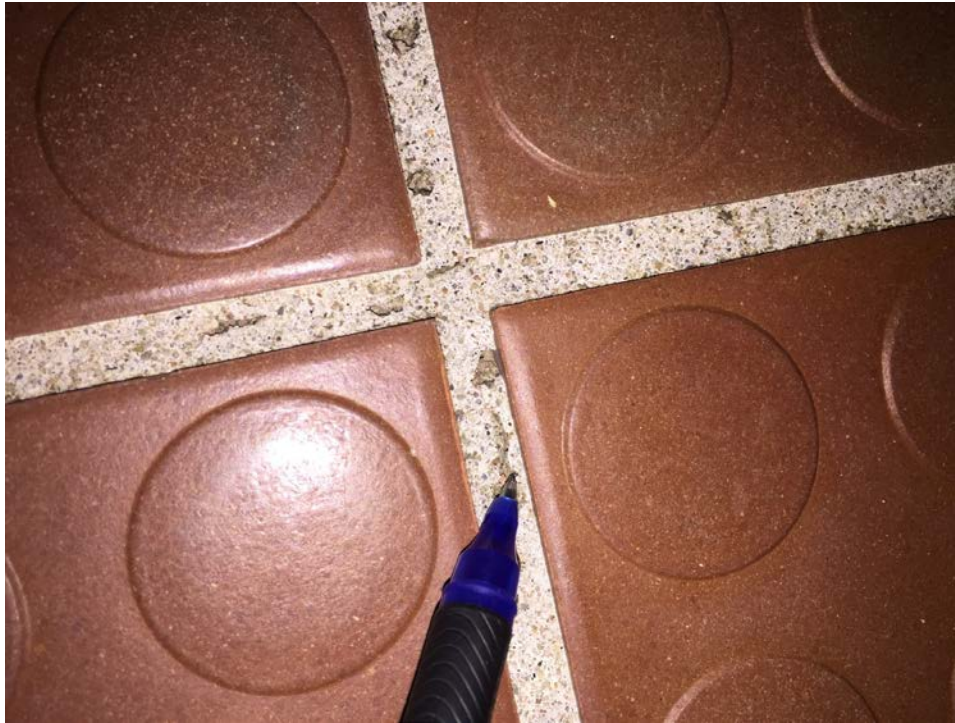
- Minor damage was observed at select tiles. Deterioration of the grout between tiles was noted throughout (Photo 17). Debonded tile locations were identified during chain drag testing as described below. Select areas of the debonded tiles were visibly deflected upward around one drain (Photo 18) and around the base of a column. Replacement of damaged tiles is recommended.

Photo 17: Failing grout at pool deck tiles

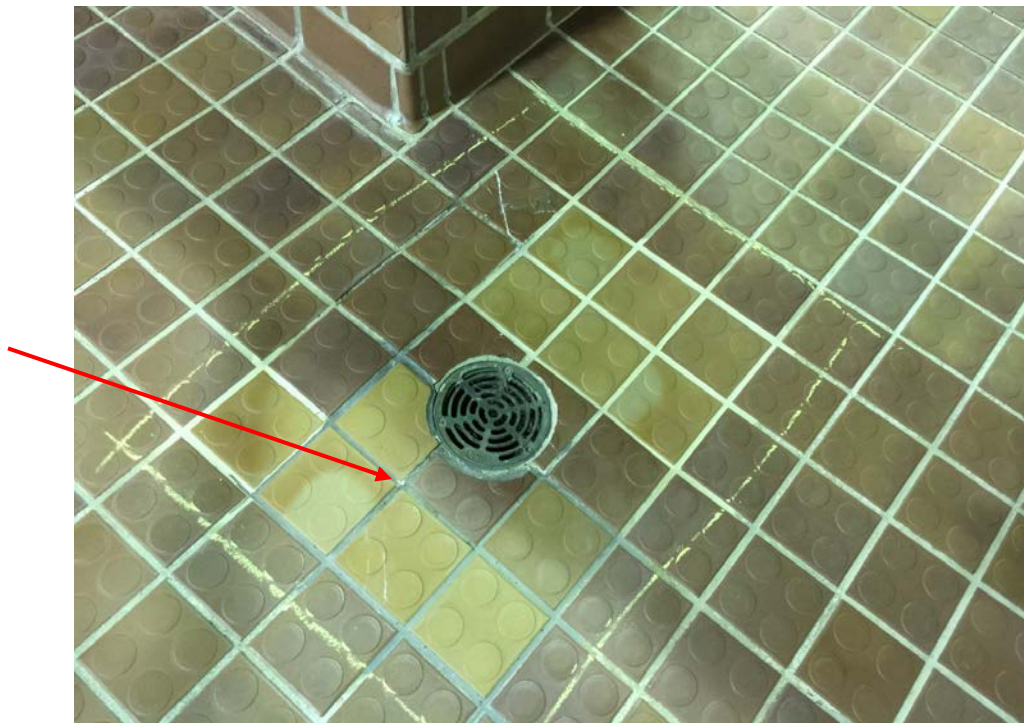
Photo 18: Failing grout at pool deck tiles

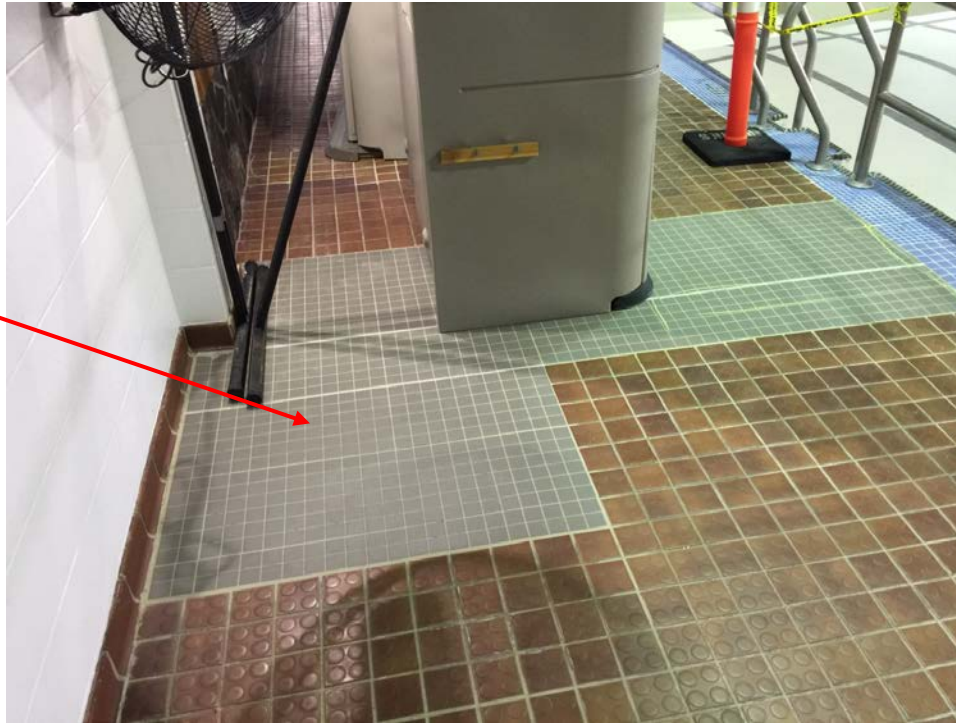
- Previous repairs were observed at several locations throughout the pool deck (Photo 19). We understand that replacement is being completed on an as needed basis where damage to the tile is observed.

**Photo 19: Tile replacement on pool deck**

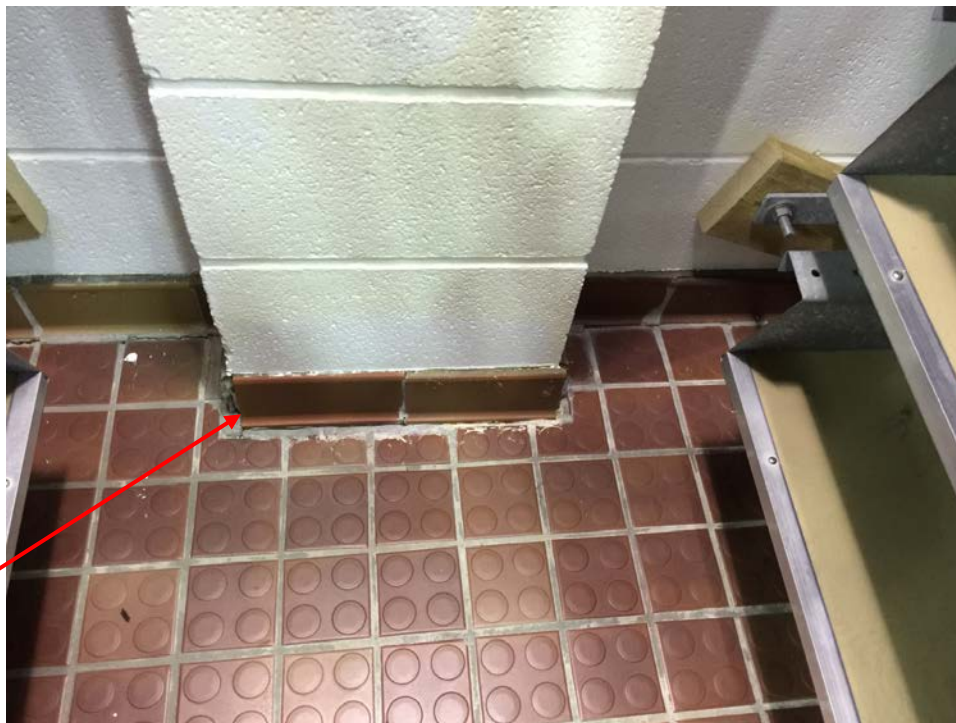
- Tile vertical terminations along the outer perimeter wall were visibly debonded / loose (Photo 20). Removal and replacement of the damaged tiles is recommended.

**Photo 20: Debonding tiles on vertical upturn along building perimeter**

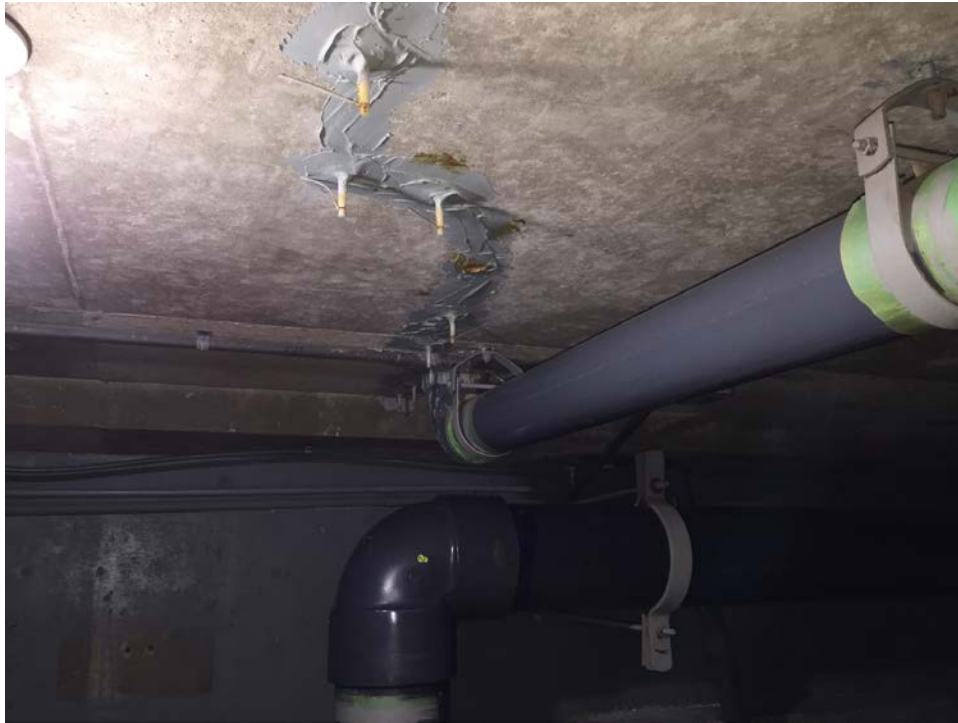
- Debonded tiles were identified at each pool deck floor drain location. Review of the underside of the floor drains at suspended slab locations, identified areas of crack injection and staining (Photo 21). Removal of the tiles around the floor drains, repair of any deteriorated concrete, and installation of new membrane and tile system at the drains is recommended.

**Photo 21: Crack injection at pool deck drain**

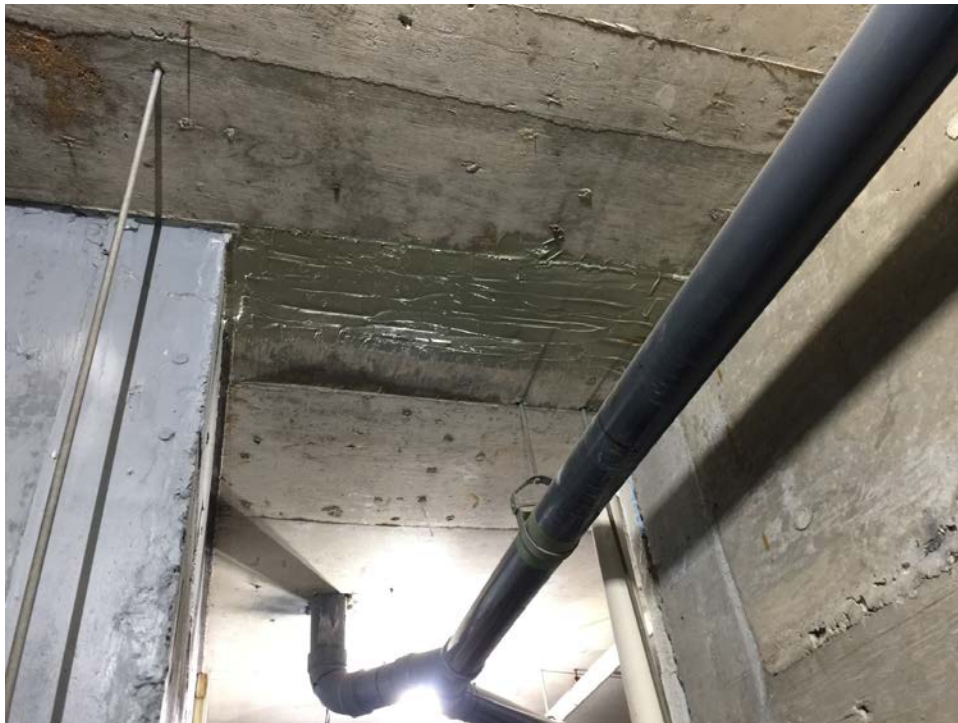
- Epoxy and crack injection was observed at multiple locations below the suspended slab, located on the east and south side of the main pool structure (Photo 22). Review of the surfaces appeared to line up with areas of previously replaced tiles as noted on Photo 19.

**Photo 22: Epoxy filler at crack location on underside of pool deck**

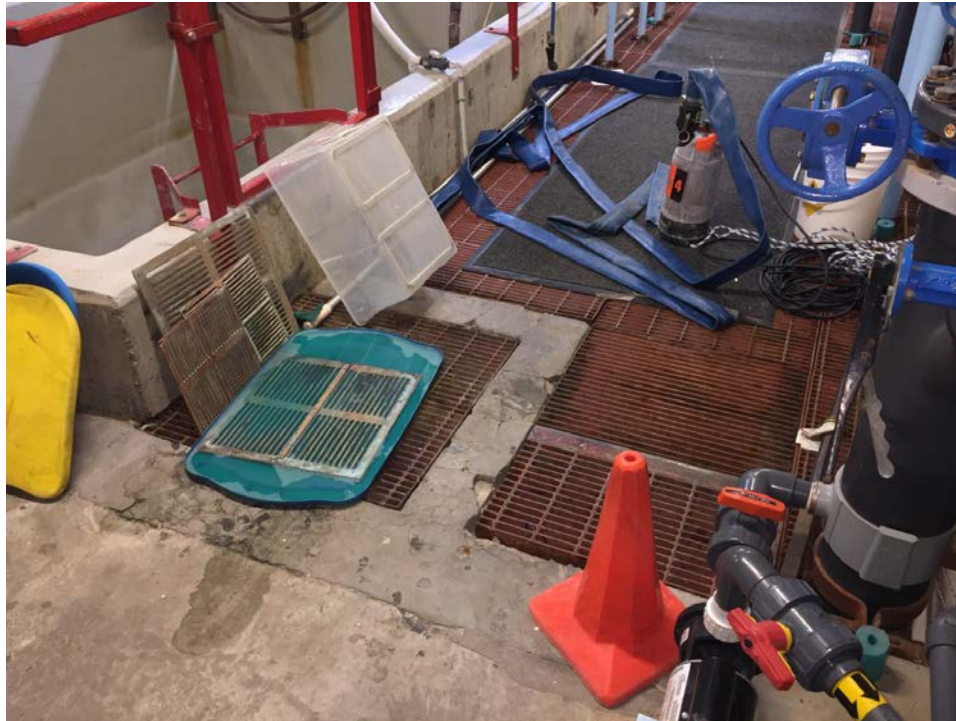
- The mechanical room contains a reinforced cast in place, unprotected concrete slab suspended and metal grating surfaces above the corridor below (Photo 23). Concrete deterioration around the metal grating flooring was observed. Repairs are recommended and would include the repair of deteriorated concrete and installation of a waterproof membrane on the suspended slab to minimize water infiltration into the slab.

**Photo 23: Unprotected concrete slab and metal grating in mechanical room**

- Installation of a new waterproof membrane in the mechanical room floor, including allowance for repair of delaminated concrete in the area of coating.

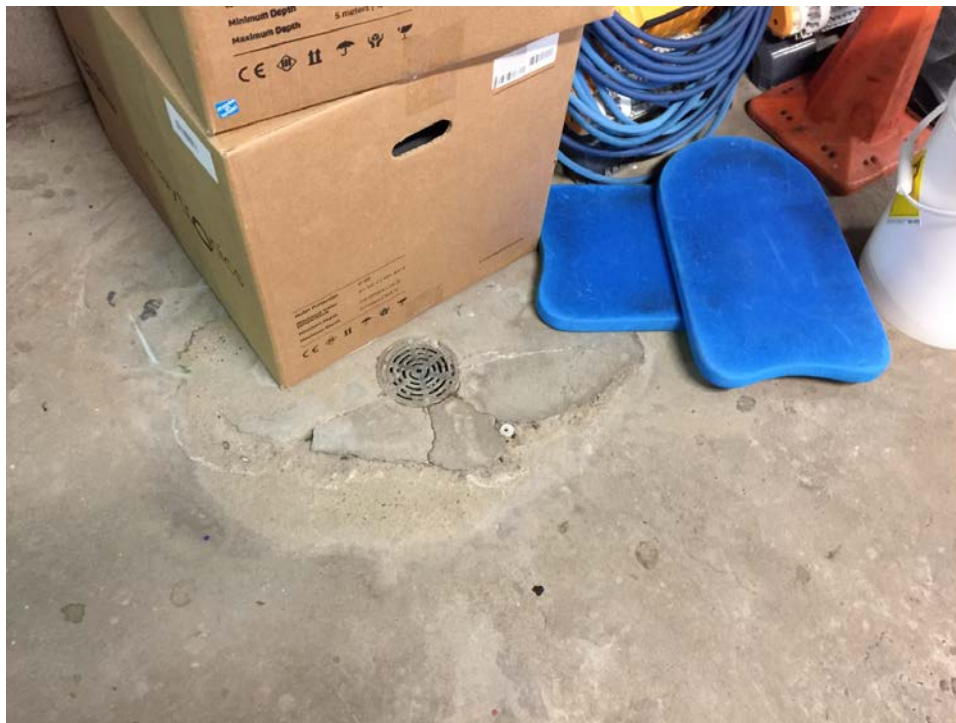
- Concrete deterioration was observed around one existing floor drain (Photo 24) in the mechanical room. Replacement of the floor drain and installation of waterproof membrane is recommended.

**Photo 24: Concrete deterioration around floor drain in mechanical room**

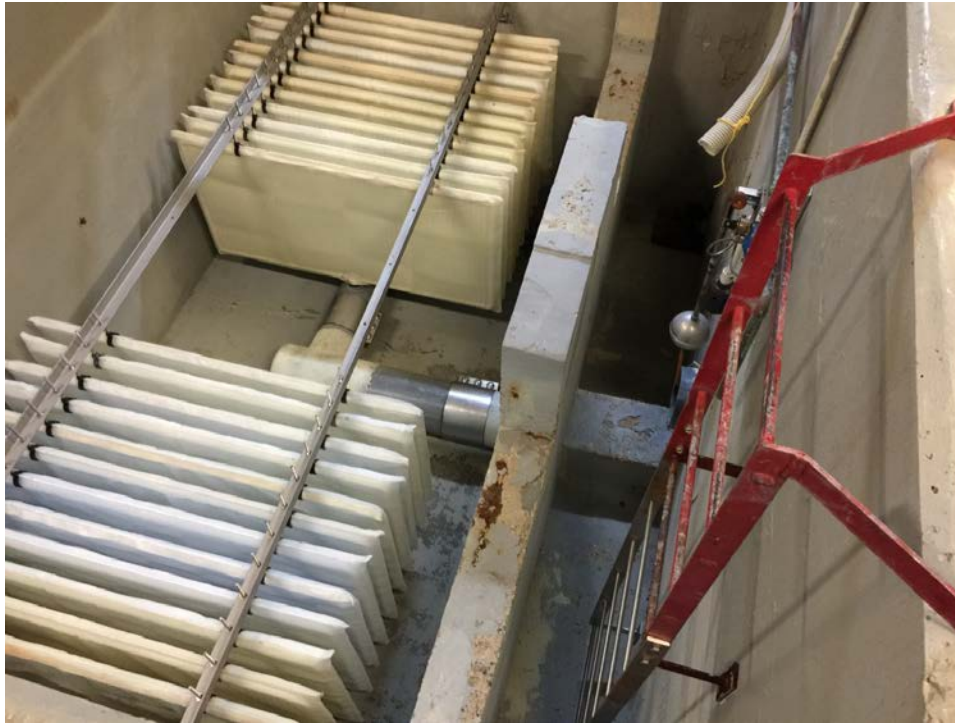
**Photo 25: Failed coating and visible concrete deterioration in mechanical room treatment tanks**

- Removal and replacement of waterproofing within saltwater treatment compartments, includes an allowance for repair of delaminated concrete within the compartments.

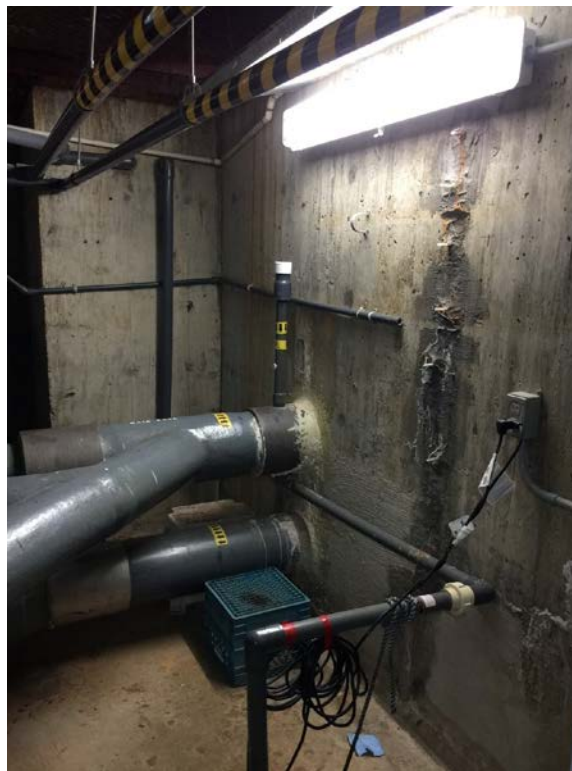
**Photo 26: Crack injection work and staining at crack locations opposite mechanical room treatment tanks**
