**From:** Caitlin Luo <luoc@ae.ca>  
**Sent:** Thursday, January 19, 2017 8:16 AM  
**To:** Lindsay Poitras  
**Cc:** Carma Holmes  
**Subject:** RE: Photos  
**Attachments:** Harbour Pool-joint on concrete slab.pdf; Harbour Pool-other joints.pdf

We have reviewed the existing structural drawings and the photos you sent. It appears that the joint along grid line 2 is a construction joint within the slab on grade (see the first attachment). The epoxy to be injected at this joint should have capacity to allow some movement.

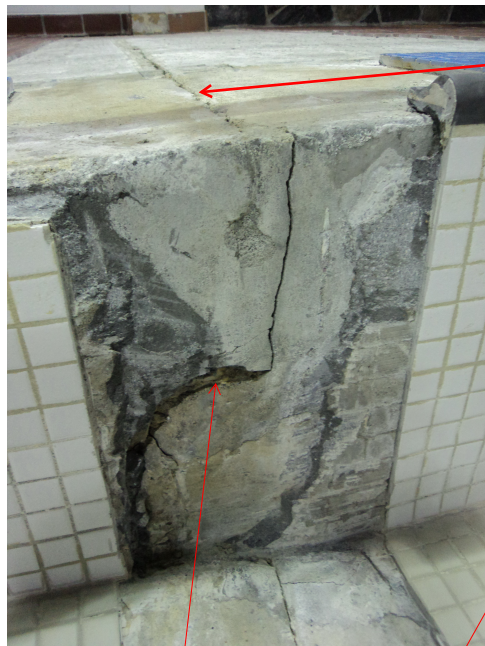
The vertical crack found along the beam at the construction joint should also be repaired.

construction joint

concrete retaining wall below main floor slab per attached photo

vertical crack - the concrete has deteriorated. The crack should be patched with a repair mortar and surface should be prepared in accordance with manufacturer's recommendations.

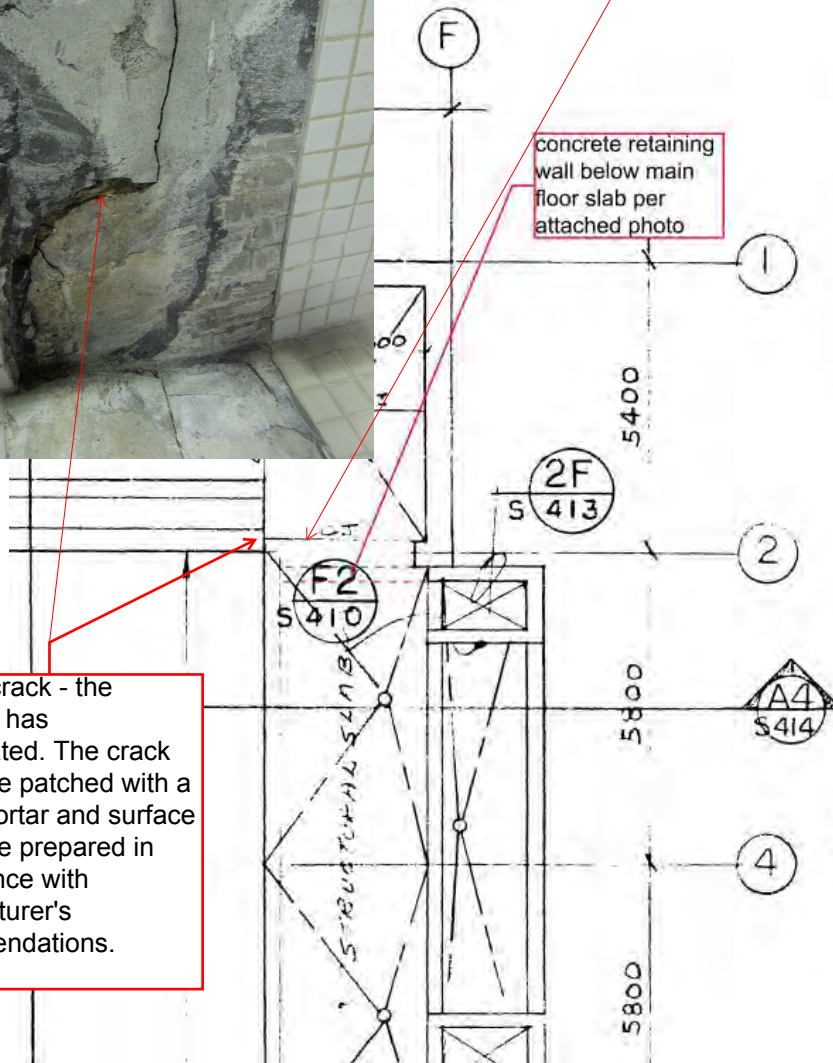
Construction Joints (CJ) - Full bulkhead between two slabs or slab and foundation wall, and having a 10mm thick joint filler between the two surfaces.

concrete wall below  
main floor slab

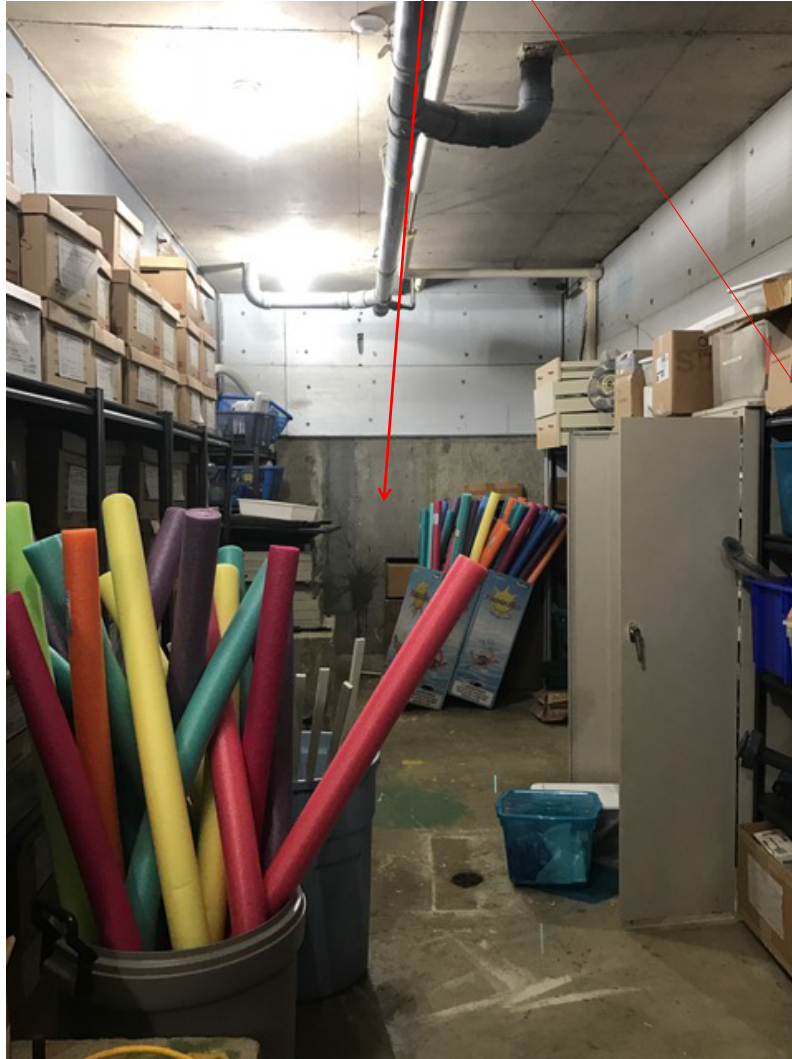
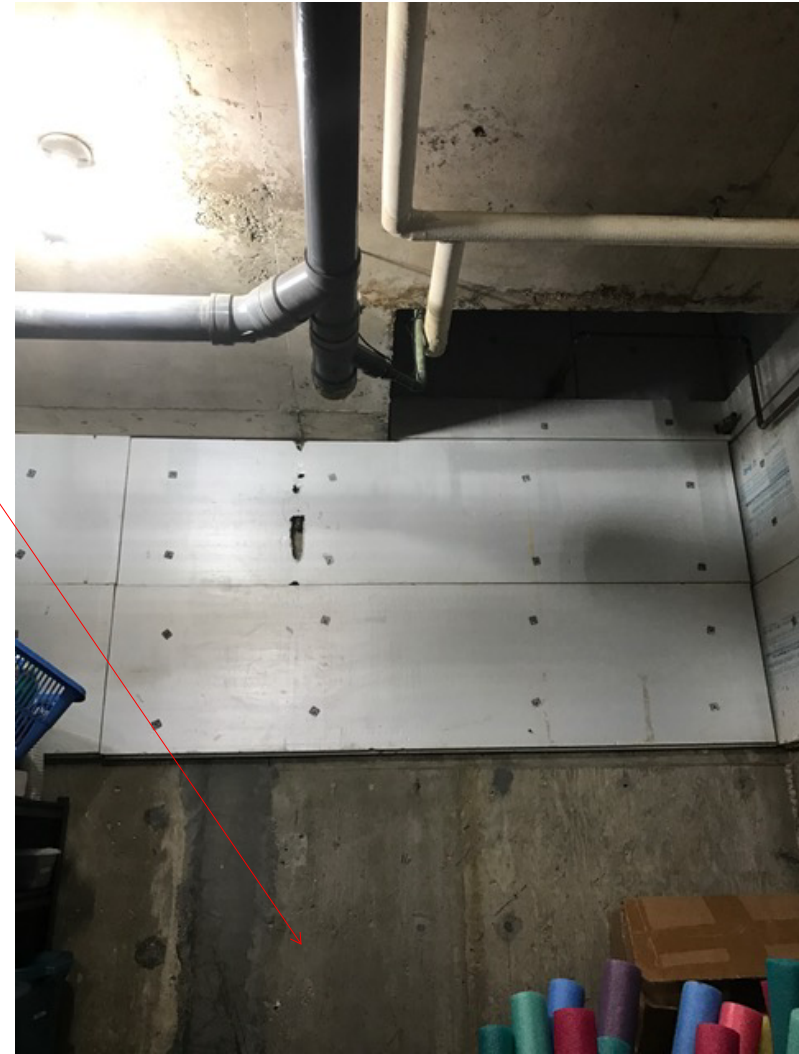
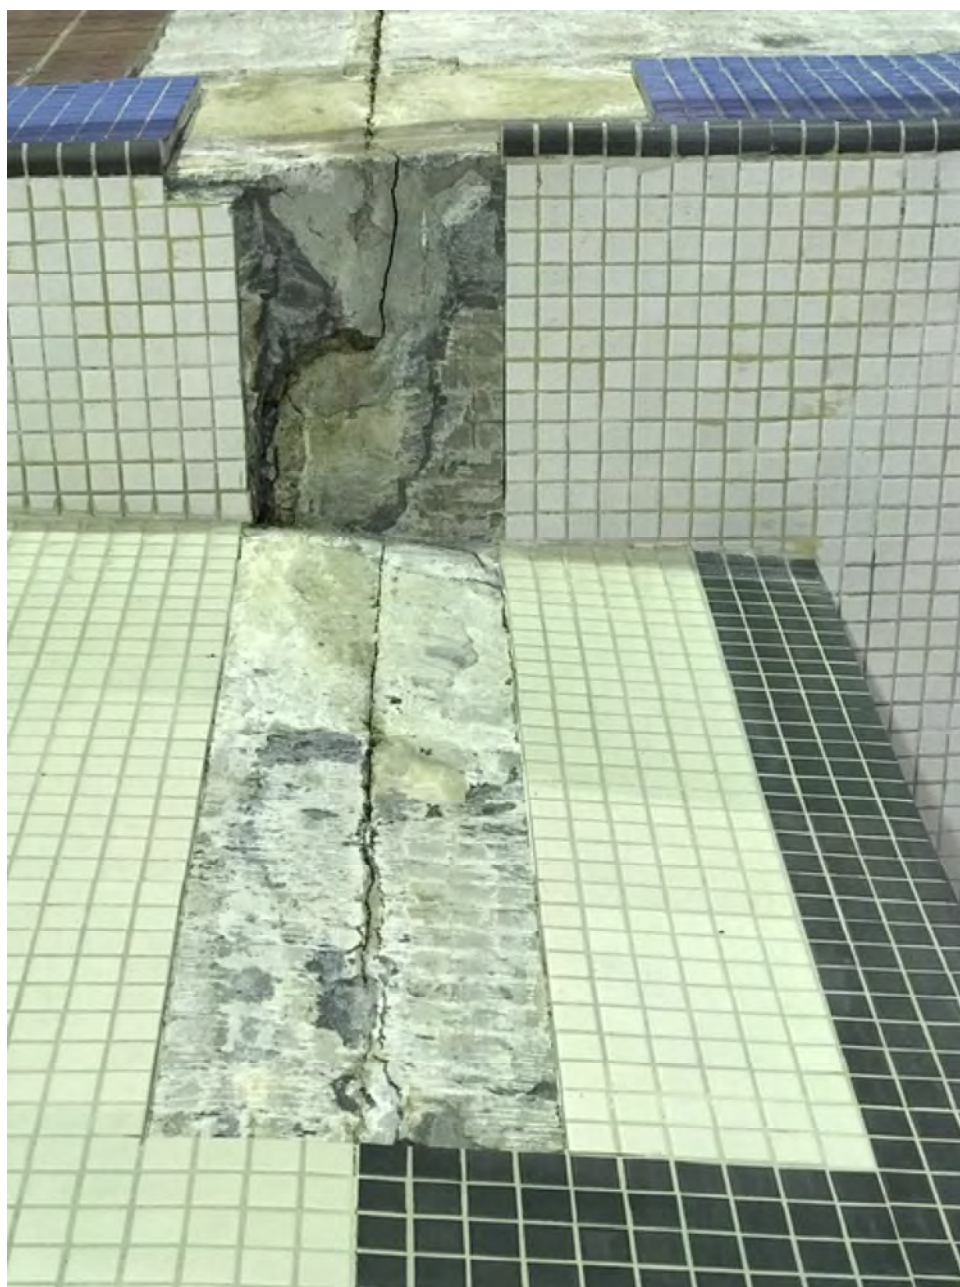
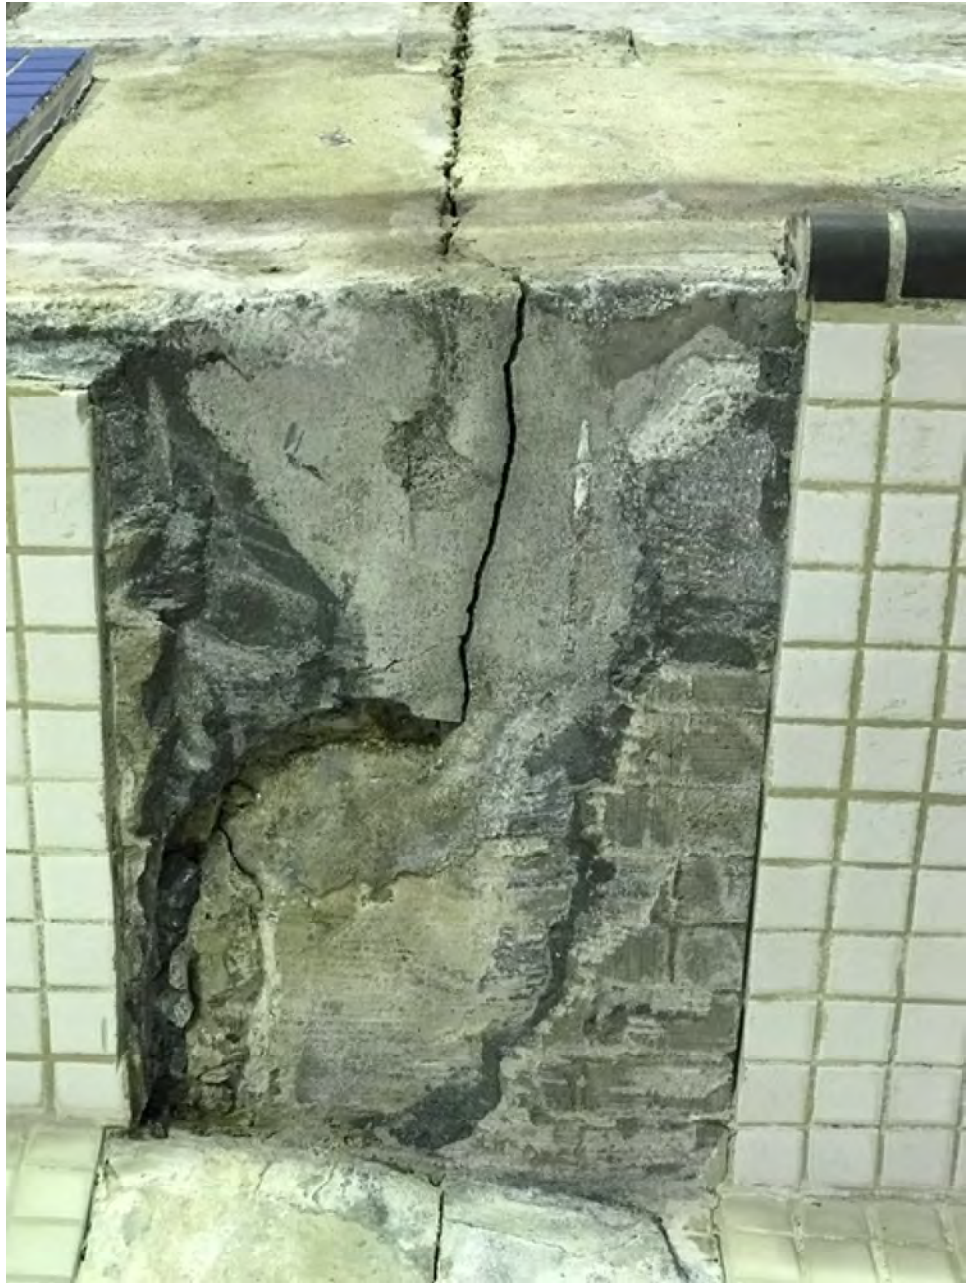
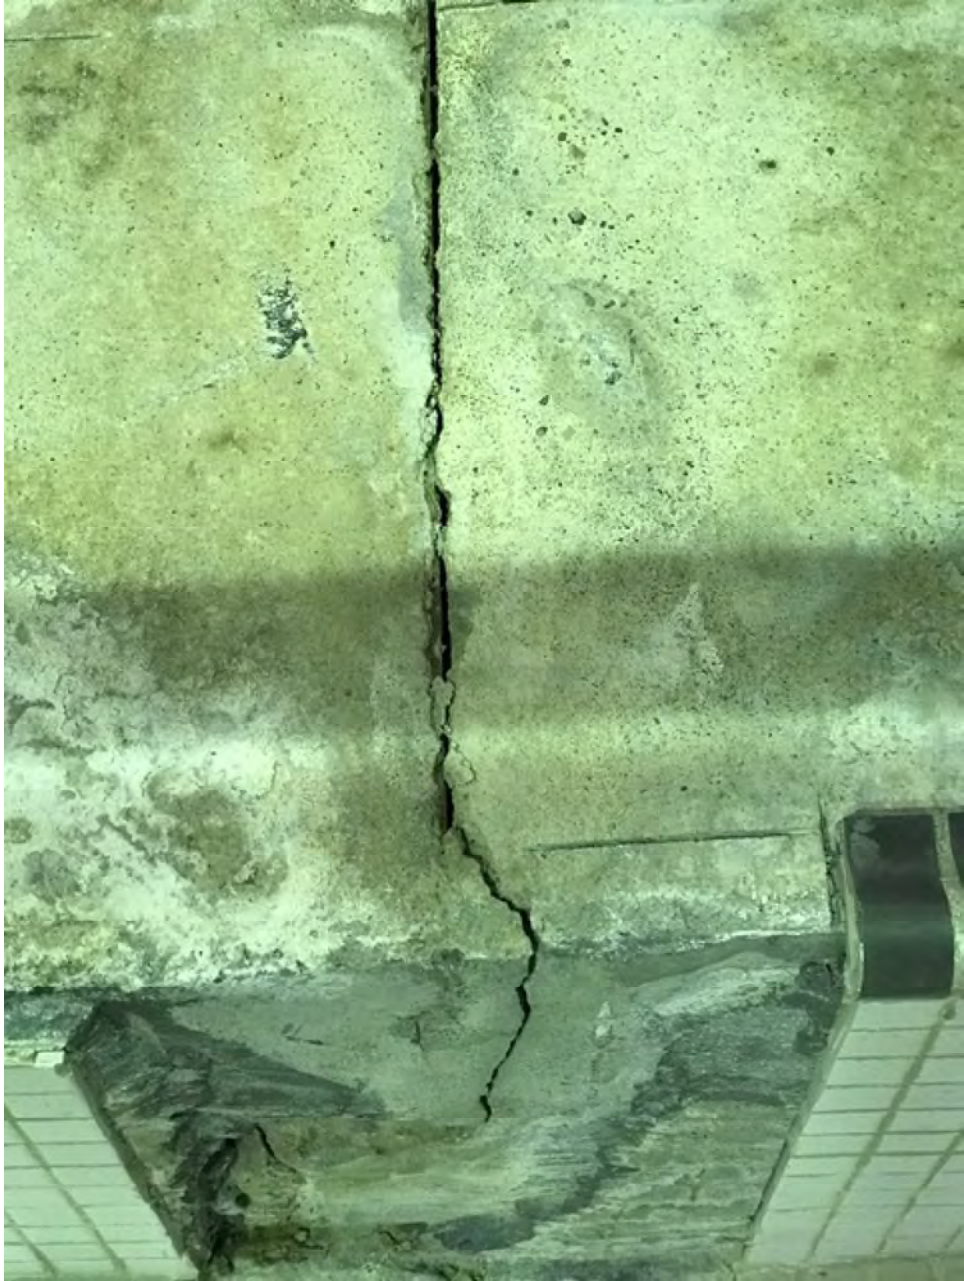
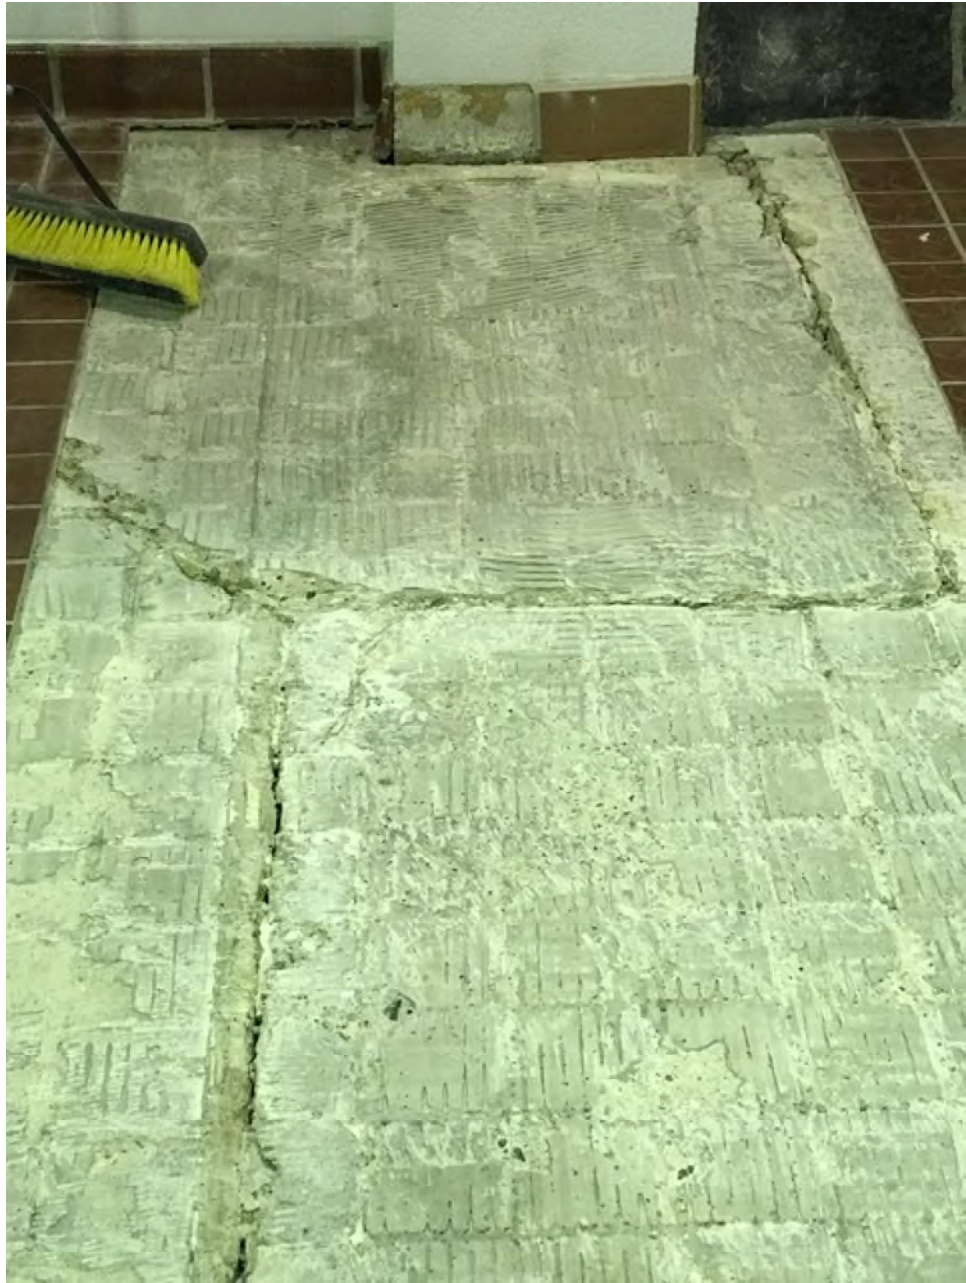
The other three locations you showed me are also joints (see the second attachment). Similar to the joint along grid line 2, the epoxy to be injected at these joint should allow some movement.
