June 11, 2015
Project No. 214320

FINAL

CITY OF FORT
SASKATCHEWAN

GOLF & CURING CLUB
FACILITY EVALUATION REPORT

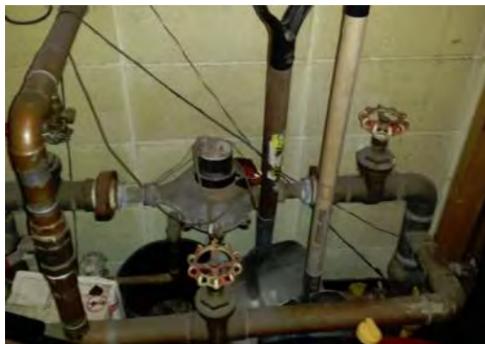
The Arena has its own dedicated 50mm diameter water service. There are backflow prevention devices installed on the line to the domestic hot water.

Figure 1: No Backflow Device @ Water service

Item	Time Frame (Years)	Approximate Cost, Installed
Replace Chiller Plant	0 (Immediately)	\$250,000
Add Backflow Prevention Device on Water Service	0-5	\$12,000
Replace Domestic Hot Water Heater	0-5	\$3,000
Replace Recirculation system	0-5	\$2,000
Convert Fixtures to low flow (IR)	3-5	\$8,000
Replace Furnaces and Kitchen Makeup Air	3-5	\$25,000
Replace Gas fired Unit heaters	5-10	\$10,000

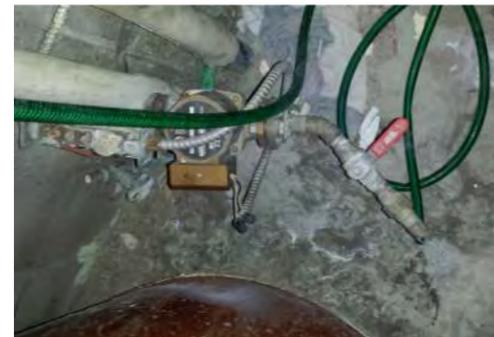
A domestic hot water re-circulation system is provided to ensure timely delivery of hot water to the plumbing fixtures. The existing recirculation unit to the tank has been disconnected and is currently out of service. It is recommended that the recirculation system be replaced with the domestic hot water system replacement.

Figure 3: Domestic Hot Water Tank Disconnected Recirculation System

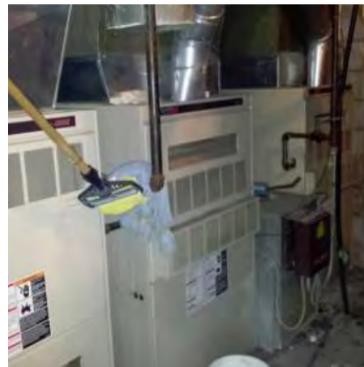
The facility utilizes a total of 4 furnaces to service the building. Three main furnaces are located in the main mechanical room and services the lobby, the main floor spectator area, the upper lounge and kitchen. The fourth furnace resides in the west side of the facility which services the west upper lounge area. The main furnaces are identical (heating only) with a heating input of 150MBH each and the fourth furnace with an input of 115 MBH. Ductwork distribution could not be reviewed to determine the condition however some of the existing distribution was noted to be buried ductwork. Consultation with facilities indicated that no concerns regarding standing water in the ductwork has been overserved over the years. Replacement of the furnaces should include a study to verify that current codes and standards for minimum ventilation rates are satisfied.

Figure 4: Main Furnaces

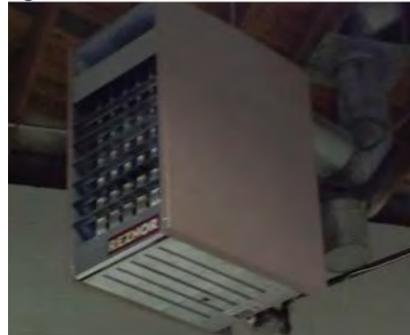
The curling rink is serviced with four gas fired unit heaters at each corner of the rink. Nameplate data could not be attained from the units due to accessibility limitations. Two of the four unit appear to have been replaced from original. The units appear to be in fair to good condition.

Figure 7: Infrared Heaters

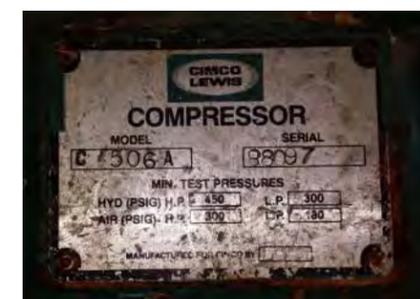
The main ammonia chiller plant is located within a dedicated room that has refrigerant monitoring and alarms. The chiller plant utilizes a water cooled system that incorporates original equipment such as: Cooling Tower, water conditioning equipment, CIMCO reciprocating compressors, belt driven with motors, shell and tube heat exchangers and distribution pumping. The chiller plant had recently suffered a catastrophic failure and has been decommissioned at the time of review. Due to the age of the equipment, it is recommended ALL original equipment be demolished and replaced with a new air cooled chiller plant complete with digital controls and refrigeration monitoring system.

Figure 10: Chiller plant

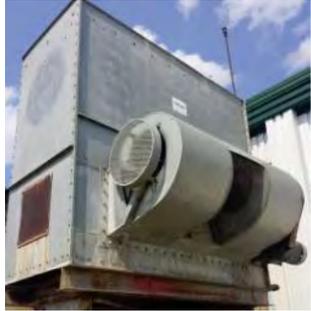
Figure 11: Cooling Tower

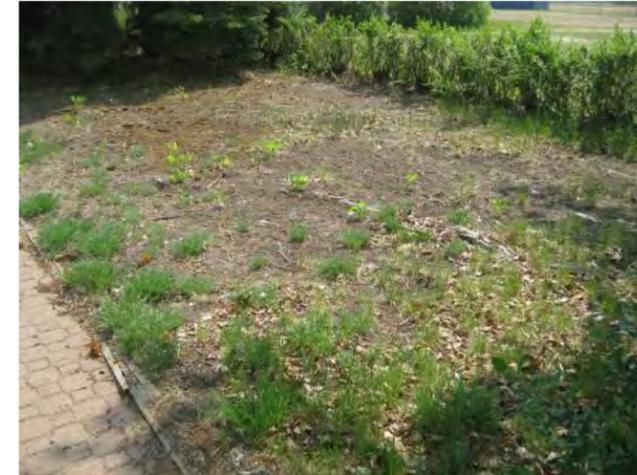
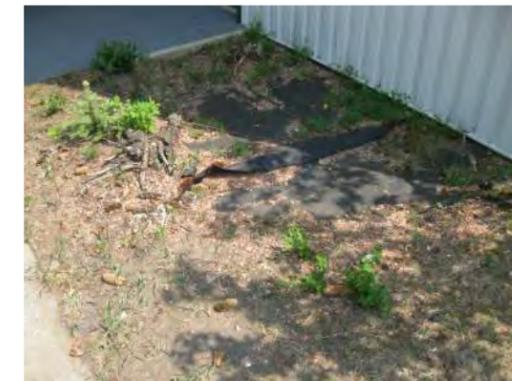
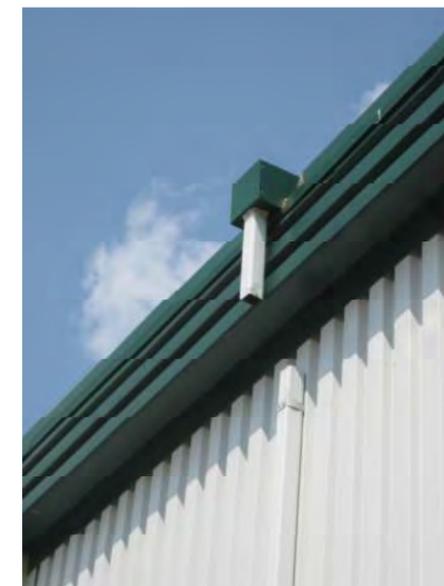
The roof of the facility is drained via rain water leaders splashing to grade level concrete splash pads. There are numerous down spouts that are disconnected and missing parts and do not have concrete splash pads. The missing parts are impairing the ability of system to direct the rain water away from the building, thereby creating the potential for water infiltration and damage to the building. It is recommended that the rain water down spouts and splash pads be repaired and placed in order to protect the facility from the effects of water migrating back towards the building.
