CITY OF FORT SASKATCHEWAN  
WATER TOWER  
COATING/INSULATION ASSESSMENT

## WATER TOWER – COATING/INSULATION ASSESSMENT

## Inspection Report

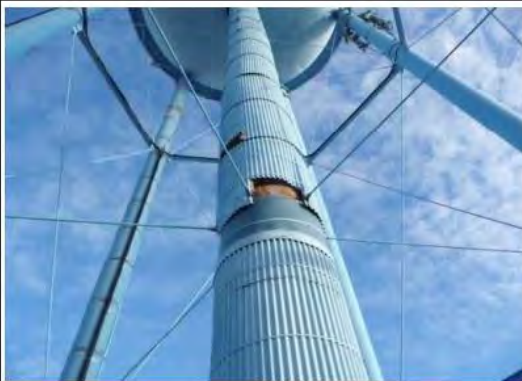
Stand pipe

**1.6** - The corrosion damage on the stand pipe occurs below the stiffener rods and the insulation water cap.

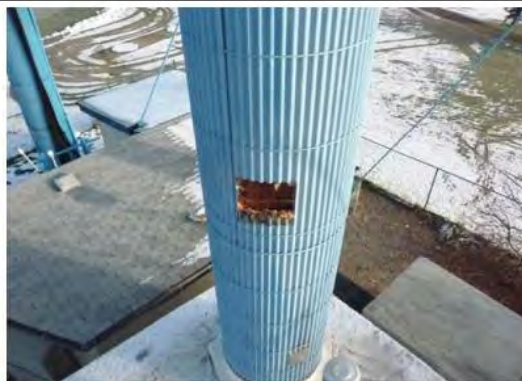
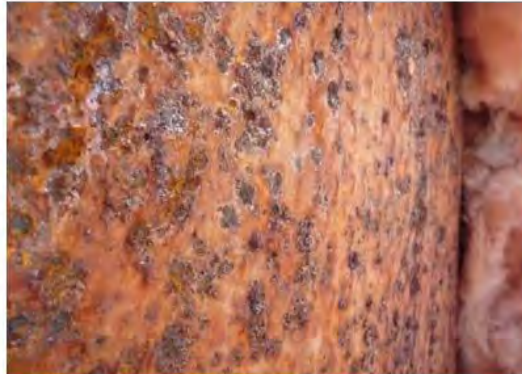
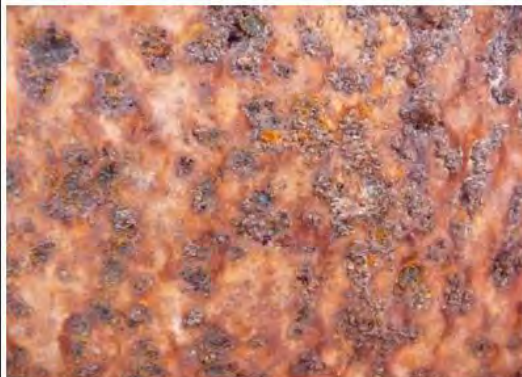
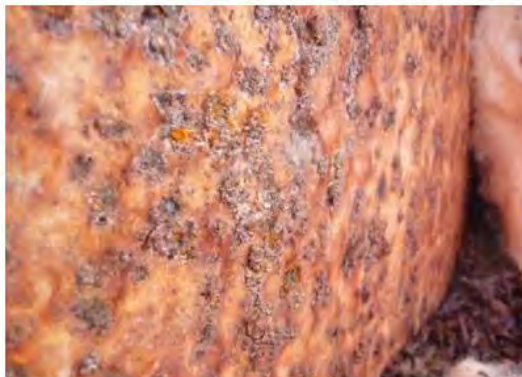
Lowest opening

**1.1** - At the lowest opening visual inspection has revealed class C steel with slight to moderate pitting on the surface. The steel mesh that holds the insulation in place has corroded nearly to dust and is destroyed by touch. Dry film thickness readings were taken on this area with a Defelsko Positector 6000 DFT gauge serial# 246275 range from a low of 0.60 mils and a high of 1.75 mils with an average of 1.00 mils. (See PosiSoft Reports for complete details). Very little of the original coating remains in this area.

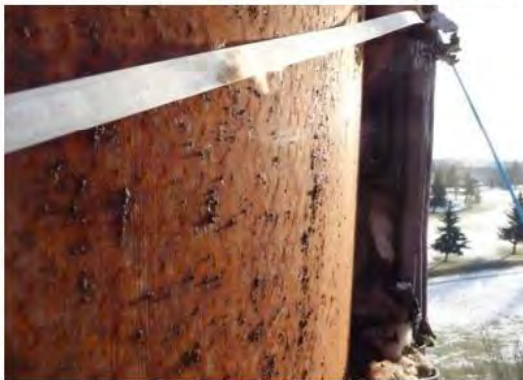
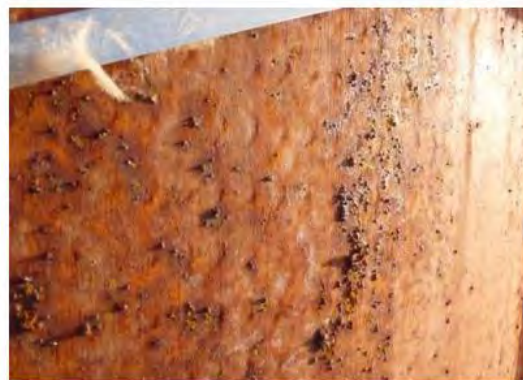
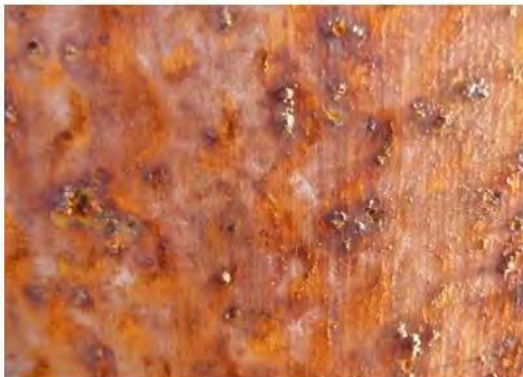
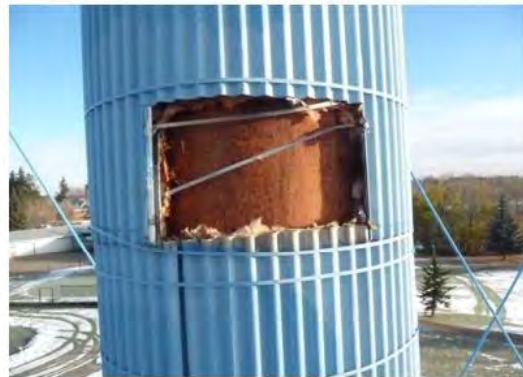
Midway Opening

**1.2** - The next section was opened approximately 12 ft above the first and visual inspection revealed Class B steel with markedly less pitting on the surface. The corrosion process is on going however to less of a degree than the lowest section. Dry film thickness readings were taken of the second section ranging from a low of 0.40 mils and a high of 3.3 mils with an average of 1.18 mils. (See PosiSoft Reports for complete details). More of the original coating remains in this area.

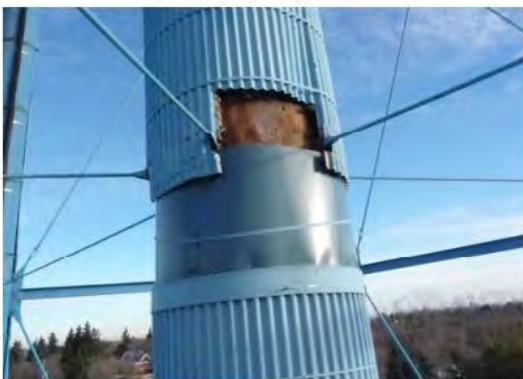
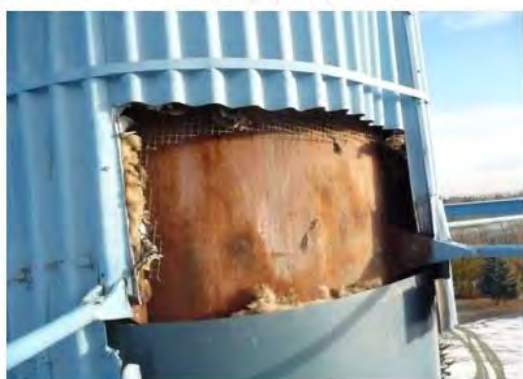
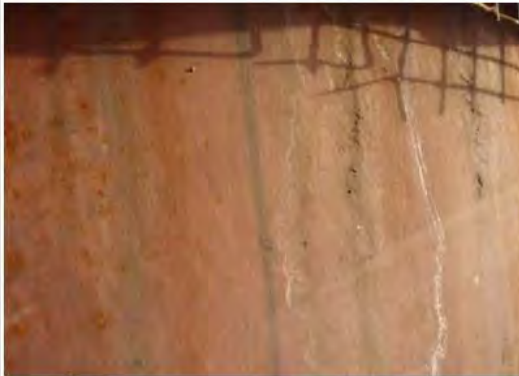
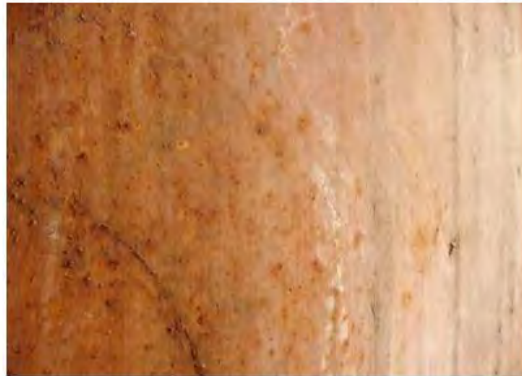
Upper Opening

**1.3** - At the highest opening approximately 12 feet above the midway opening is just below the first attachment point of the stiffener rods and Visual inspection has revealed Class A Steel with no visible pitting. Some water staining was observed in this area possibly due to the cracking of the caulk utilized around the stiffener supports. Dry film thickness readings were taken of the upper most section ranging from a low of 0.65 mils and a high of 2.0 mils with an average of 1.28 mils. (See PosiSoft Reports for complete details). Most all of the original coating remains in this area.

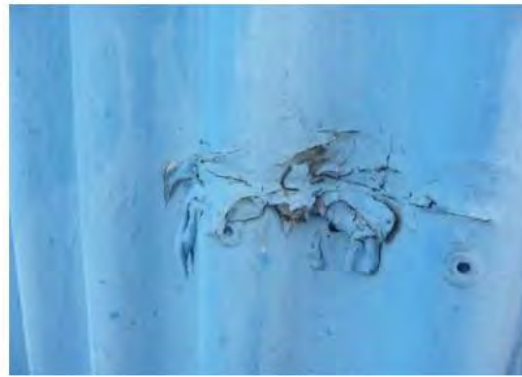
Calking around the Strut

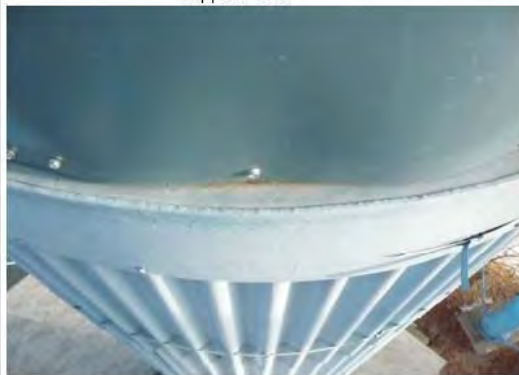
Top Of The Water Cap

- A. The weather barrier (insulation water cap) at the expansion joint is not weather tight permitting water to enter behind the cladding. As a result, below this point, the insulation is damaged and the standpipe is badly corroded. The insulation below this point appears to contain mold.
- B. The insulation system above the expansion joint is in better condition but is still not sealed as evidenced by the corrosion on the standpipe and damaged insulation.
- C. At multiple inspection points, the insulation appears to have slipped down and as a result some spots are missing insulation.
- D. In view of the condition of the existing insulation and the fact that there is no insulation in isolated locations, the R-value of the standpipe insulation is very inconsistent.

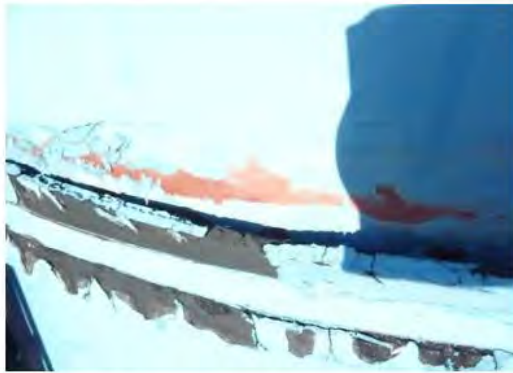
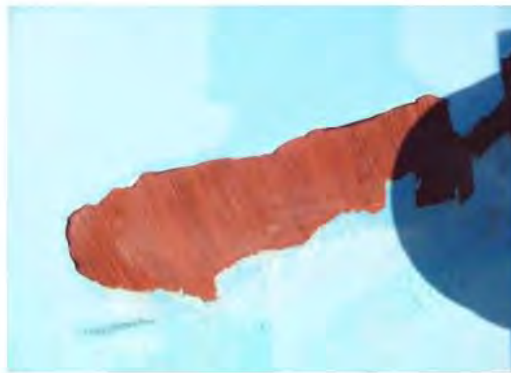
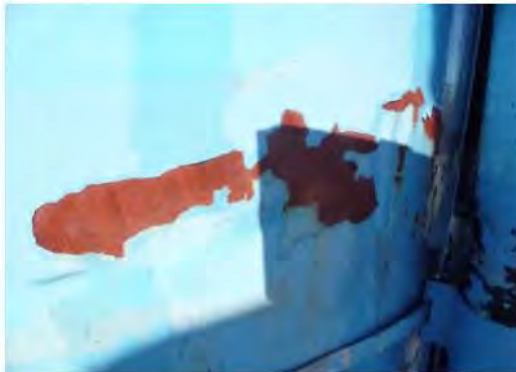
**1.4** - Several areas of missing top coat were observed on the western most support leg and visual inspection revealed that the areas under the foam protective strips have failed revealing the primer coating underneath. Dry film thickness readings were taken of the exposed primer ranging from a low of 0.4 mils and a high of 1.2 mils with an average of 0.75 mils. (See PosiSoft Reports for complete details). Most all of the original primer remains in these areas.

Under foam protected cable strap

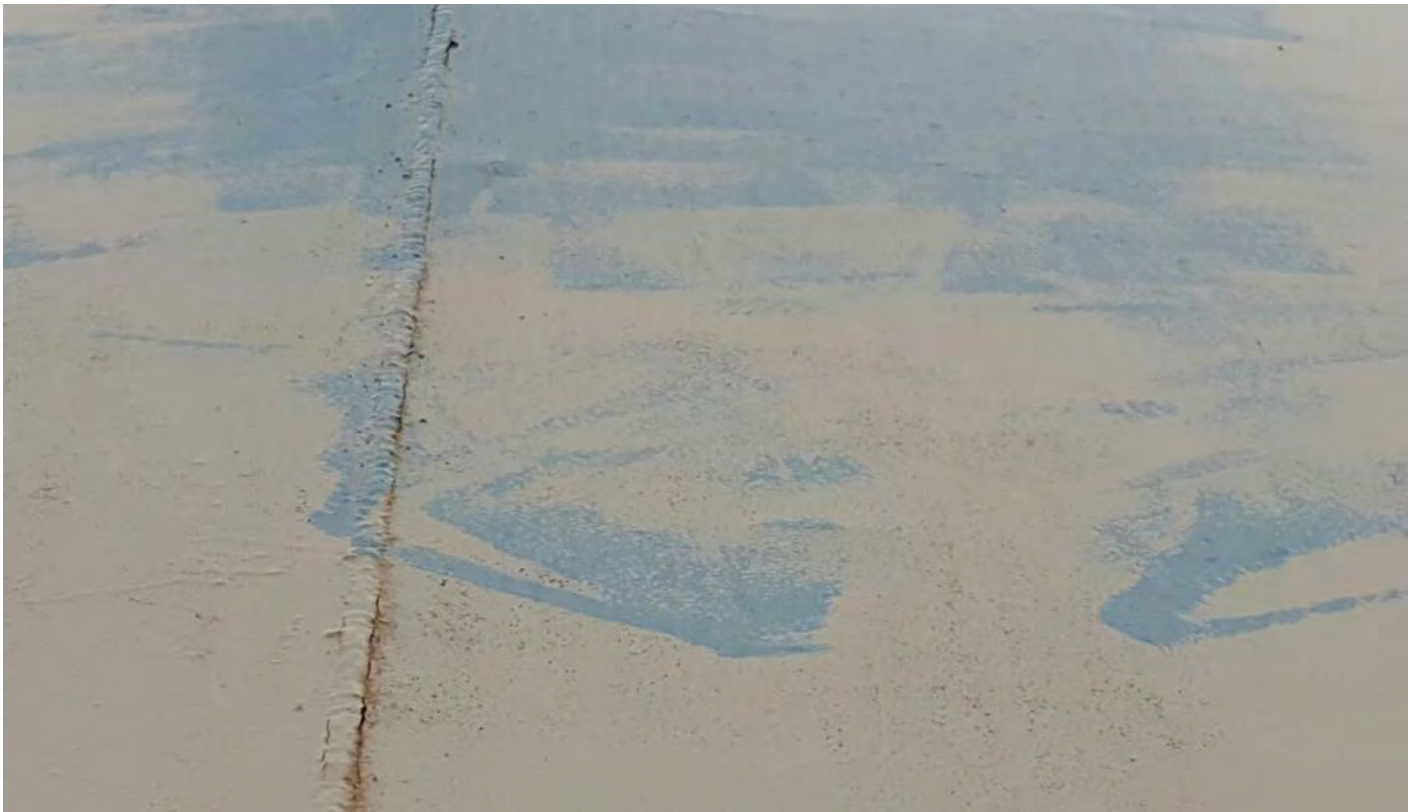
**Exposed Mid Coat and small areas of Bare Metal**

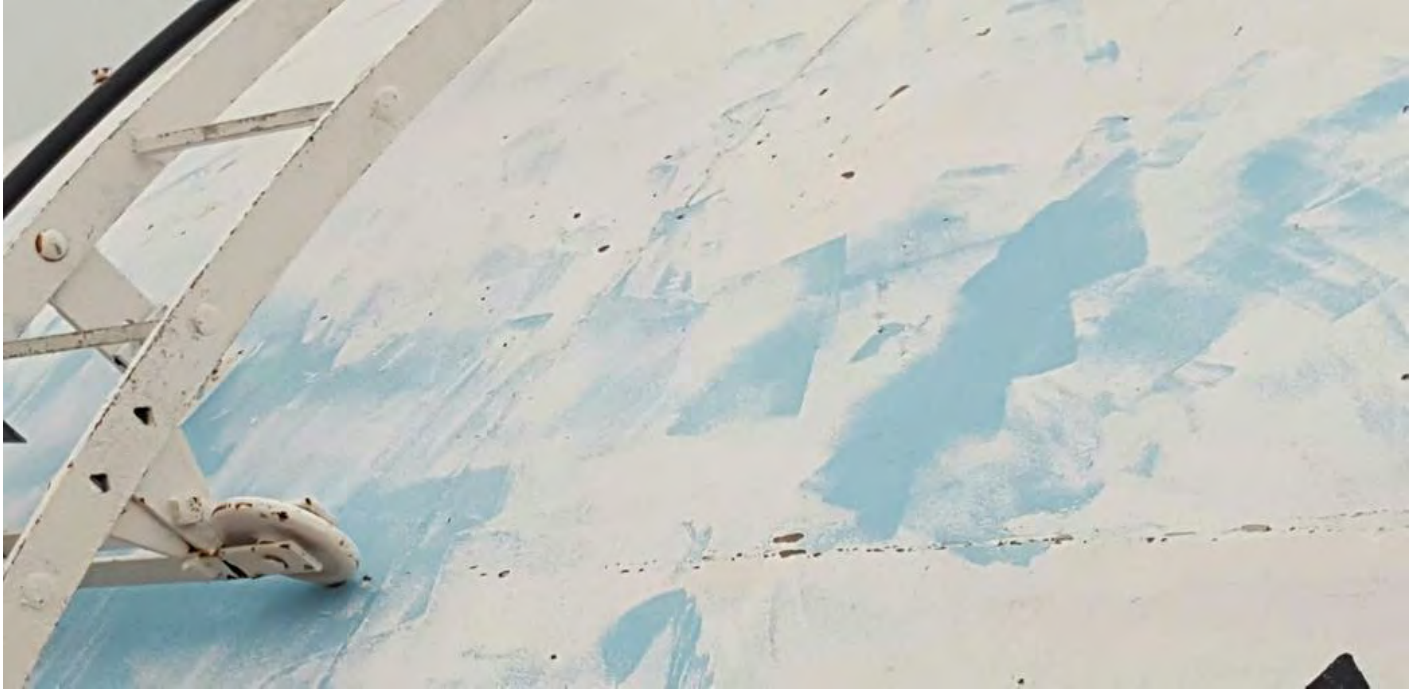
**Top Coat Breakdown**

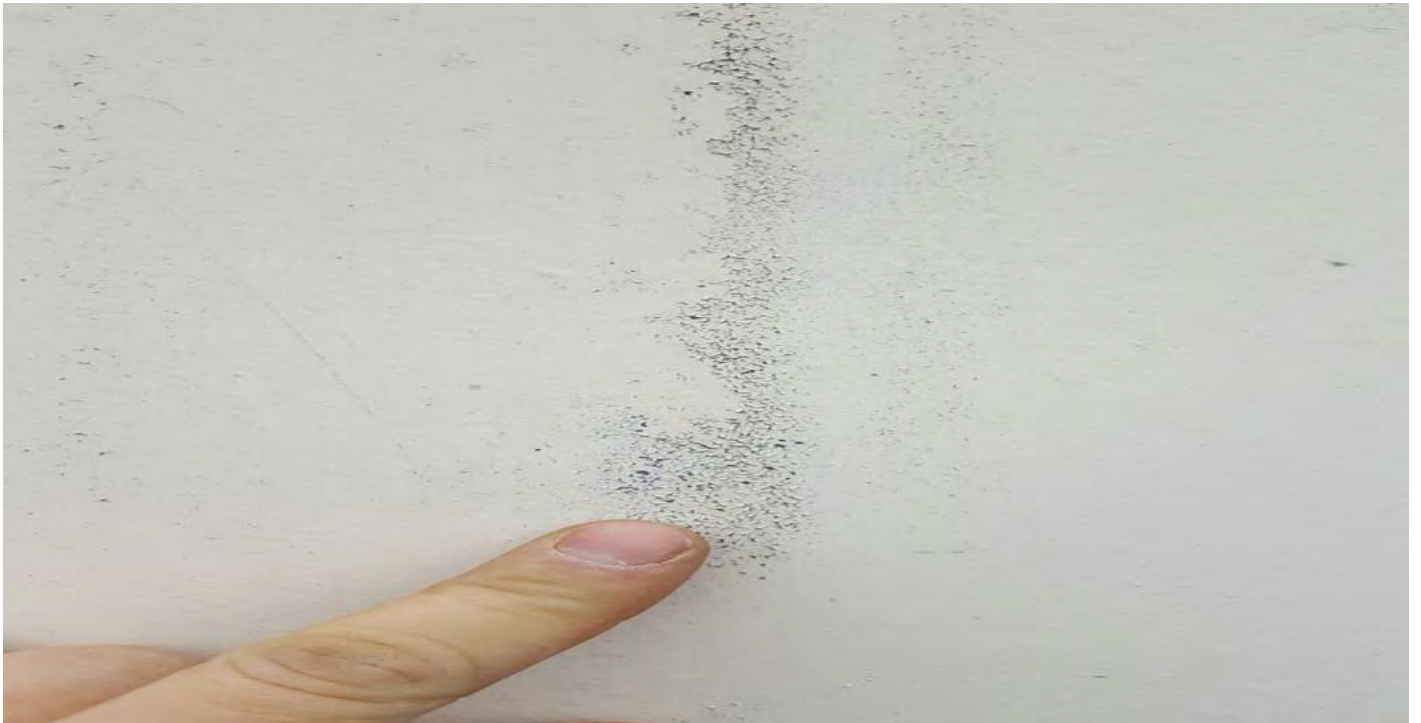
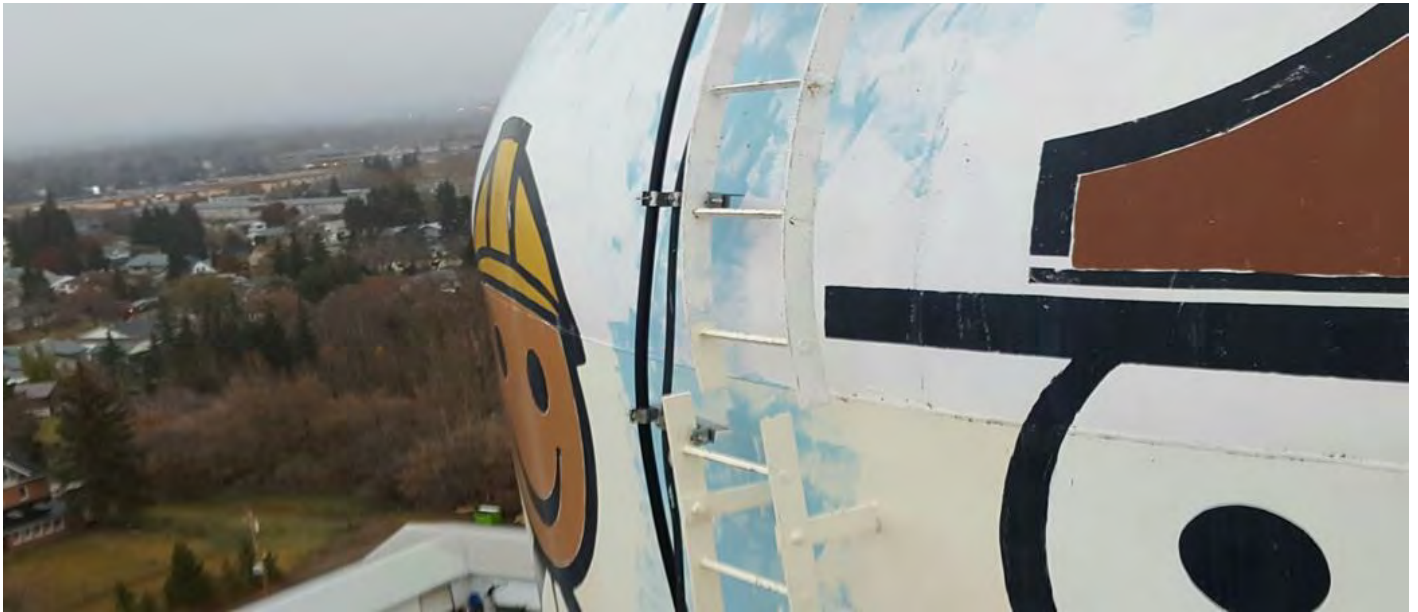
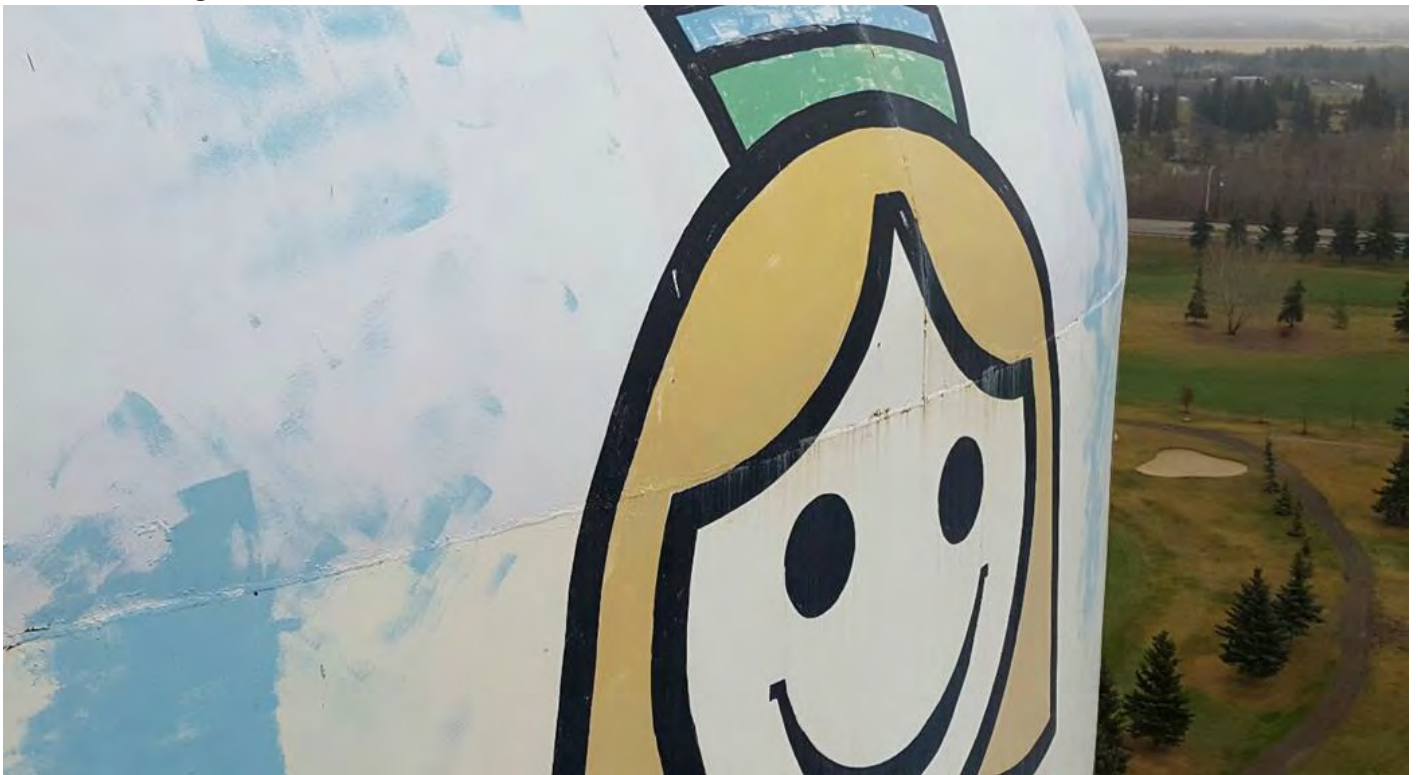
While the majority of the coating remains intact, it has oxidized and is exhibiting a general loss of gloss and is chalking in most areas. In areas of southern exposure, the top coat has largely worn away exposing the mid-coat in large areas. There are areas where the coating has failed, exposing bare metal, particularly along weld seams. The average Dry Film Thickness (DFT) was approximately 6 mils.

**General Coating Condition**
