Ground-Penetrating Radar  
Report# 20808  
City of Fort Saskatchewan – Harbour Pool

1 March 2017

Re: **Ground-penetrating Radar Digital Report #20808**

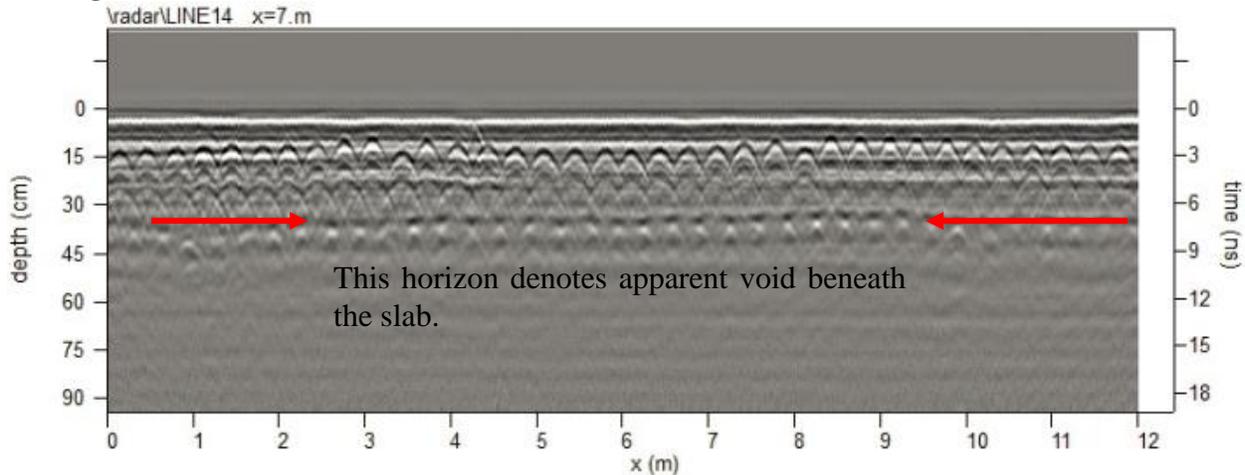
**Figure 05:** GPR Profile of data gathered in a pool basin.

From a depth of 0-~40cm the data appears to attenuate as expected in a relatively thick slab-on-grade. At ~40cm, there is a strong horizon which is visible across the entire GPR profile. This horizon denotes a concrete-air interface and was used to determine that a void-space existed beneath this pool. Consultation with an engineering drawing from this location later corroborated that the pool was built on its own footings as a structural element of the building in which it had been installed. Voiding beneath this particular pool basin was actually part of its design.

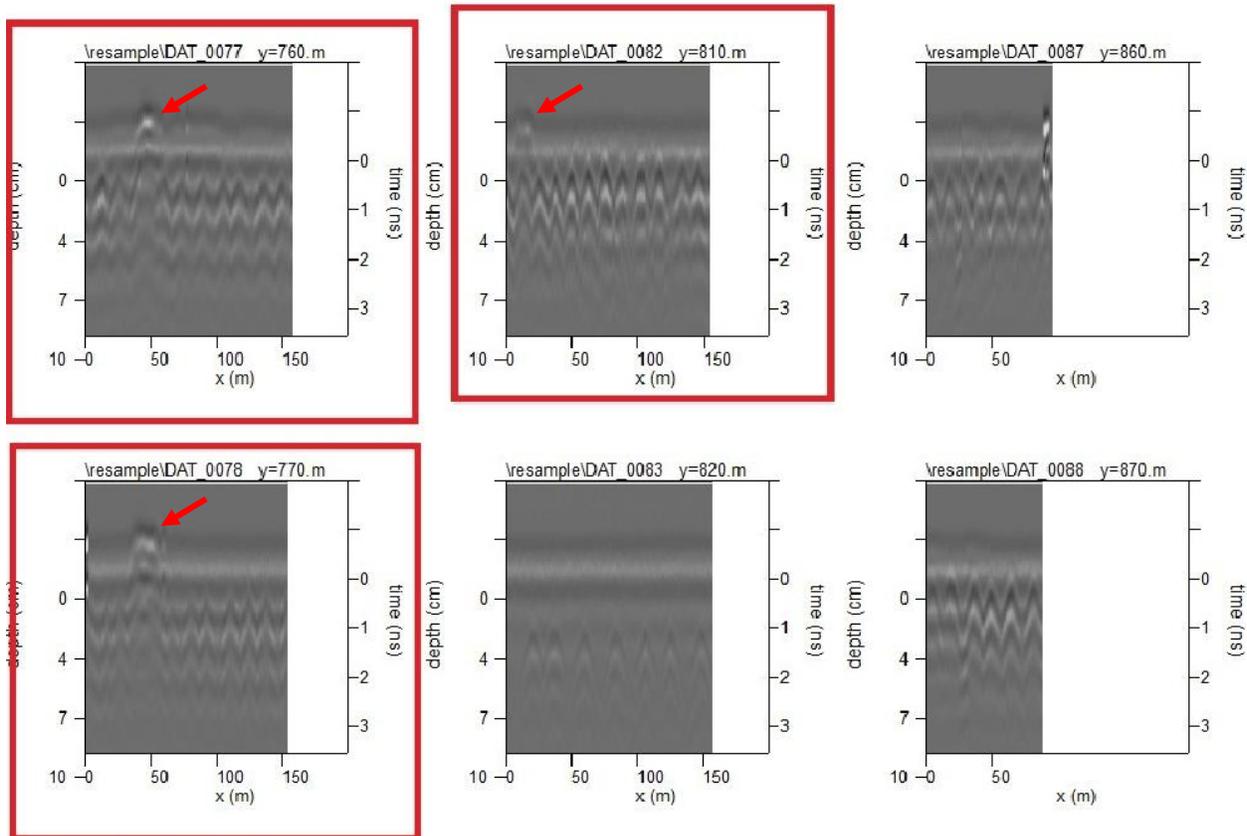
**Figure 06:** GPR profile showing confirmed honeycomb voiding in a concrete structure.

Honeycomb voiding is a relatively common failure in concrete and is the result of construction methods which fail to cause the cement and aggregate mixture in the concrete to settle appropriately. This causes air pockets to be trapped in the concrete. In the case of a salt-water pool basin, honeycomb voiding may provide a path for the salt-water to contact the steel reinforcement bars causing premature corrosion and rebar failure.
