## Harbour Pool

### 2018 Main Pool, Warm Pool and Whirl Pool Structural Assessment

10001 - 94 Avenue  
Fort Saskatchewan, Alberta

March 2018

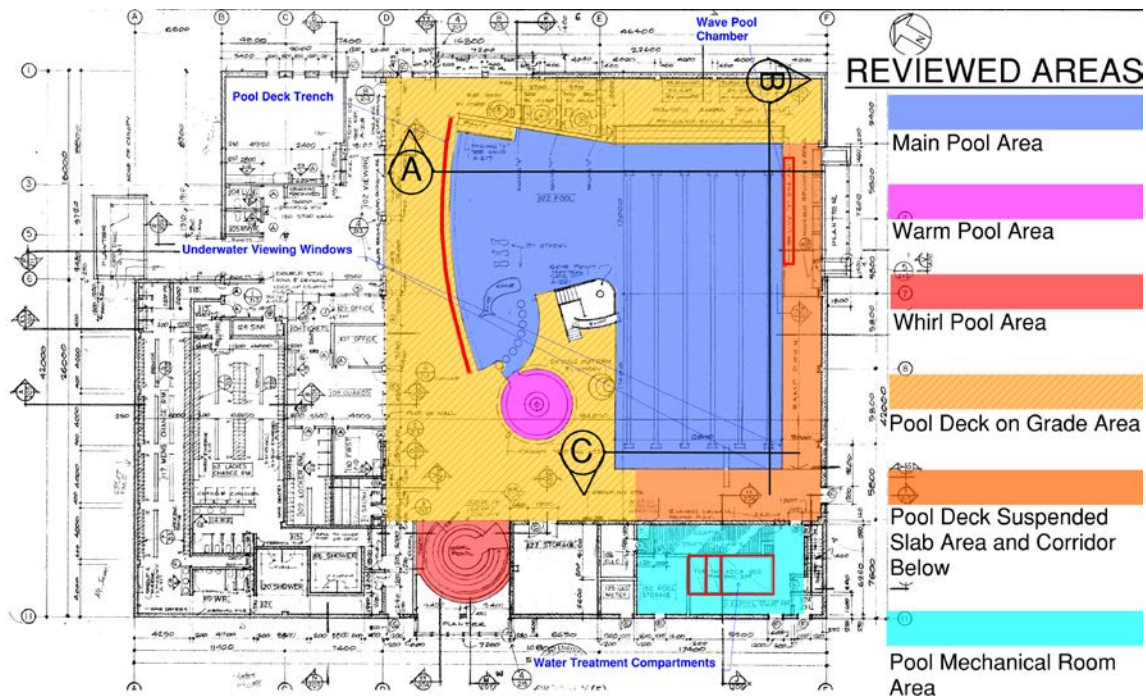
### Figure 1 – Harbour Pool Area

The swimming pool area of the structure is approximately 1,200 sq. m and is located at the east end of the structure (Appendix A, Figure 1). The main swimming pool (approximately 500 sq. m) consists of a water spray park area and a 25 m x 12.8 m swimming pool and deep end; warm pool (approximately 25 sq. m); and whirl pool (approximately 30 sq. m). A mechanical room with the water filtration and treatment equipment is located at the southeast corner of the structure.

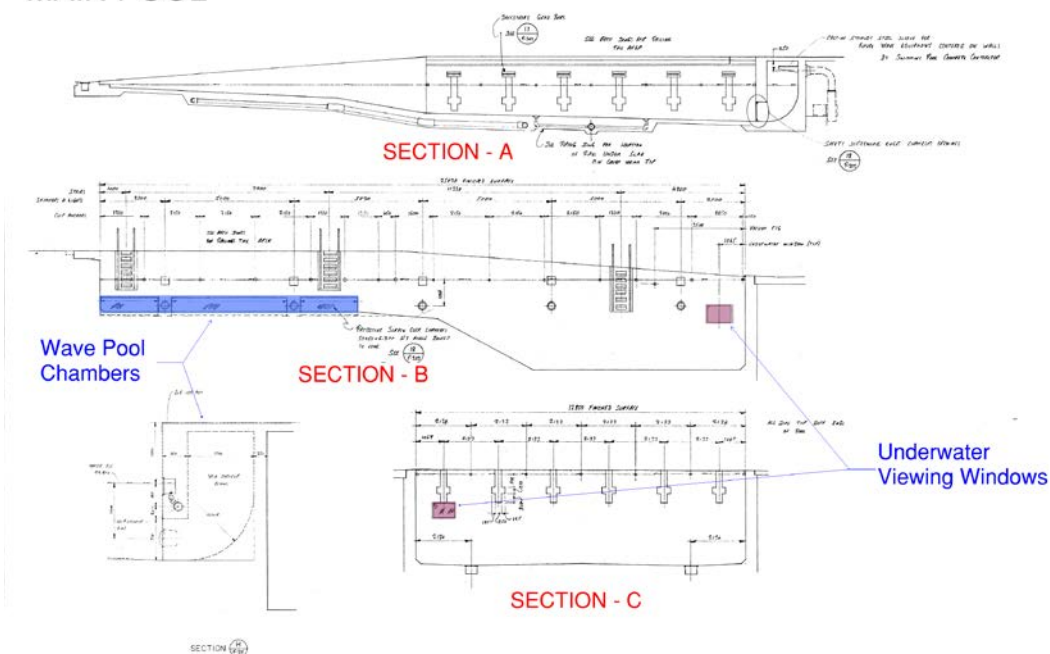
### Figure 2 – Main Pool Sections

Located at the northeast end of the main pool in the deep end are three wave pool chambers (Figure 2). The chamber is constructed between a 450 mm and 250 mm thick reinforced cast in place walls that form the wave chambers. The inner wave chamber wall is supported on a strip footing below. The wave pool chambers have been abandoned and sealed off from the interior corridor.

Two 600 mm x 900 mm underwater viewing windows are cast into the concrete walls, are located at the south east end of the main pool deep end (Figure 2).

- Underwater viewing windows are located in the deep end of the main pool area (Figure 2). Viewing windows generally appear to be in fair condition (Photo 5). Efflorescent staining was observed around the viewing window (Photo 6). A cementitious parging material has been installed around the window block out. The parging material was loose during review; however, the underlying concrete appeared sound. We were informed that during filling operation of the pool, leakage at the windows occurs until sufficient pressure is obtained to seal the windows but that leakage does not occur once the pool is full. Immediate repairs are not required, however, probable costs for replacement have been provided in our recommendations.

- Wave pool chambers are located at the northeast end of the deep end (Figure 2). A bonded thin concrete topping appears to have been applied onto the concrete structure (Photo 8). Debonding and failure of the thin concrete topping was observed at multiple locations in the wave pool chambers. Water staining and efflorescence at crack locations was observed on the hallway opposite the wave pool chamber (Photo 9). Hammer sounding of the underlying structural concrete structure was not possible during review, however, corrosion was observed at one small location. We note that the wave pool chambers are exposed to wetting and drying conditions and exposed to higher mechanical forces due to movement of water in these chambers, resulting in more severe exposure conditions than adjacent areas. Removal of the loose material, concrete repairs, application of a waterproofing membrane system on the exposed concrete structure, and sealing the wave pool chamber openings is recommended.
