**From:** Caitlin Luo <luoc@ae.ca>  
**Sent:** Thursday, January 19, 2017 8:16 AM  
**To:** Lindsay Poitras  
**Cc:** Carma Holmes  
**Subject:** RE: Photos  
**Attachments:** Harbour Pool-joint on concrete slab.pdf; Harbour Pool-other joints.pdf

We have reviewed the existing structural drawings and the photos you sent. It appears that the joint along grid line 2 is a construction joint within the slab on grade (see the first attachment). The epoxy to be injected at this joint should have capacity to allow some movement.

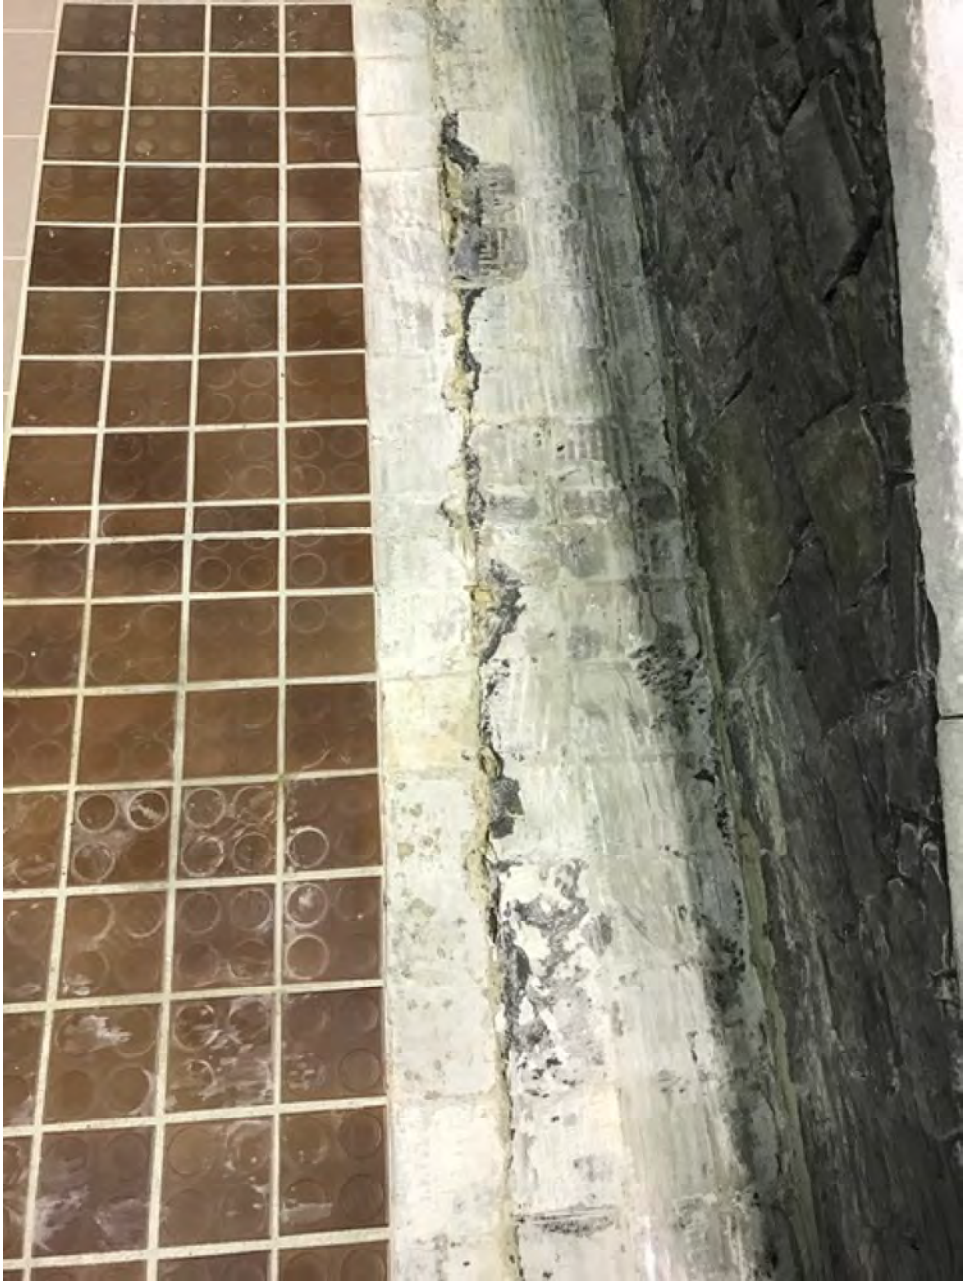
The vertical crack found along the beam at the construction joint should also be repaired.

vertical crack - the concrete has deteriorated. The crack should be patched with a repair mortar and surface should be prepared in accordance with manufacturer's recommendations.

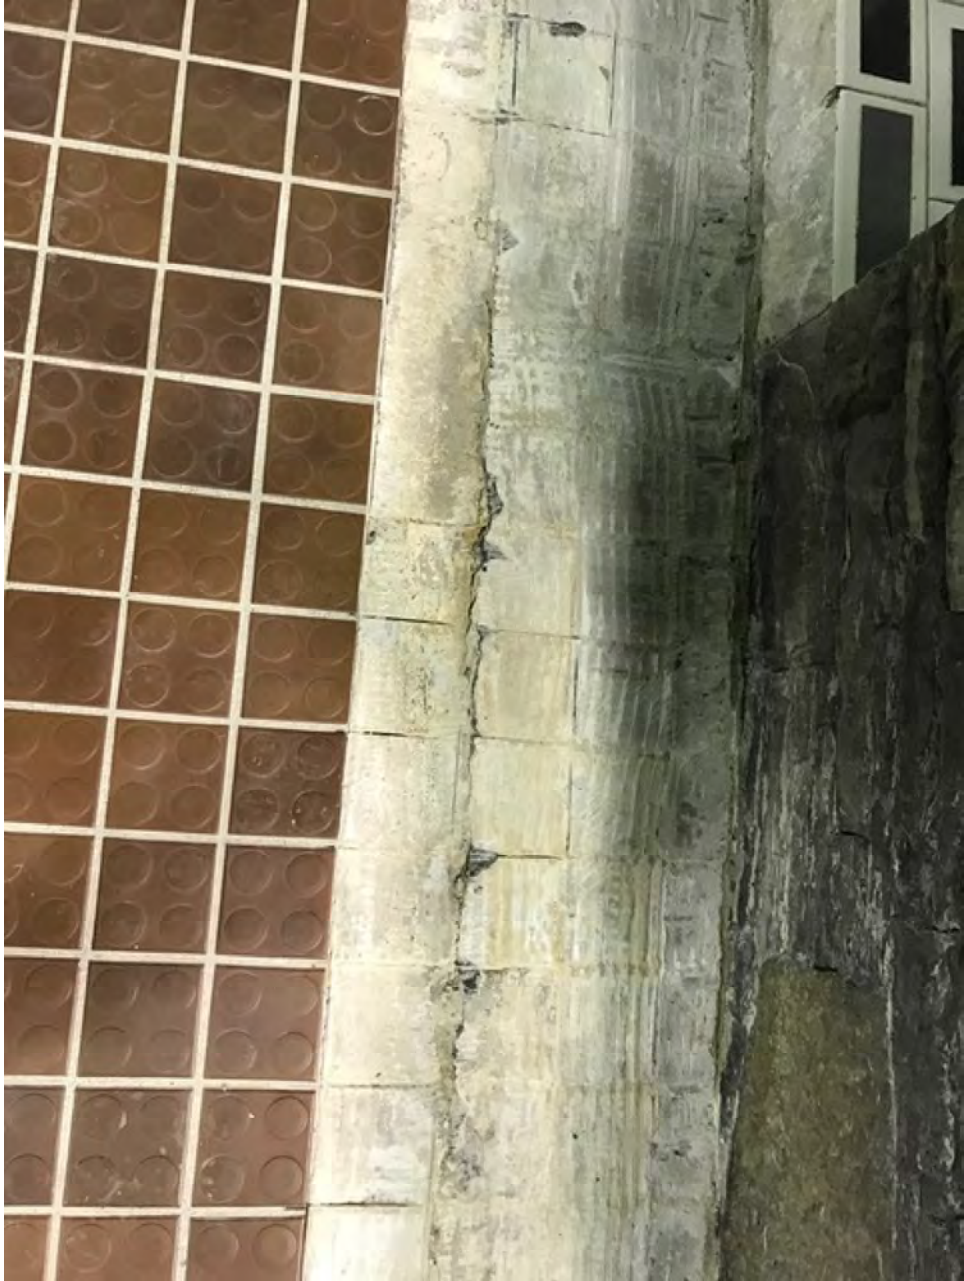
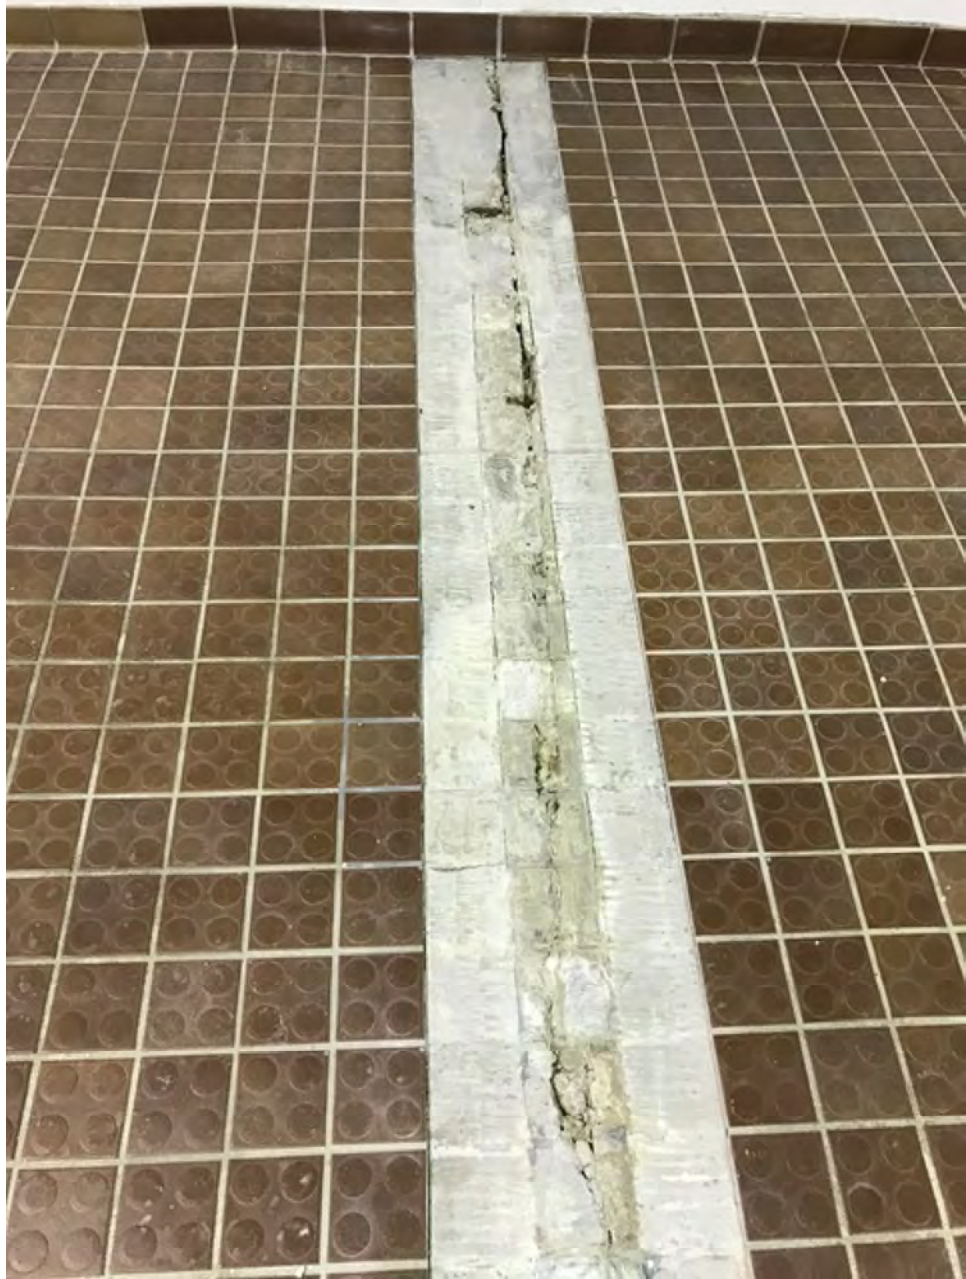
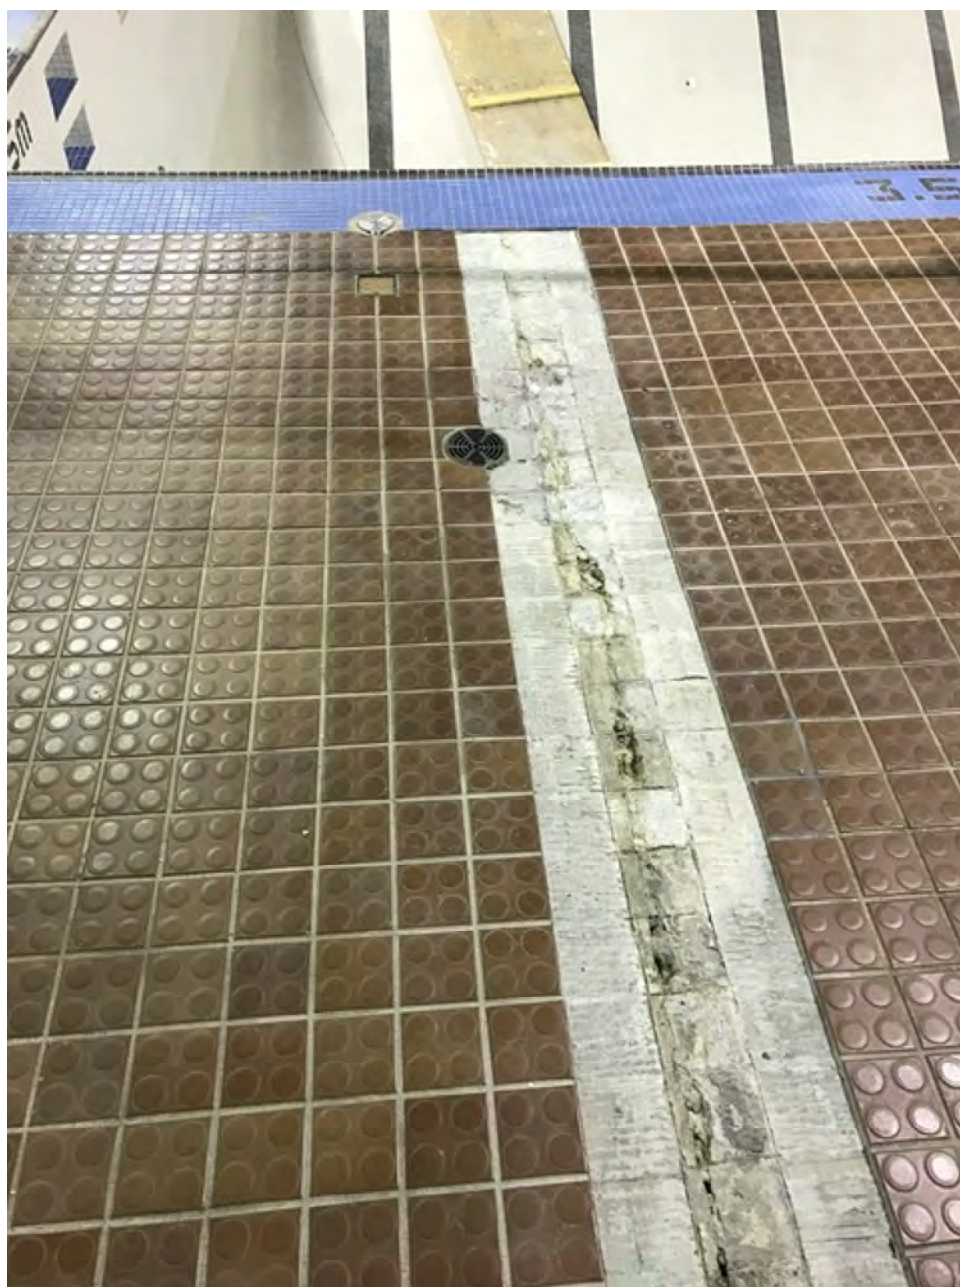
The other three locations you showed me are also joints (see the second attachment). Similar to the joint along grid line 2, the epoxy to be injected at these joint should allow some movement.
