June 11, 2015
Project No. 214320

FINAL

CITY OF FORT
SASKATCHEWAN

GOLF & CURING CLUB
FACILITY EVALUATION REPORT

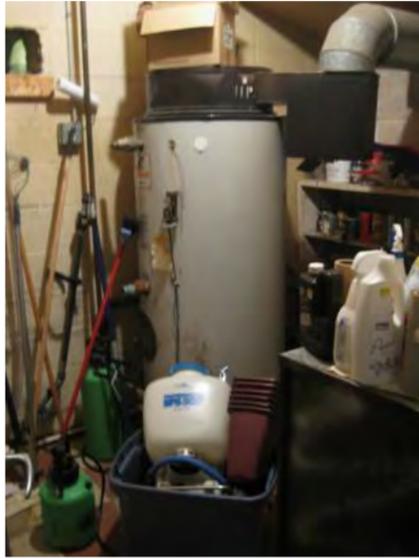
Mechanical Room #12

Some floor stains were noticed in the Mechanical room, but are of no structural concern here. Also, noticed the roof portion of this room, which showed some stained area, probably due to water leak from a pipe as the area above was not accessible.

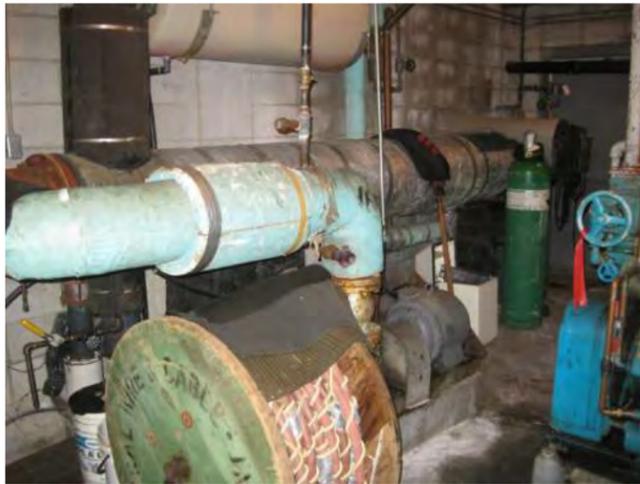
Ice Plant #14

The roof itself and associated flashings were beyond the scope of this visual review but it should be noted that a significant water leak was seen dripping from the ceiling of the ice plant during a rain event back in 2010. BR2 was informed that the roof of this area was upgraded to resolve this issue, and since this repair was completed no further leakage has been observed. The damage left behind from the leaking roof has never been repaired and compromises the fire resistance rating of the roof structure over the mechanical room. Water staining was also noted in several locations throughout the building, however it is difficult to determine if new leaks or staining has occurred since the 2010 report was issued. If these stained ceilings are in areas where no upgrades to the roofing were performed in the past 5 years, it is recommended that further investigations take place to determine their source.

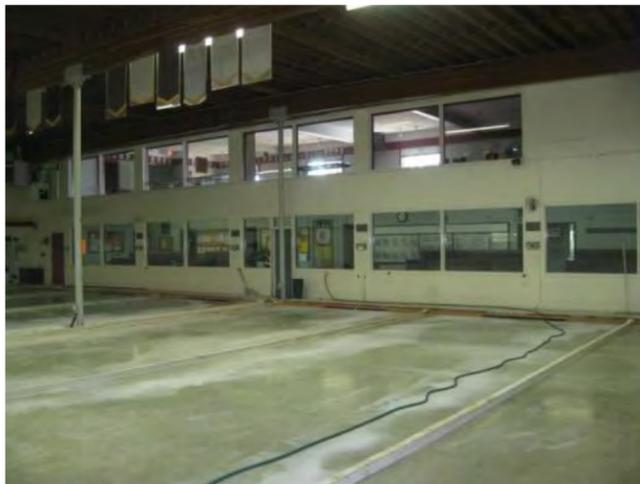
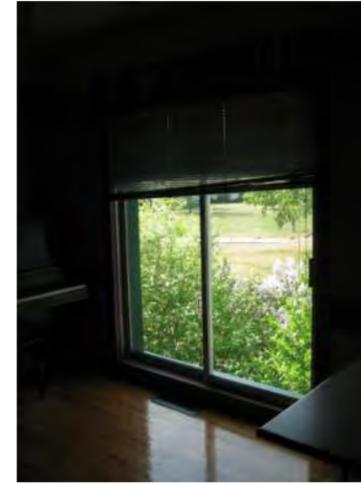
Curling Rink #16

Based on the visual observations, the Curling Rink is in reasonably good structural condition. As the wood structural work, in the rink area roofing, needs to be addressed with the roof to be verified and confirmed for proper draining, due to permanent deflection of the wood purlins, the cost estimation suggested would be around \$ 175,000.00. A Structural Engineer registered in the province of Alberta should be retained for the Design and to produce working drawings for this roof remedial works.
