CITY OF FORT SASKATCHEWAN  
WATER TOWER  
COATING/INSULATION ASSESSMENT

## WATER TOWER – COATING/INSULATION ASSESSMENT

## Inspection Report

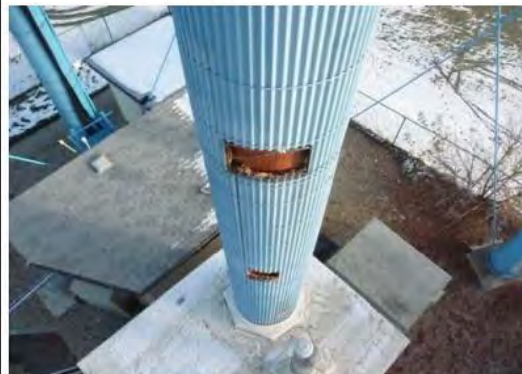
Lowest opening

**1.1** - At the lowest opening visual inspection has revealed class C steel with slight to moderate pitting on the surface. The steel mesh that holds the insulation in place has corroded nearly to dust and is destroyed by touch. Dry film thickness readings were taken on this area with a Defelsko Positector 6000 DFT gauge serial# 246275 range from a low of 0.60 mils and a high of 1.75 mils with an average of 1.00 mils. (See PosiSoft Reports for complete details). Very little of the original coating remains in this area.

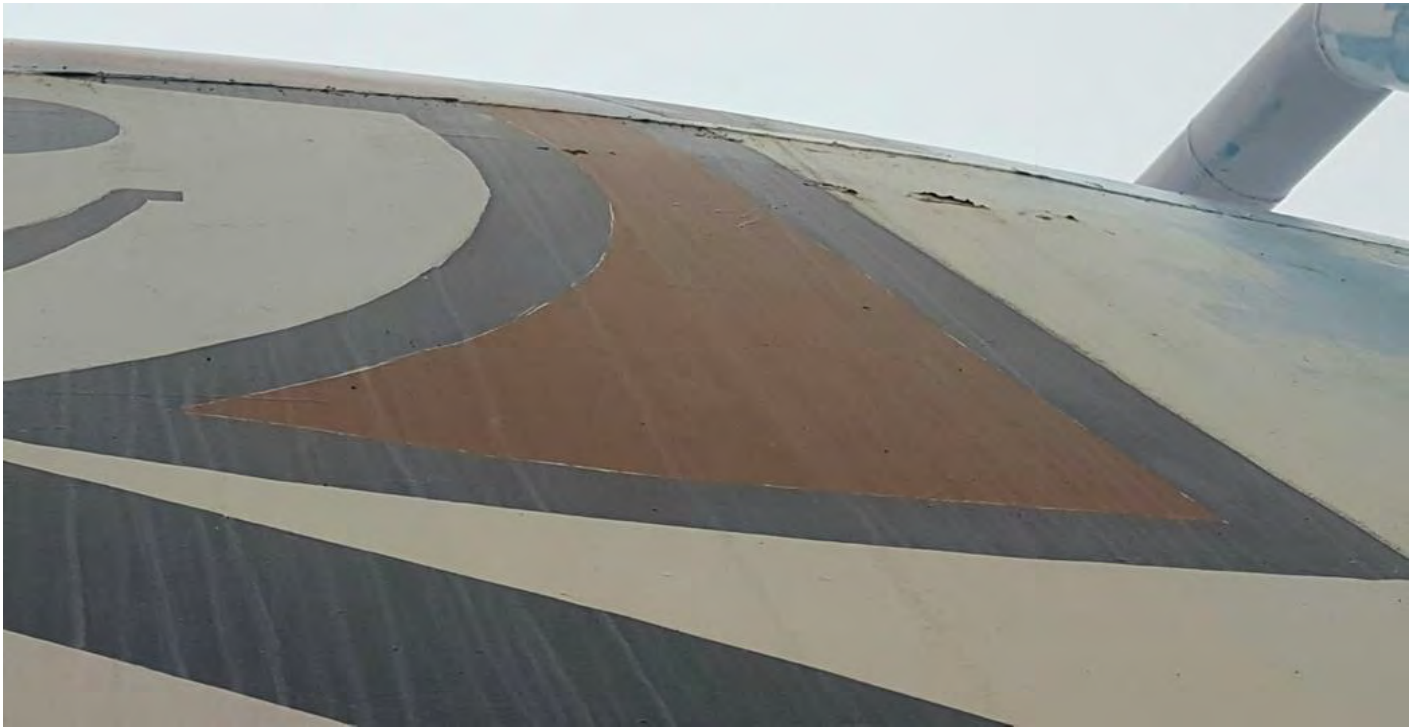
**General Coating Condition**

While the majority of the coating remains intact, it has oxidized and is exhibiting a general loss of gloss and is chalking in most areas. In areas of southern exposure, the top coat has largely worn away exposing the mid-coat in large areas. There are areas where the coating has failed, exposing bare metal, particularly along weld seams. The average Dry Film Thickness (DFT) was approximately 6 mils.
